Road Safety Audit Review

VT 15 & I-89 Exit 15 NB City of Winooski

April 6, 2006

Road Safety Audit Review Review Report

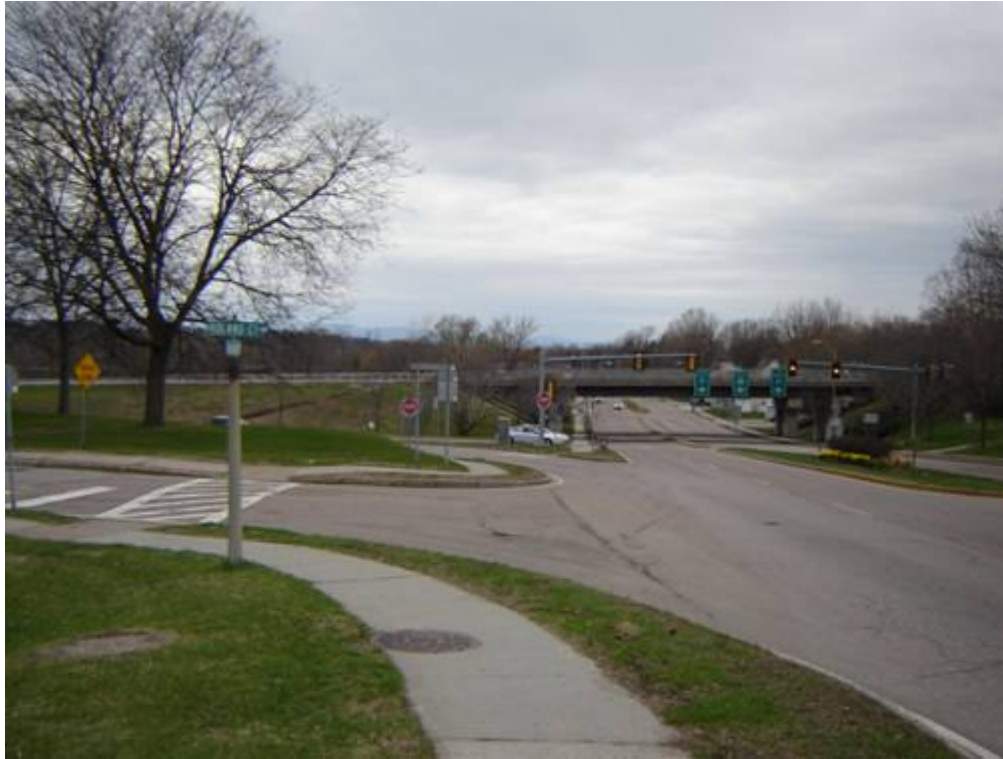
**Figure 3.
VT 15,
Looking
West (Roland
Court is first
on the left
hand side
followed by
the I-89 slip
lane)**

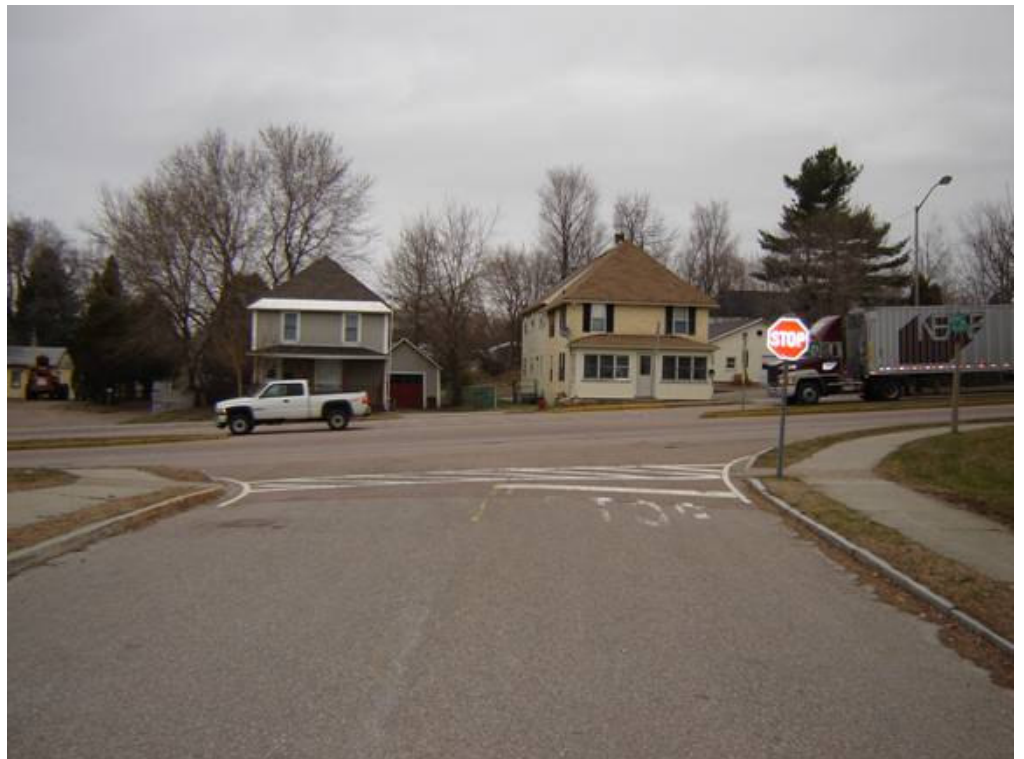
**Figure 4. Roland
Court, Looking
North towards
VT 15**

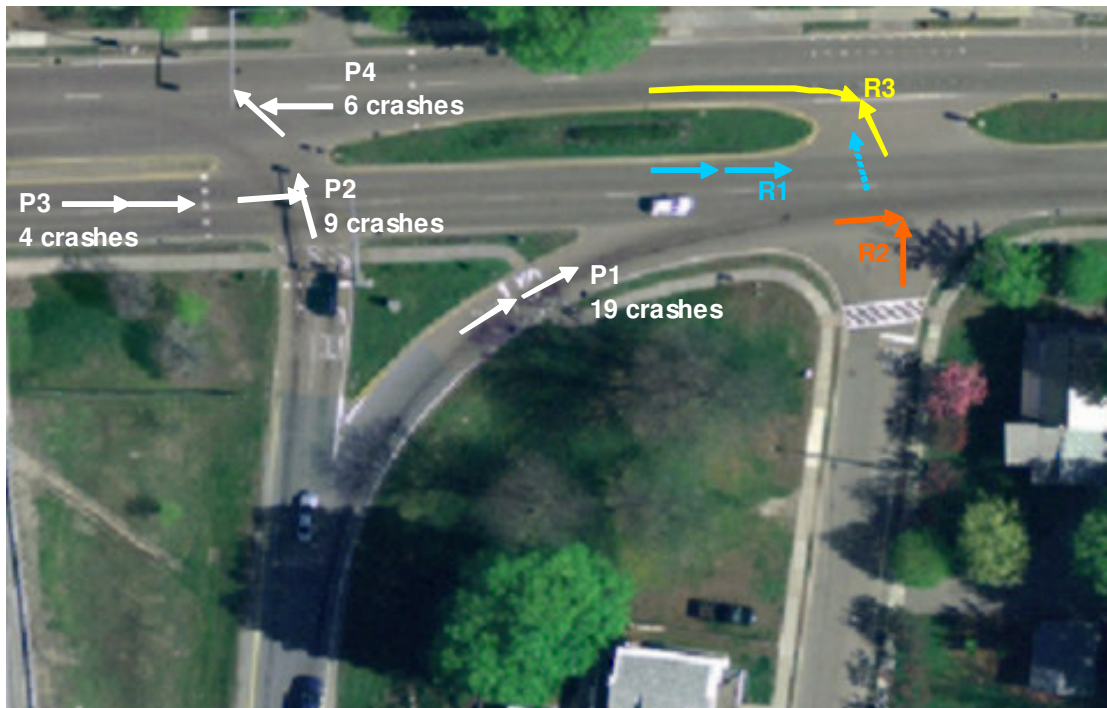
Figure 5. Major Crash Patterns for the 2001-2004 Reporting Period

The crash reports for the 2001 to 2004 reporting period were reviewed in order to identify prominent crash patterns within the area of concern. Four crash patterns were recognized as illustrated in Figure 5.

The pattern with the most crashes (P1 in Figure 5) took place at the slip lane. In this case, motorists rear-ended each other as a result of the first car stopped at the stop sign moving and stopping again and the motorist behind thinking that the car in front was gone.

The second pattern with the most crashes (P2) took place on the eastbound approach on VT 15. On this approach, people were involved in right-angle crashes due to red light running on VT 15. In the crash report narratives, some of the motorists involved said that the sun was shining on the signal lenses and that they could not tell the color of the traffic lights. Some others simply stated that the lights went from green to yellow.

Still on the eastbound approach, a less important pattern (P3) consists of rear-end crashes in which the front vehicle stopped for the change of lights.

In the westbound direction, right-angle crashes at the intersection are also taking place (P4). As was the case for pattern P2, these crashes are due to red light running. In the narratives of the crash reports, a couple of motorists indicated that they had failed to notice the color of the light or that it was red. For the other crashes, the reason was not stated.

Another somewhat recognizable pattern is the one with rear-end crashes in the deceleration lane (P5). In this instance, somebody was usually rear-ending another vehicle as a result of the vehicle at fault driving too fast to stop in time. There were two such crashes during the four-year period (at least another one was recorded for 2005).

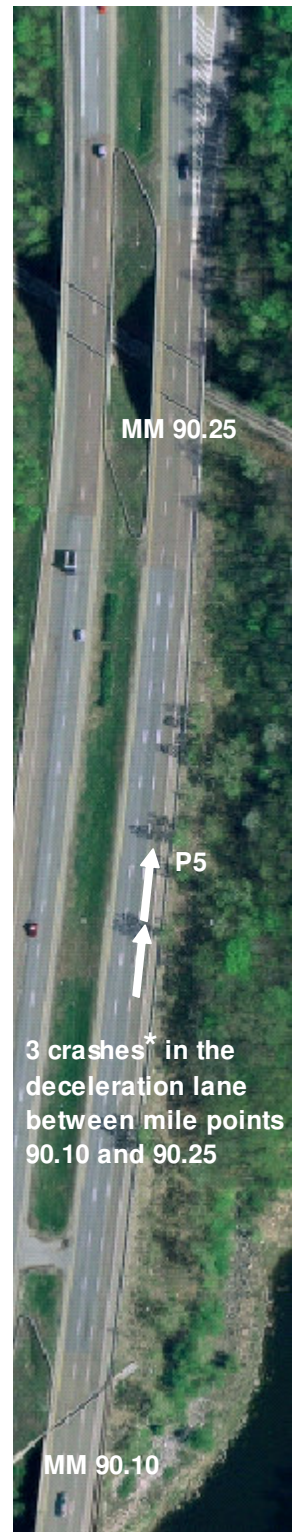
Roland Court Crashes

R1: Rear-end; Time 0715; VT 15 vehicle stopped to let a car out of Roland Ct.

R2: Right-angle; Time 0559; Motorist out of Roland Ct did not observe any traffic on VT 15, made left turn.

R3: Head-on; Time 0715; Resident came out of drive at 363 E, went EB in WB lane to reach the median opening.

See the text for comments on P1 through P 5

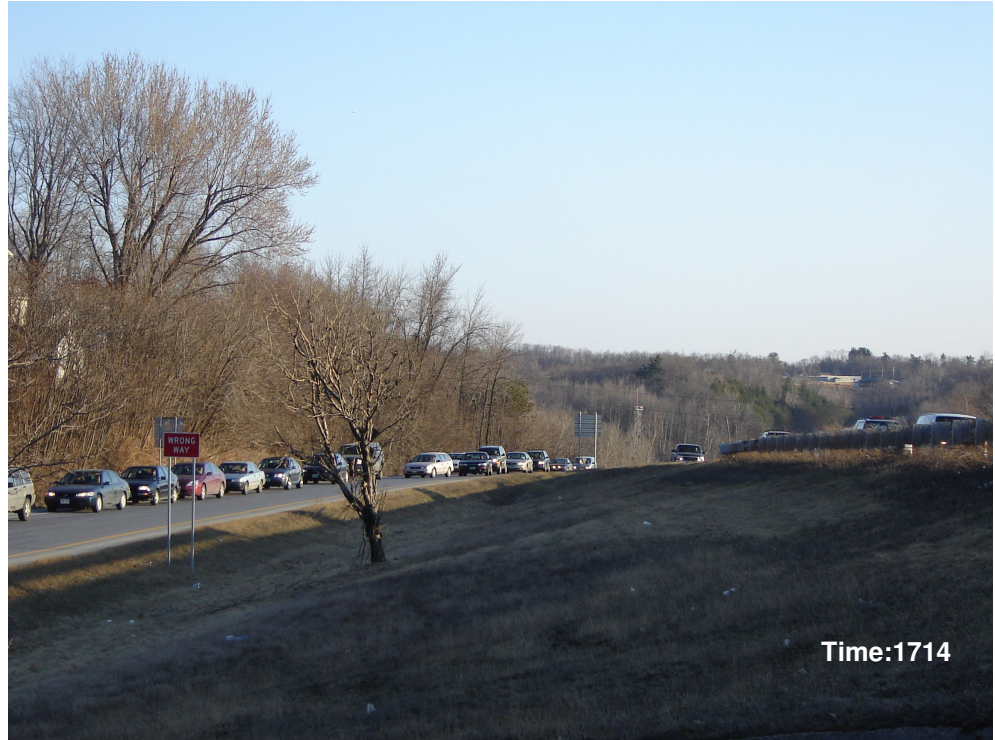
**Figure 6.
Right
Turning
Traffic
Queues-up on
the Off-
Ramp during
the PM Peak**

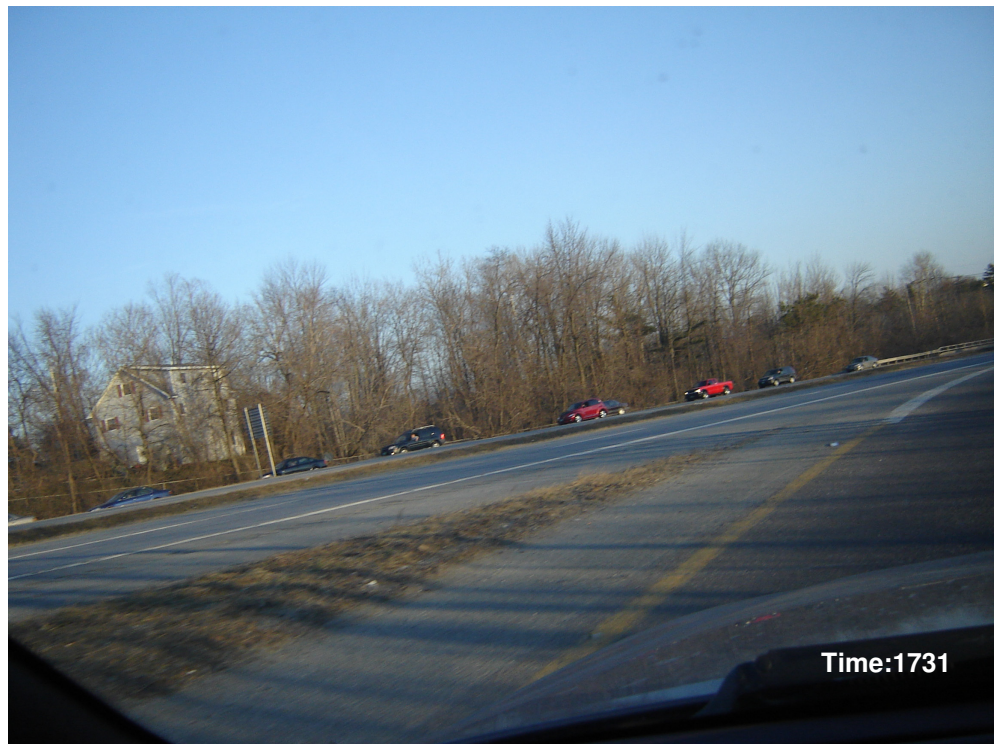
**Figure 7.
The Queue
Extends Past
the Gore
Area into the
Deceleration
Lane on I-89
NB during
the PM Peak
(View is from
the on ramp)**

3) continued - Traffic queues up on the off-ramp past the gore area into the deceleration lane during the PM peak hour.			√							b) Install a yellow Exit Only sign (E11-a) below the E-61 guide sign.
