Appendix A: Phase 2 Report

1.0 INTRODUCTION

This Phase 2 report summarizes existing and future transportation/land use conditions and potential performance measures. Section 2.0 assesses existing land use, access management, safety, bicycle and pedestrian facilities, and transit service. Performance measures (Section 3.1) are presented for evaluating existing multimodal transportation performance. Section 3.3 applies these performance measures to the year 2010 to establish an understanding of existing conditions, while Section 3.4 assesses conditions in the year 2035. Vehicular mobility is evaluated using a traffic microsimulation model.

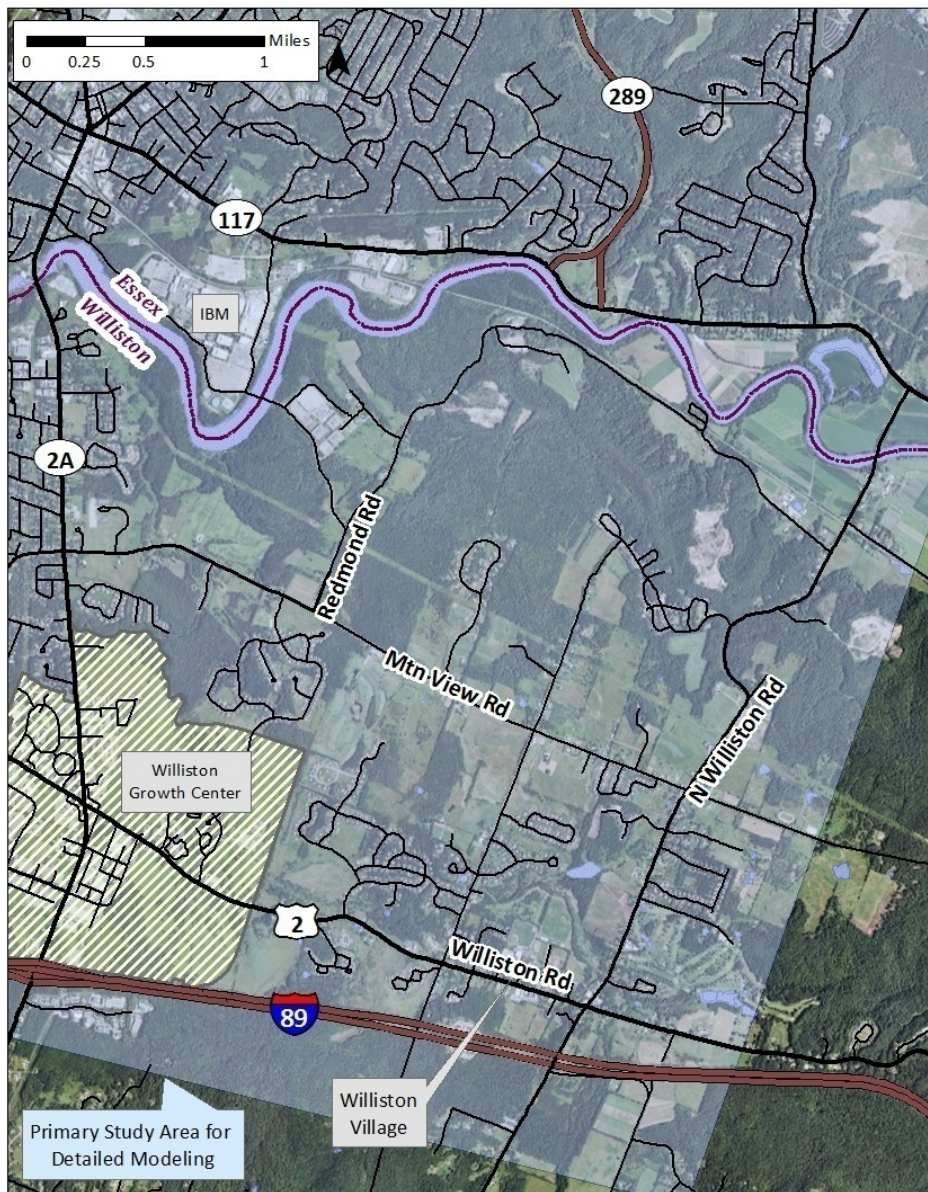
Figure 8: Mountain View Road, Redmond Road, and North Williston Road Corridors

Mountain View Road between VT2A and North Williston Road (see vicinity map in Figure 8) serves as a collector for adjacent residential neighborhoods and frontage residences. Between Mountain View Road and US2 are medium density residential land uses. The dominant land uses north of Mountain View Road are categorized as agriculture/rural residential that include large lot single family homes, agriculture properties, and largely undeveloped areas within Williston.

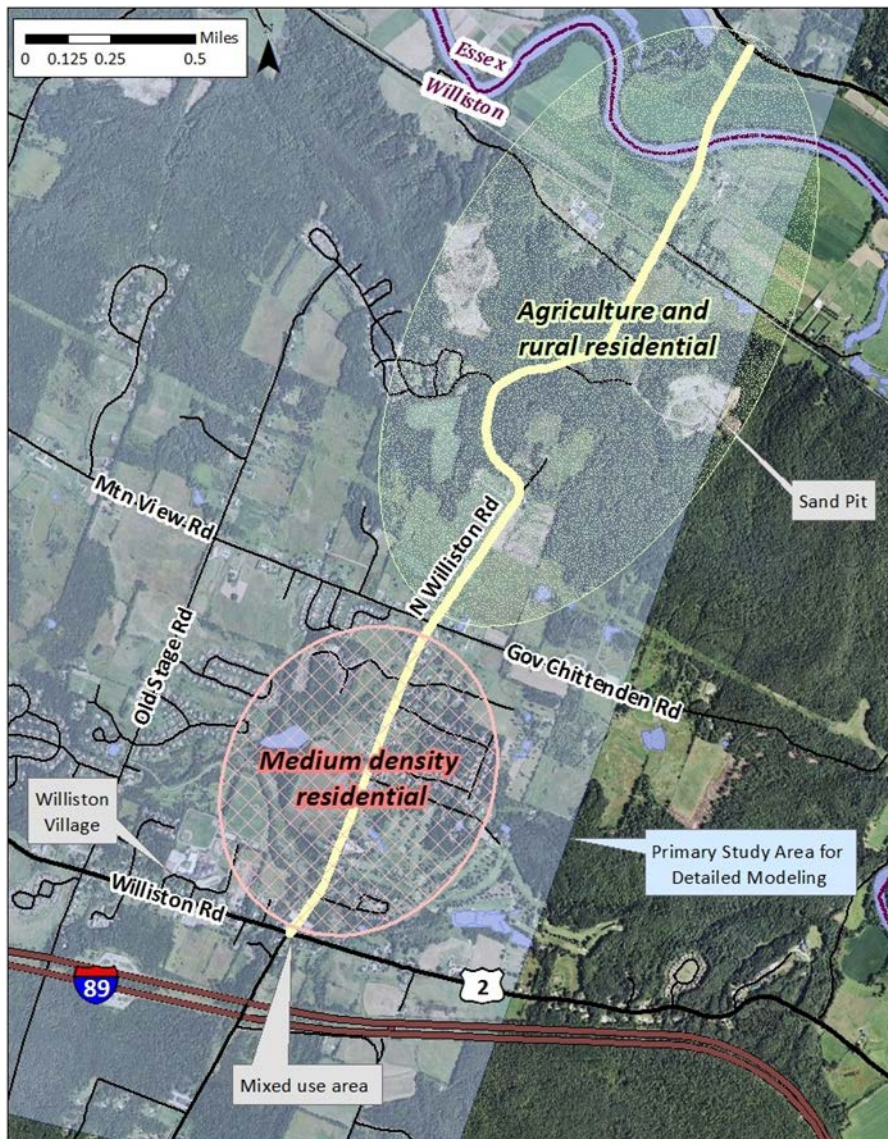
Figure 9: Land Uses on North Williston Road

As shown in Figure 9, north of Mountain View/Governor Chittenden Road, the dominant land uses of North Williston Road are agriculture/rural residential and largely undeveloped areas. The one exception is the Sand Pit used for mining and extraction. To the south of Mountain View Road are medium density residential land uses. The land uses at the intersection of US2 and North Williston Road are a moderately dense mix of residential, institutional, and commercial uses that leads to Williston's historic village. Both southern quadrants of the intersection are residential.

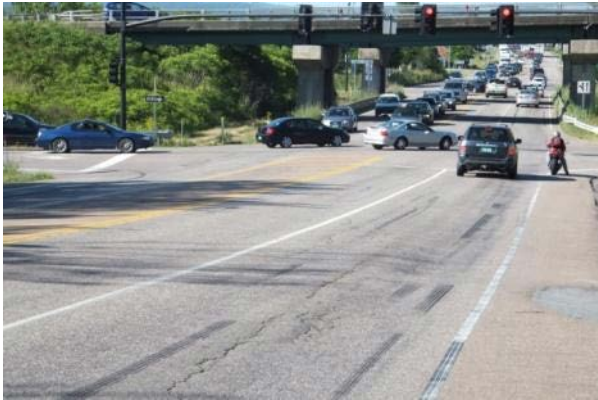
Potential Issues	Example
<p>Issue 1: Downgrade</p> <p>Based on a review of the crash history, 13 of the 17 crashes, for which the direction of travel was coded, occurred on the northbound approach of VT 2A. These crashes included four rear-end crashes, three sideswipe same direction crashes, and one single vehicle crash that may be correlated with the downgrade. There are multiple skid marks on the downgrade, which is further evidence of a potential safety issue.</p>

<p>View of the northbound approach along VT 2A. Photo shows the multiple skid marks at the bottom of the downgrade.</p>

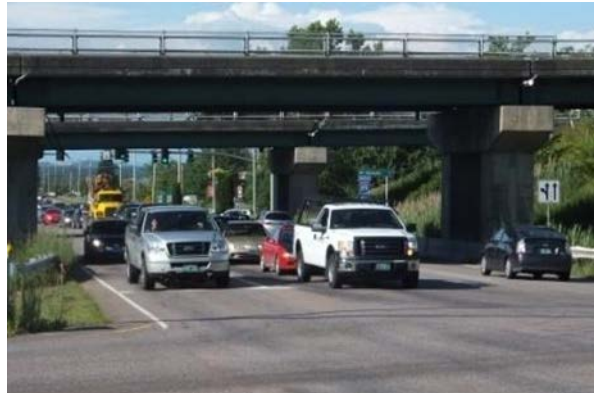
Based on a review of the crash history, there appears to be a slight increase in crashes for the morning and midday peaks, and a substantial increase in crashes for the evening peak. The crash potential was confirmed during evening peak review as long queues were observed to extend from the intersection at the southbound ramp back through Marshall Avenue to Conner Drive.

View of southbound approach of VT 2A during PM peak. Photo shows the lengthy queue that extends north through several intersections.

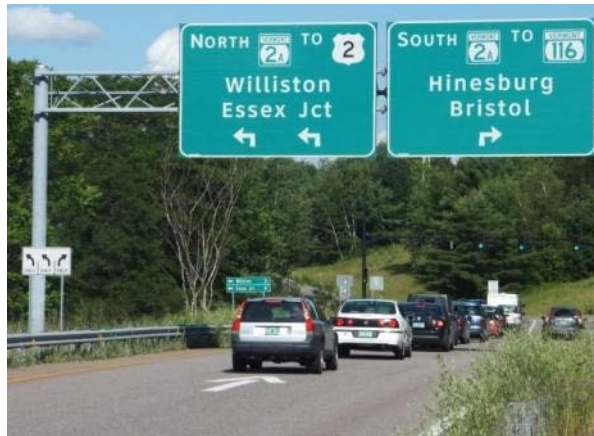
Lane markings are present near the intersection to designate three lanes (left, shared thru-left, and exclusive right-turn lane), but the southbound ramp is relatively wide and designated as a single lane where the deceleration lane diverges from the freeway. Drivers tend to queue in the middle lane and do not fully utilize the dual left-turn lanes, which is the predominant movement. There are no skip marks to guide adjacent turning vehicles in the dual left-turn lanes from the southbound ramp onto VT 2A. One of the five crashes on the southbound ramp was a sideswipe same direction crash.

View of I-89 southbound off-ramp. Photo shows the relatively wide cross-section with limited pavement markings to designate lane use. A queue is building in the center lane that serves as a shared thru-left, while the left-most lane is under-utilized.

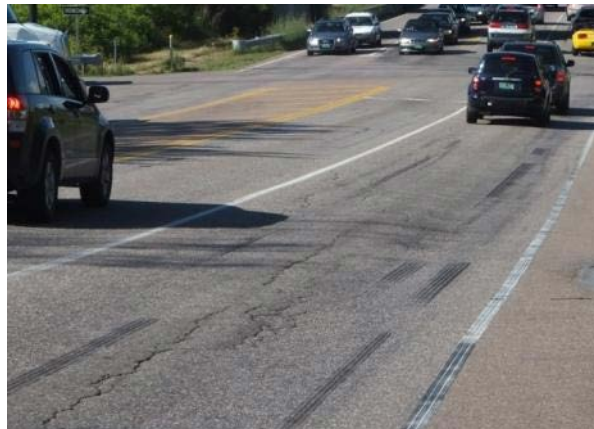
Issue 4: Poor pavement condition

More than 20 percent of the crashes occurred during wet conditions (i.e., rain, snow, or sleet).

The pavement condition at the intersection is in fair to poor condition. There is evidence of pavement rutting, particularly on the downgrade, which can contribute to wet-weather crashes.

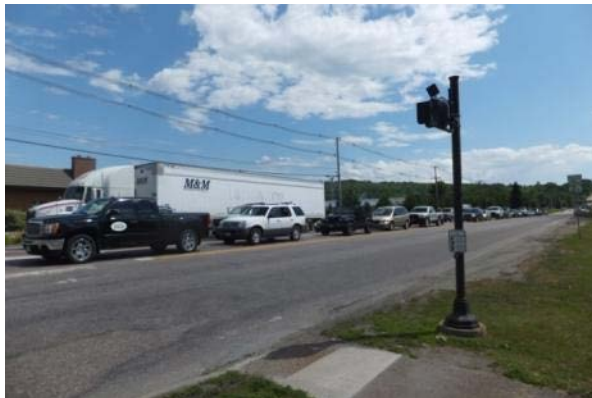
Potential Issues	Example
<p>Issue 1: Peak period congestion</p> <p>Based on a review of the crash history, there appears to be an increase in crashes for the evening peak. The crash potential was confirmed during evening peak review as long queues were observed in the northbound left-turn lane, eastbound through and left-turn lanes, and westbound shared through/right-turn lane. Double-cycling is occurring on these approaches and several vehicles must wait for the next cycle.</p> <p>Long queues in the eastbound through lane block the right-turn lane in the PM peak. The queues back-up almost to Trader Lane at certain times. The queue from Trader Lane is also long and exacerbated by the northbound left-turns; this queue extends back to VT-2A at certain times of the day.</p> <p>More than 60 percent of crashes at this location are rear end and more than 90 percent are property damage only. This is likely associated with the congestion as there is a large number of relatively low-speed and low-severity crashes.</p>

<p>View of the northbound approach of VT 2A. Photo shows a substantial queue in the northbound left-turn lane.</p>

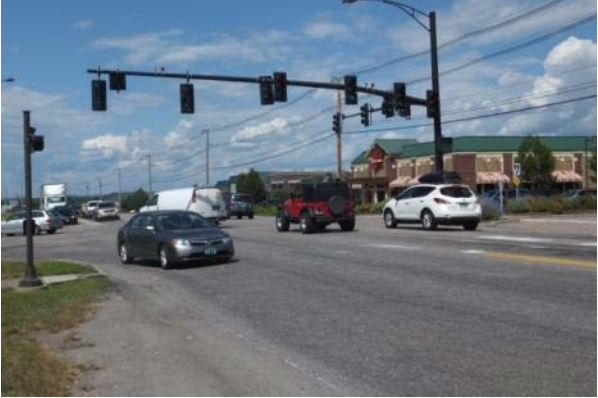
Potential Issues	Example
<p>Issue 2: Driver behavior</p> <p>It appears that congestion and delays are leading to undesirable driver behavior. Specifically, drivers often use the end of the yellow interval and the all red interval to enter the intersection so they do not have to wait for the next cycle. Several red-light violations were observed at the onset of the red interval.</p> <p>Despite the fully-protected left-turn phasing at this intersection, 14 percent of crashes are left-turn. This is an indication of drivers violating the red interval.</p> <p>Based on a review of the five-year crash history, 41 of the 86 crashes were reported as “inattention”, “distracted”, or “drowsy” driving.</p>

<p>Photo shows a white van entering and completing a left-turn during the red interval.</p>
<p>Issue 3: Limited lane guidance for dual lefts</p> <p>There are no skip marks to guide adjacent turning vehicles in the dual left-turn lanes from the westbound approach onto VT 2A.</p> <p>One of the ten crashes from the westbound approach was a sideswipe same direction crash.</p>

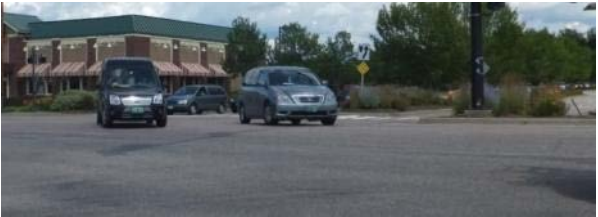
<p>View of the westbound approach. Photo shows the dual left-turns from Maple Tree Place and the lack of skip marks to guide adjacent drivers.</p>

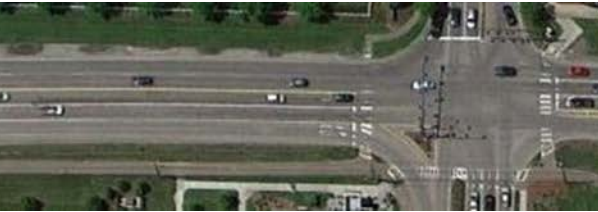
<p>Issue 4: Right-turn trap on NB approach</p> <p>There are two lanes in the northbound direction and the right lane turns into a right-turn-only lane. This may contribute to sideswipe same direction crashes when drivers are not aware of the right-turn trap and change lanes to stay in the through lane.</p> <p>Based on a review of the crash history, 6 of the 67 crashes on VT 2A were coded as sideswipe same direction; 4 of the 6 sideswipes were coded as northbound and the remaining 2 were not coded.</p>

<p>Aerial view of VT 2A approaching the intersection of Marshall Drive / Maple Tree Place. Image shows the 4-lane cross-section that transitions to a single through lane moving left to right.</p>
<p>Issue 5: Poor pavement condition</p> <p>Nearly 20 percent of the crashes occurred during wet conditions (i.e., rain, snow, or sleet). There is evidence of pavement rutting and smoothing along the NB and SB approaches, which may be contributing to wet-weather crashes.</p>

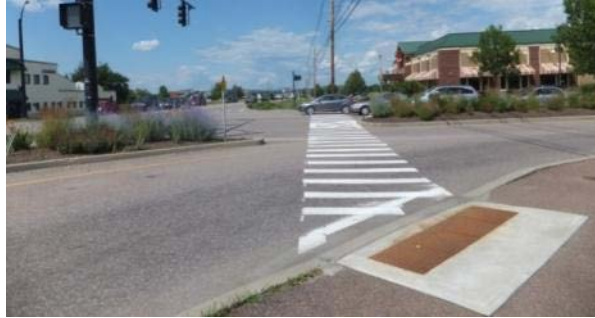
During the field review, one pedestrian commented that the crossing time was too short to cross VT-2A. The crossing time appears to be based on the 4ft/s walking speed assumed in the old version of the MUTCD. The latest version assumes a slower walking speed to account for pedestrians with mobility restrictions. There are limited pedestrian facilities on the west side of the road and no crosswalk across the eastbound approach. The pedestrian signal in the northeast quadrant is not working properly (appears that a bulb is out).

View of the crosswalk across Maple Tree Place. Photo shows the relatively long crossing distance for pedestrians.

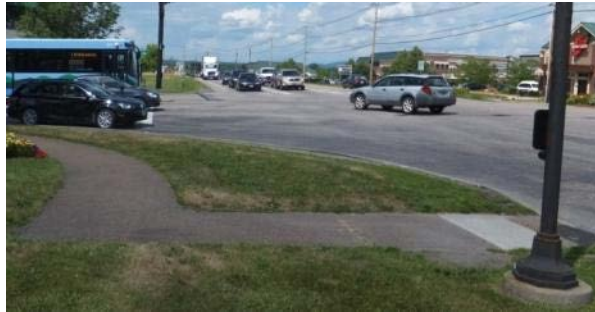
View looking north from the southwest corner. Photo shows the discontinuous sidewalk and the lack of crosswalk across Marshall Avenue.

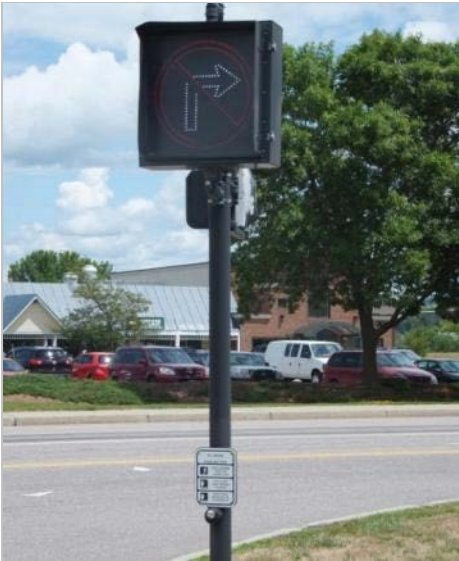
There are blank-out signs to prohibit right-turn-on-red when the pedestrian signal is activated. This helps to limit conflicts between crossing pedestrians and right-turning vehicles.

Photo shows the no right-turn-on-red sign activated when the pedestrian phase is activated.

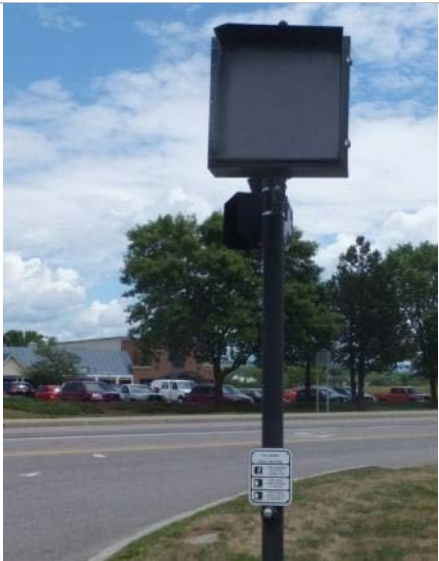
Photo shows the no right-turn-on-red sign “blacked-out” when the pedestrian phase is not activated.

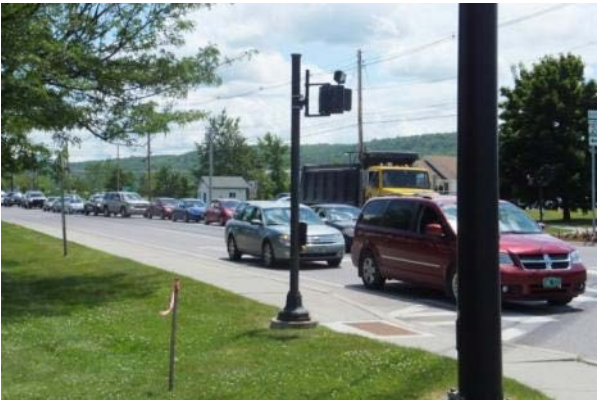
Potential Issues	Example
<p>Issue 1: Peak period congestion</p> <p>Based on a review of the crash history, there appears to be an increase in crashes for the midday peak and even more so for the evening peak. The crash potential was confirmed as long queues and double-cycling were observed during the midday peak for the VT-2A northbound and southbound left-turn and through movements. During the evening peak, long queues and double-cycling were observed for the westbound left-turns and southbound through movements. Queues from the WB left-turn lane were also observed spilling-over to the through lane. The through vehicles utilized the right-turn lane to avoid the queue, but this is not an optimal situation. More than 40 percent of crashes at this location are rear end and 90 percent are property damage only. This is likely associated with the congestion as there is a large number of relatively low-speed and low-severity crashes.</p>

<p>View of westbound approach. Photo shows the lengthy queue in the evening peak.</p>

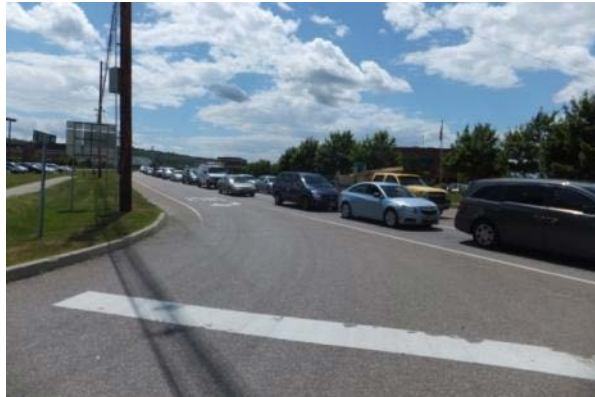
View of northbound approach. Photo shows the lengthy queue in the midday peak.

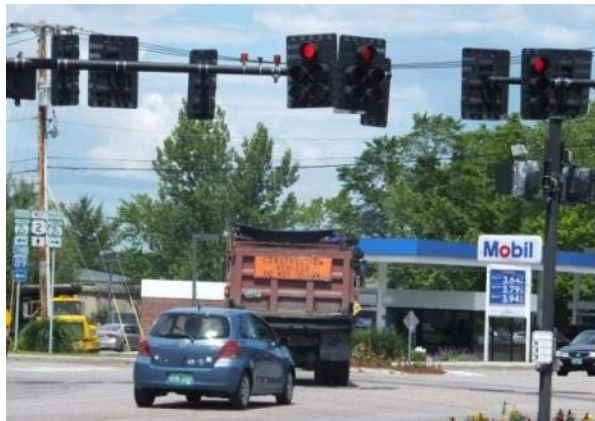
Based on a review of the five-year crash history, 43 of the 105 crashes were reported as “inattention” or “distracted” driving.

Photo shows two left-turning vehicles entering the intersection during the red interval after the protected left-turn phase.

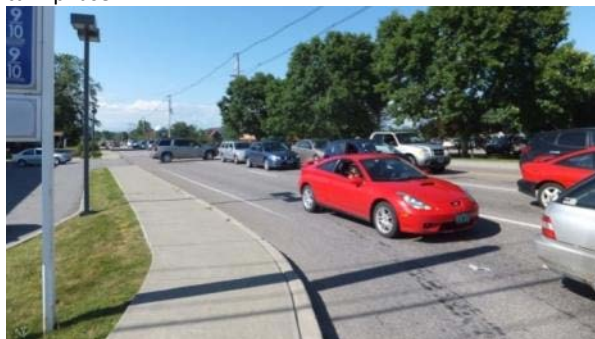
View of southbound approach. Photo shows the lengthy queue in the evening peak and undesirable behaviors where drivers are forcing their way into the queue to turn left out of driveways near the intersection.

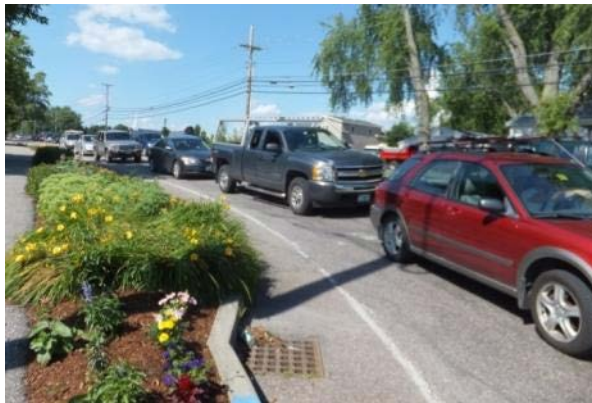
Potential Issues	Example
<p>Issue 1: Peak period congestion</p> <p>Based on a review of the crash history, there appears to be an increase in crashes for the morning, midday, and evening peaks. The crash potential was confirmed, particularly during the midday and evening peaks as long queues and double-cycling were observed for the VT-2A southbound approach. The queues from the southbound through lane block the right-turn lane. Nearly 60 percent of crashes at this location are rear end and 96 percent are property damage only. This is likely associated with the congestion as there is a large number of relatively low-speed and low-severity crashes.</p>

<p>View of the southbound approach along VT 2A. Photo shows the lengthy queue blocking the right-turn lane during the midday peak.</p>
<p>Issue 2: Driver behavior</p> <p>Based on a review of the five-year crash history, 17 of the 49 crashes were reported as “inattention” or “distracted” driving and 2 crashes were reported as “impaired” driving.</p>

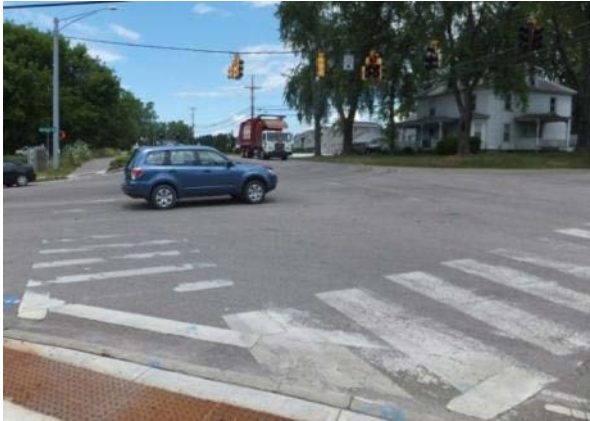
<p>View of crosswalks looking north from the southwest corner. Photo shows the relatively long crossing distance and faded crosswalks.</p>

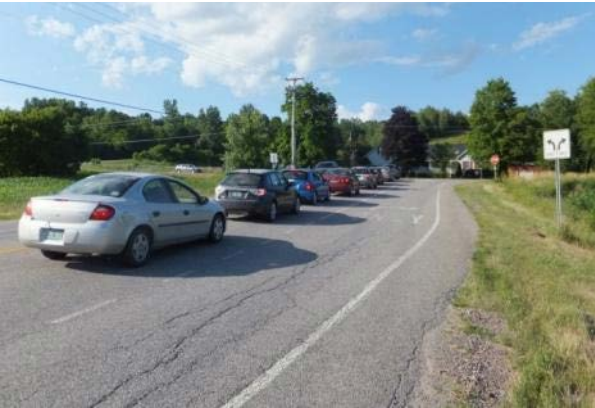
Potential Issues	Example
<p>Issue 1: Peak period congestion</p> <p>Based on a review of the crash history, there appears to be an increase in crashes for the evening peak. The crash potential was confirmed during the field review as moderate queues were observed on the stop-controlled approach (N. Williston Road) during the evening peak. During this time, there are fewer gaps on the mainline (VT 117) and drivers on the minor road must find a suitable gap.</p> <p>In some cases, the queue from the left-turn lane extended far enough to block the entrance to the right-turn lane. During these conditions, vehicles were observed using the shoulder to access the right-turn lane.</p> <p>Left-turn (45%) and angle (15%) crashes represent 60 percent of the total crashes at this location. These crash types are associated with gap-acceptance issues, particularly at a three-legged stop-controlled intersection where there are no through movements from the minor road.</p>

<p>View of minor road approach on N. Williston Road (northbound approach). Photo shows a lengthy queue in the evening peak.</p>

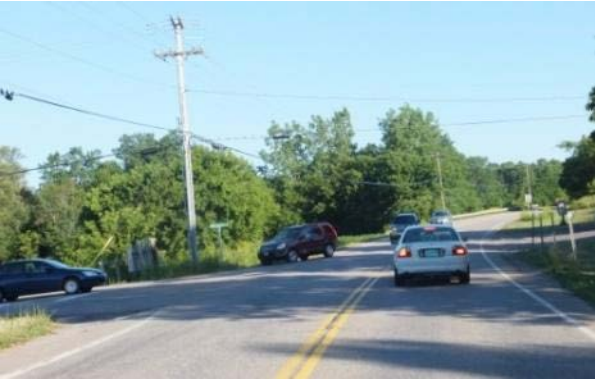
<p>View looking west from the mainline (VT 117). Photo shows a driver on the major road waiting for a suitable gap to turn left while another driver waits on the minor road for both directions to clear.</p>

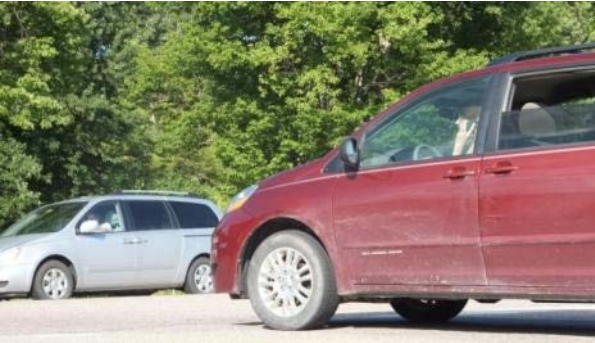
<p>Photo shows a driver talking on a cell phone while waiting to turn from the minor road.</p>

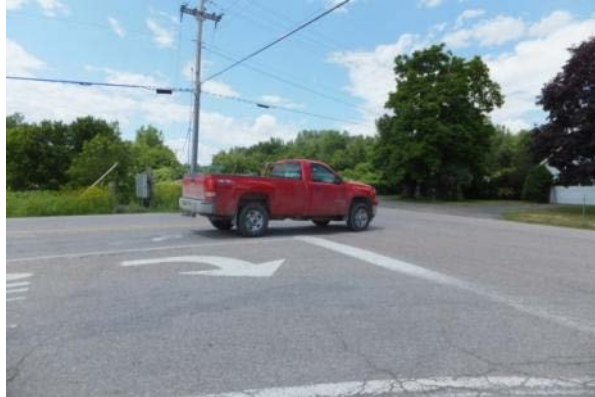
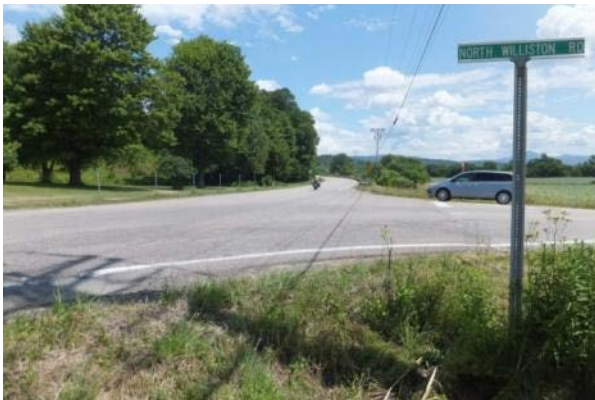
View of the intersection looking east. Photo shows the limited sight distance to the east due to the horizontal curve and vegetation.

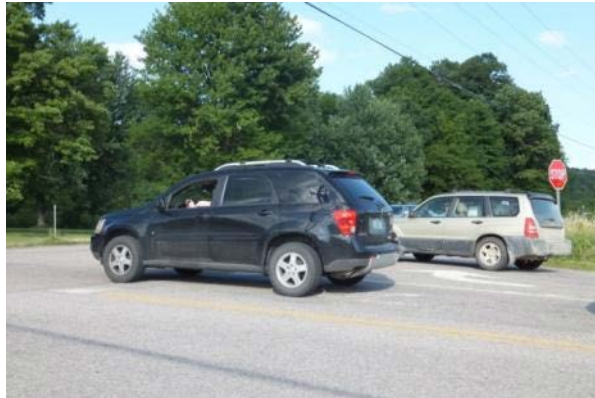
The third factor that contributes to sight obstructions at the intersection is the adjacent turn lanes from the minor road. When vehicles are in both the left- and right-turn lanes, they obstruct the view of the adjacent driver.

View of the northbound approach. Photo shows two adjacent vehicles that obstruct the sight distance of the other driver.

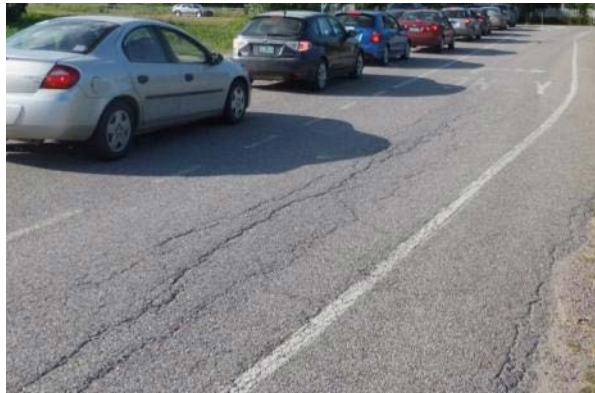
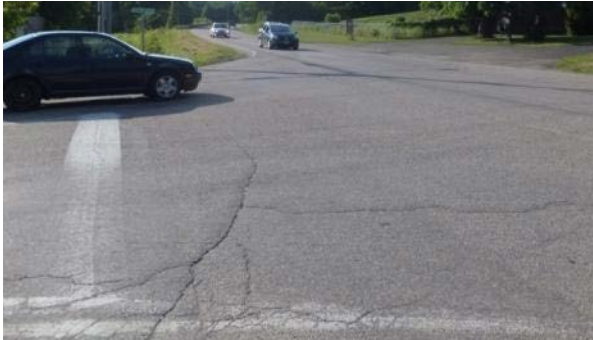
Issue 4: Poor pavement condition

There is evidence of pavement cracking, rutting, and smoothing near the intersection, which may be contributing to wet-weather crashes. Based on a review of the crash history, 10 percent of crashes occurred during wet conditions (i.e., rain, snow, or sleet), and the weather condition was not reported for 15 percent of crashes. The fatal crash at this location also occurred during wet conditions.

Examples of poor pavement condition at this location.

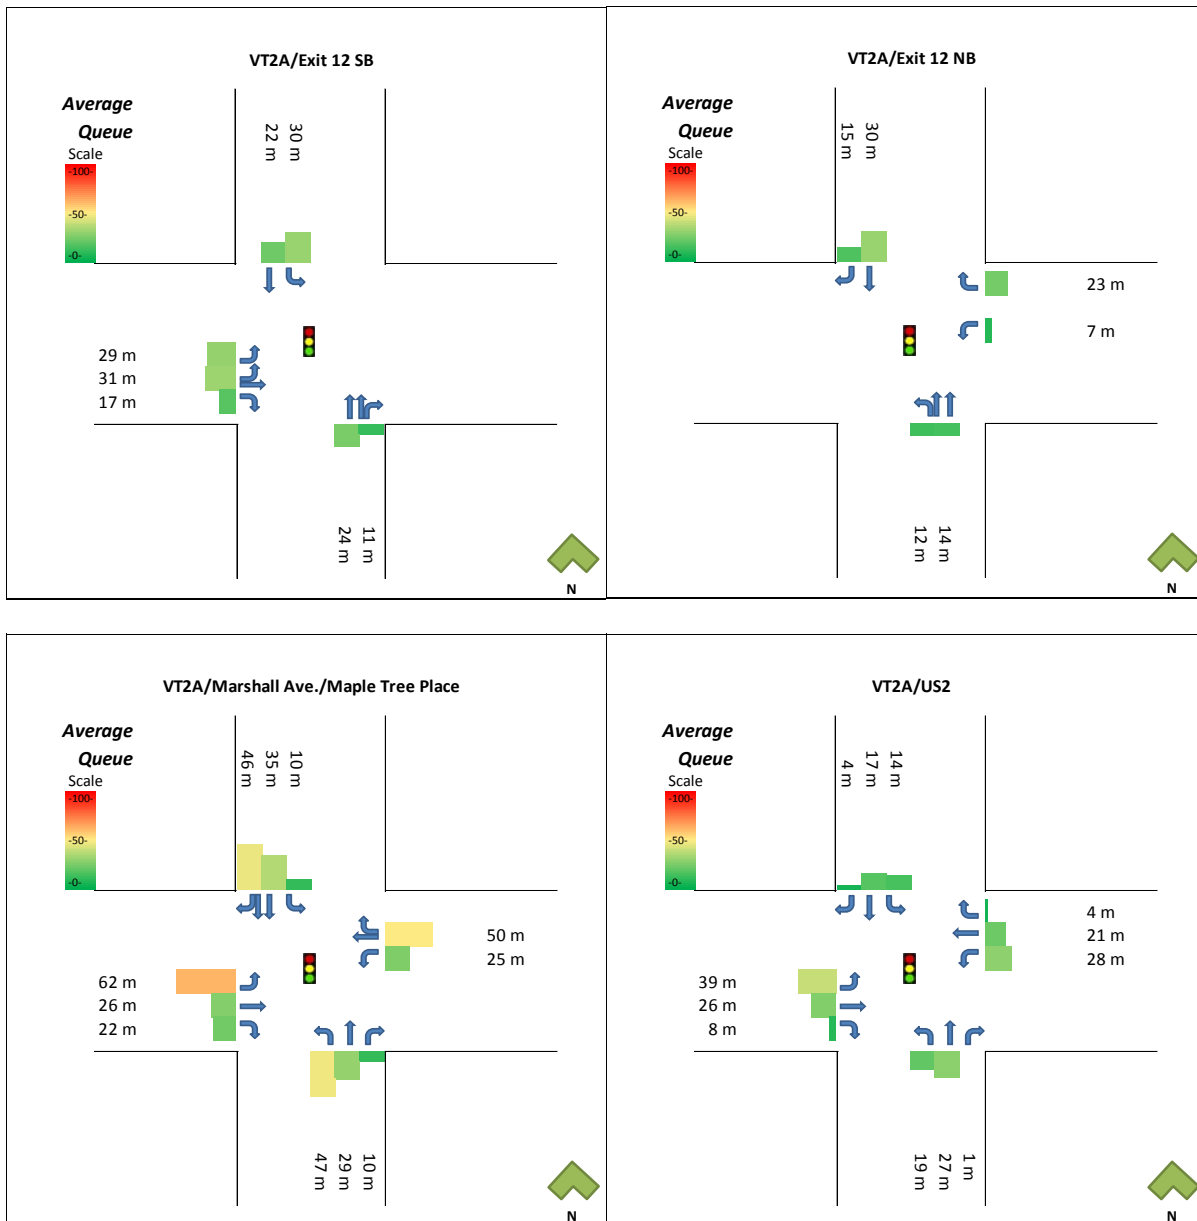
Figure 22: Average Queues in Meters by Lane-Primary Intersections, 2010 Base

The model results for Level-of-Service (LOS) and delay (Figure 21) and vehicle queues (Figure 22) for the primary study intersections are presented here. Overall intersection LOS is only available for signalized intersections.

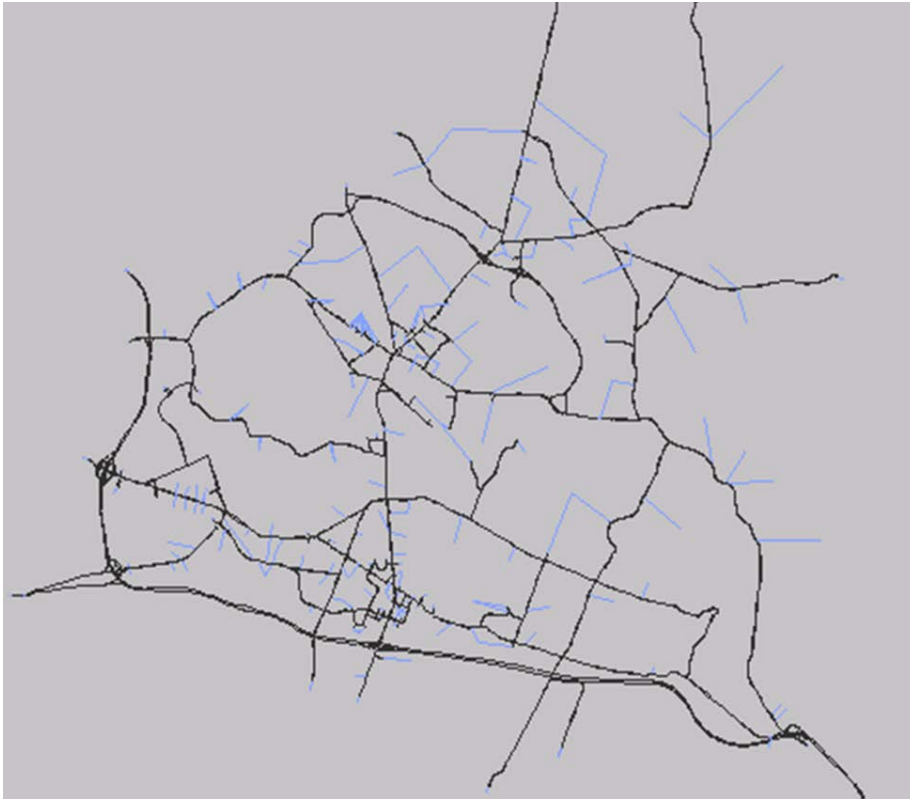
Figure 35: Microsimulation Model Network

The road network is represented using TransModeler, a microscopic traffic simulation software package that was developed by Caliper, the same software developer of TransCad, the CCRPC’s regional modeling software. Figure 35 shows a representation of the WENTS study area road network.

Road links are coded to represent road types differentiated by functional class (e.g. arterial, collector, local), incorporating information on road capacity and operating speed.

The model includes intersection controls (i.e. stop signs, signals, roundabouts), lane designations, circulation restrictions, and turn restrictions. The model incorporates detailed information on traffic signal timing, phasing, and sequencing.
