NORTH WILLISTON ROAD SCOPING STUDY EXISTING CONDITIONS

DECEMBER 2017

PREPARED FOR:
TOWN OF WILLISTON
CHITTENDEN COUNTY REGIONAL PLANNING COMMISSION

SUBMITTED BY:
RSG

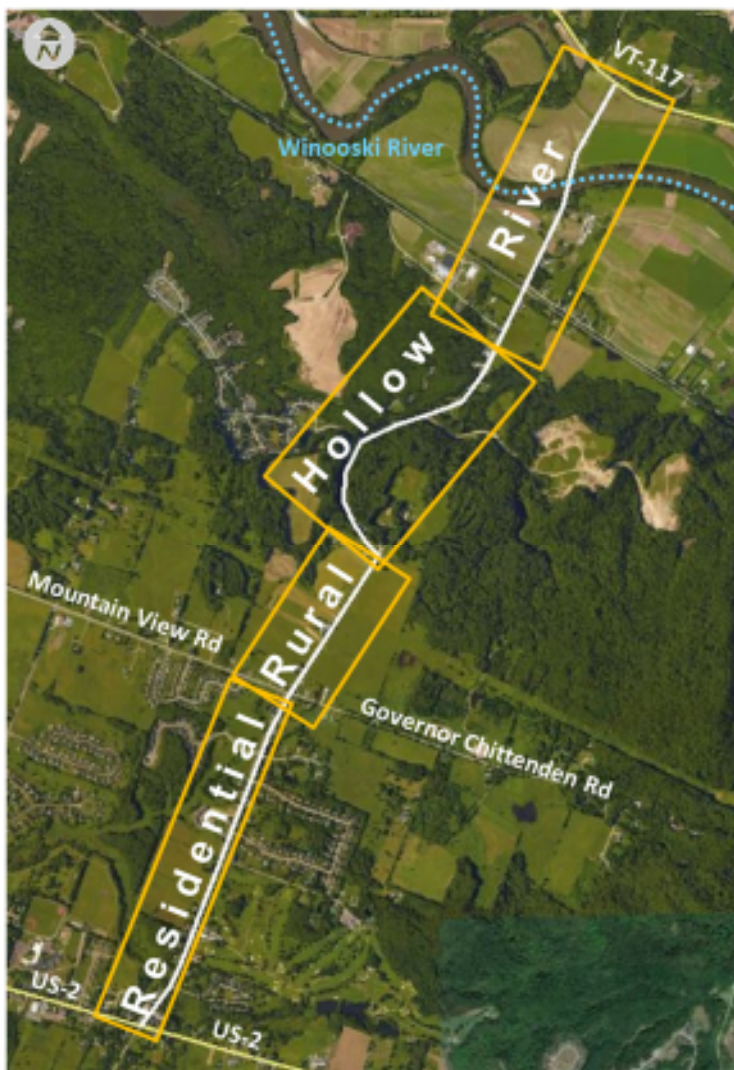
Figure 1-2. Roadway Segments

The geographic area of the study includes four distinct roadway segments along North Williston Road: residential, rural, hollow, and river (Figure 1-2). In the residential section, the roadway is 26-feet wide, with 10-foot travel lanes and 3-foot shoulders in both directions. In the remaining three segments, north of Mountain View Road, North Williston Road is approximately 24-feet wide, with 11-foot travel lanes and 1-foot shoulders. The right-of-way is assumed to be a 3-rod width (49.5 feet), according to the Town.

The **residential** segment is between Williston Road (US Route 2) and Mountain View Road, characterized by a denser development pattern with looping streets and cul-de-sacs that funnel vehicular traffic onto North Williston Road. The terrain is relatively level, and an existing 6-foot asphalt path runs along the western side of the roadway.

The **rural** segment is between Mountain View Road and Peterson Lane, characterized by less dense development, relatively level terrain, and no existing bicycle or pedestrian infrastructure.

The **hollow** segment is between Peterson Lane and Fay Lane, characterized by the relatively steep and winding descent northbound from the rural plateau to the Winooski River valley. The upper portion of the hollow is relatively undeveloped, with more houses

towards the river. Toward the middle of this segment is the tee intersection of Williston Woods Road, which provides access to a senior living community consisting of 122 manufactured homes. Throughout the rest of the Hollow segment, the roadway appears relatively narrow, with significant drainage ditches on both sides and no bicycle or pedestrian infrastructure.

The **river** segment is between Fay Lane and the Winooski River and includes the North Williston Historic District whose prominence came about with the advent of the railroad that passes through the area. The area is comprised of residential homes and agricultural use. There are no dedicated bicycle or pedestrian facilities on this roadway segment.

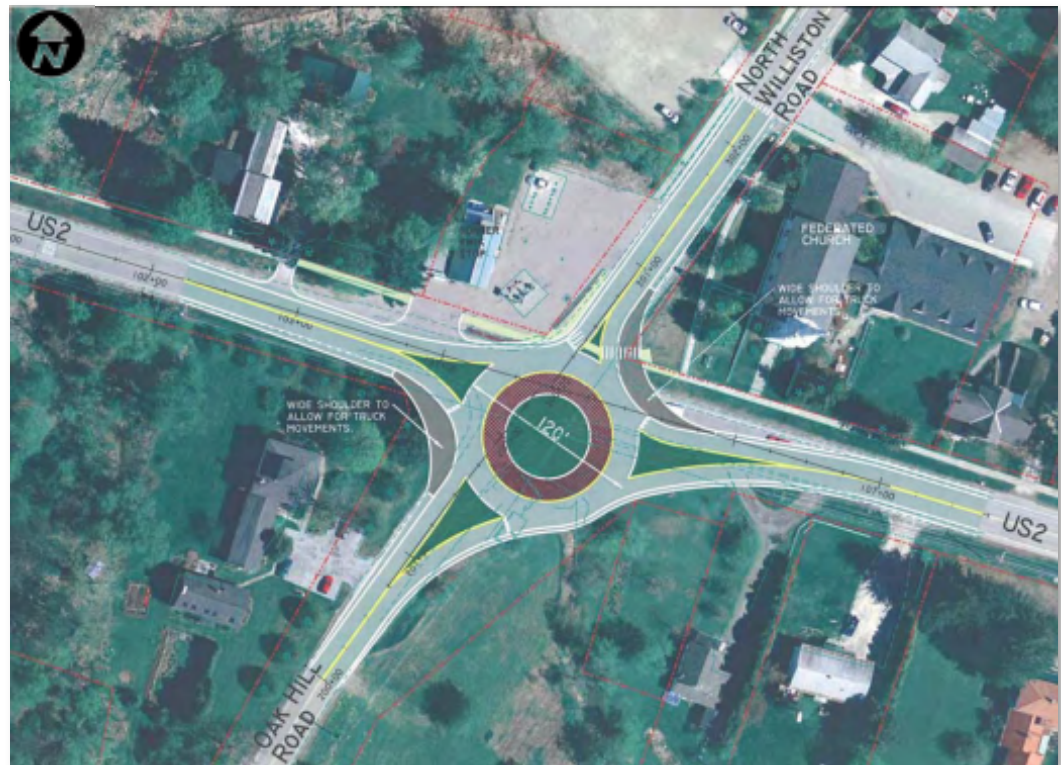
Figure 3-1. Roundabout Alternative of the US-2 Intersection Study

There were four considered alternatives, including a signal, a roundabout, and modifications of these. The Town Selectboard's initial preferred alternative was the roundabout alternative; however, following much public input, the decision was modified in favor of keeping the intersection as a four-way stop-controlled intersection.

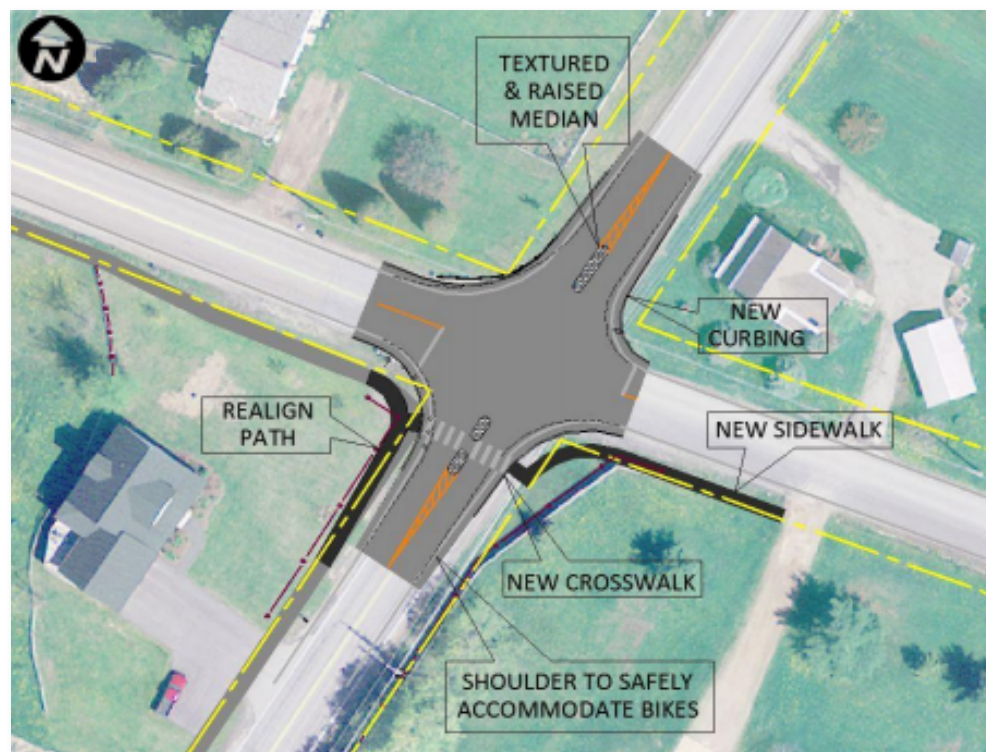
Figure 3-2. One Set of the Final Recommendations of the Mountain View Road Intersection Study

Six build alternatives were considered, ranging from converting to an all-way stop, to installing a roundabout. The preferred alternative was a combination of safety and traffic calming measures, which was partially implemented in the spring of 2013.

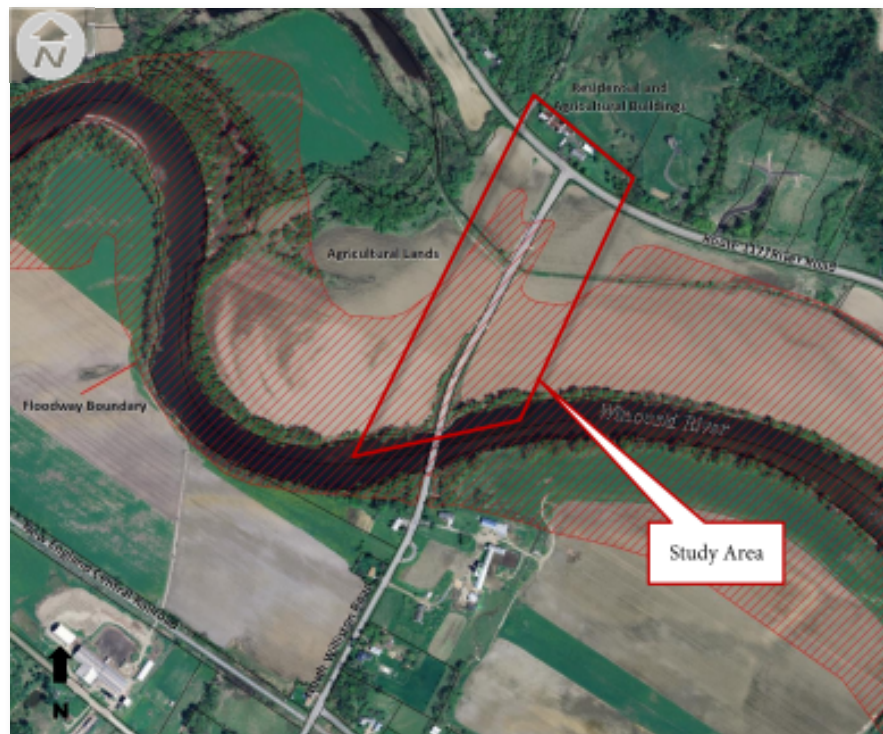
Figure 3-3. Floodway Boundary and VT-117 Intersection Study Area

1. Queuing and vehicle crashes during peak hours, partially caused by left turns from North Williston Road onto VT-117
2. Flooding of North Williston Road between this intersection and the Winooski River bridge several times each year

This study recommended alternatives to meet the two major needs of the intersection and surrounding roadway: 1) a resiliency project to reduce the duration and impact of roadway closures (including a wider culvert, reconstructed roadway banks, and a network of roadway closure alert signs), and 2) a roundabout or signal at the intersection of VT-117.

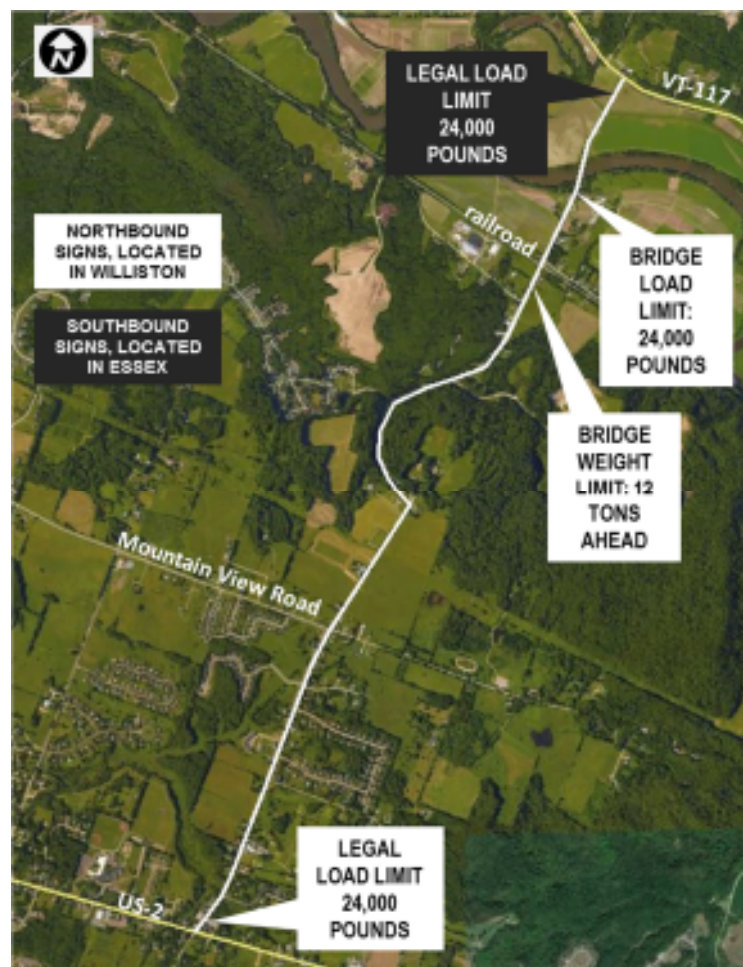
Figure 4-2: Weight Limit Signs on North Williston Road

Figure 4-2 shows the locations of weight limit signs in the northbound and southbound directions on North Williston Road.

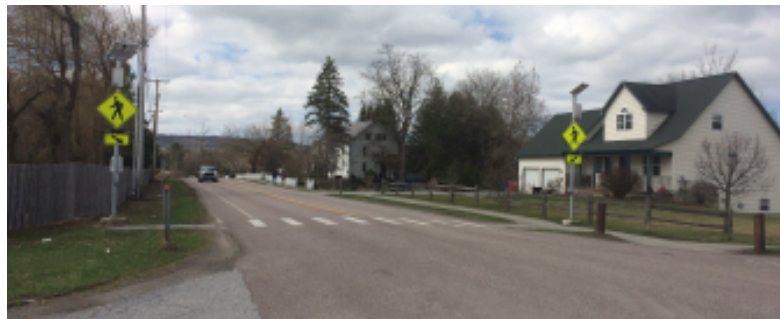
Figure 4-6. Pedestrian Crossing at Mountain View Road

There are six marked pedestrian crossings on North Williston Road, all of which are between US-2 and Mountain View Road. The Mountain View Road intersection has a crosswalk across the southern leg (northbound approach), with rectangular rapid flashing beacons (RRFBs).

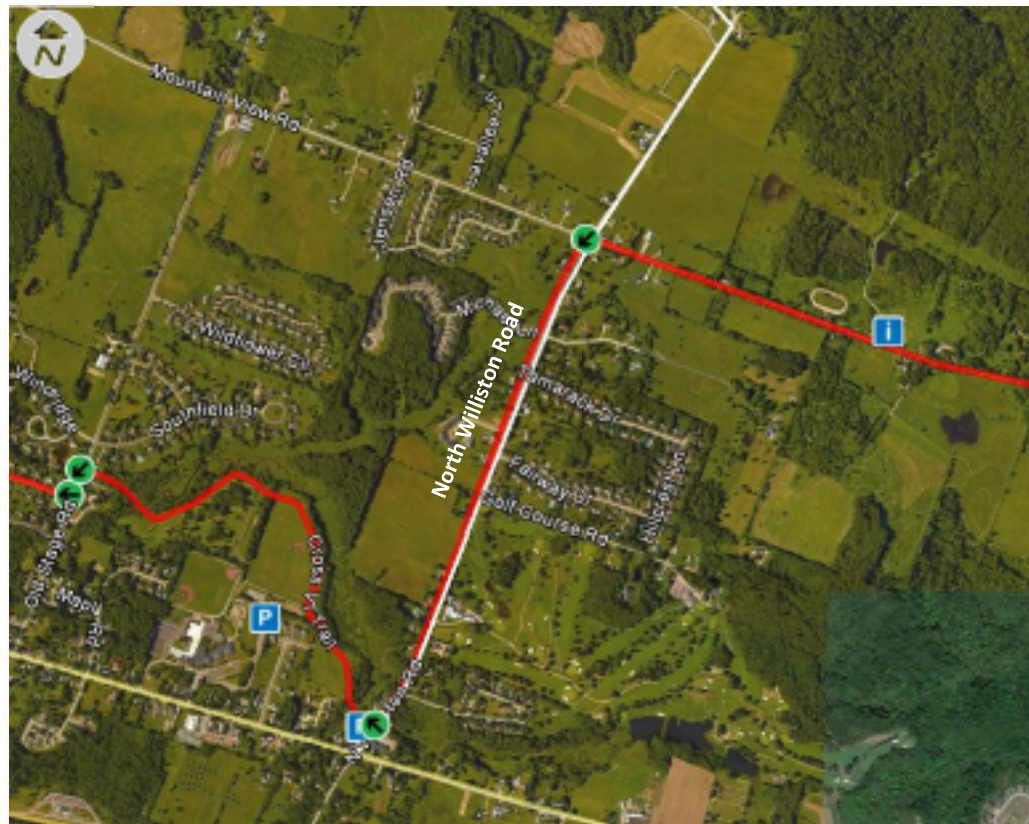
Figure 4-7. Cross Vermont Trail Map

The **Cross Vermont Trail**, an in-progress recreational path across the state being stitched together by a multitude of local paths, runs along the segment of North Williston Road south of Mountain View Road (unmarked), then veers off to the west on a marked Cross Vermont path. This off-road segment travels past Williston Central School and ends at Old Stage Road. Bicyclists on the segment along North Williston Road might use the asphalt sidewalk on the west side of the road or travel on the road itself.

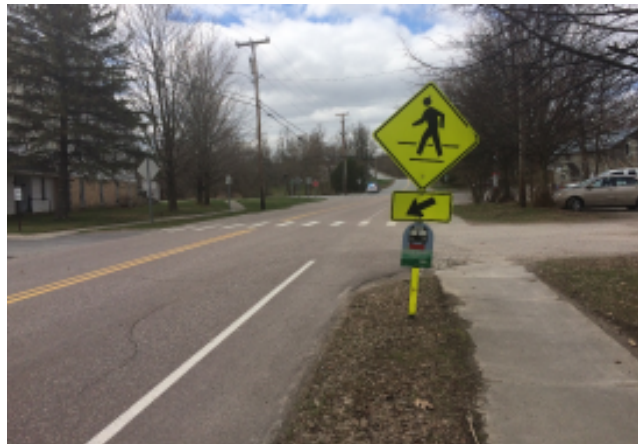
Figure 4-10. Bus Stop Near Williston Federated Church

Green Mountain Transit serves North Williston Road with the #1V (Williston Village) bus. The #1V bus is a spur of the #1 (Williston) route, which runs seven days a week between the Downtown Transit Center in Burlington and Tafts Corner in Williston. The #1V travels along US-2 between Tafts Corner and North Williston Road, along North Williston Road to Mountain View Road, and along Industrial Ave to US-2. The #1V loop occurs five times in a weekday and does not run on weekends. Along North Williston Road, it stops at the Williston Federated Church and Fairway Drive.

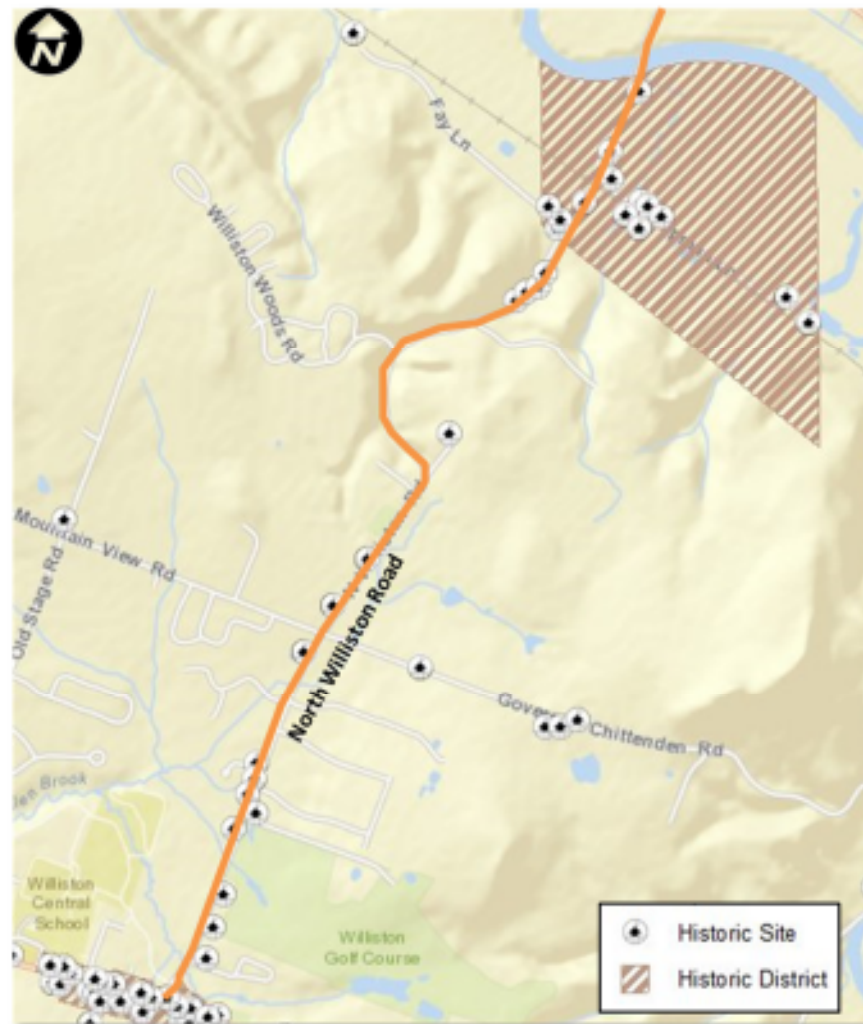
Figure 4-12. Historic Sites and Districts

There are a number of historic sites along North Williston Road, as well as a high concentration along US-2 in Williston Village. Williston Village and the segment of North Williston Road between Fay Lane and the Winooski River - part of the area of town sometimes called North Williston - are both historic districts. Development in North Williston was spurred by construction of a Central Vermont Railroad depot in 1850. The historic sites along North Williston Road shown in Figure 4-12 are largely houses and farmhouses built in the mid-1800s.

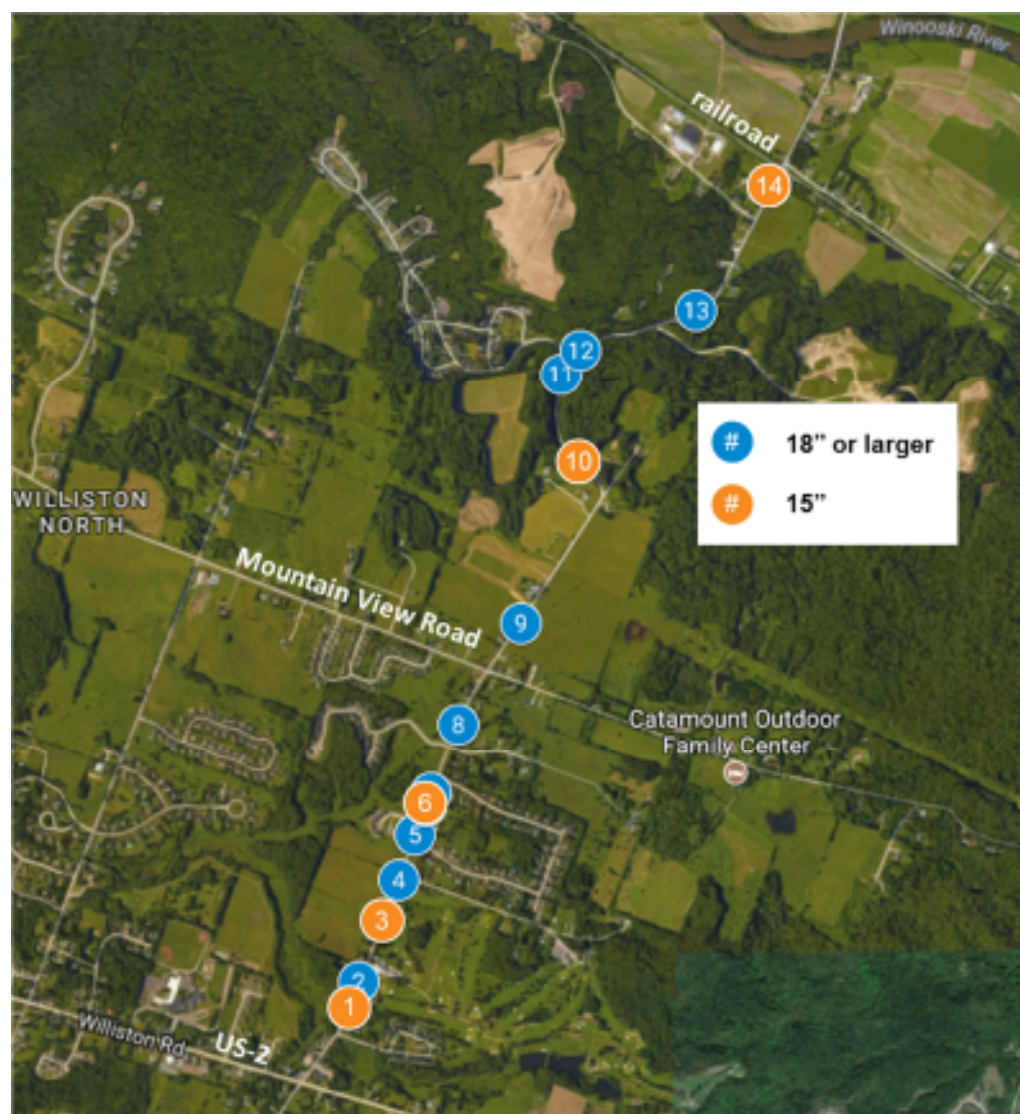
Figure 4-13. Culverts Across North Williston Road

North Williston Road crosses both the Allen Brook and the Winooski River. It also crosses several smaller seasonal and year-round streams, which can continue their natural path through culverts under the road. There are 14 culvert crossings of North Williston Road, several of which are smaller than VTrans' 18-inch minimum diameter, shown in Figure 4-13.

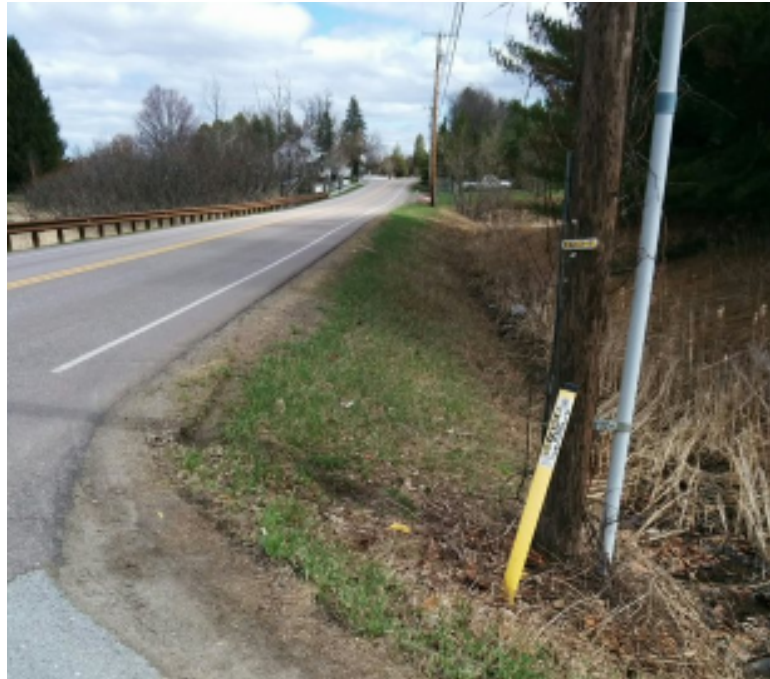
Figure 4-15. Drainage Ditch - Looking North from Spruce Lane

The following photographs document existing drainage and roadside slope conditions in various sections of North Williston Road.

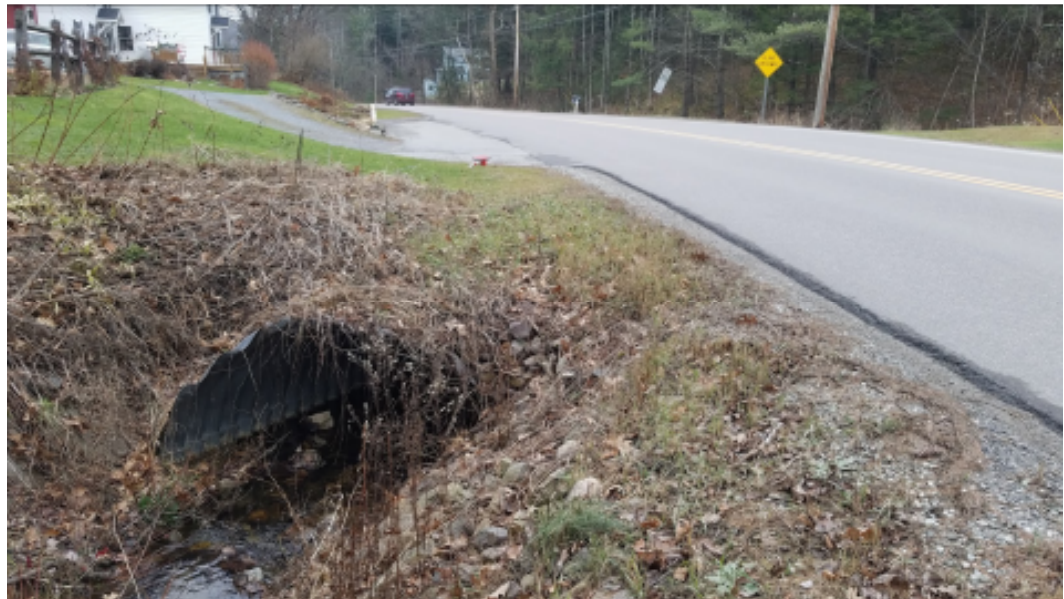
Figure 4-16. Culvert Across Williston Woods Road

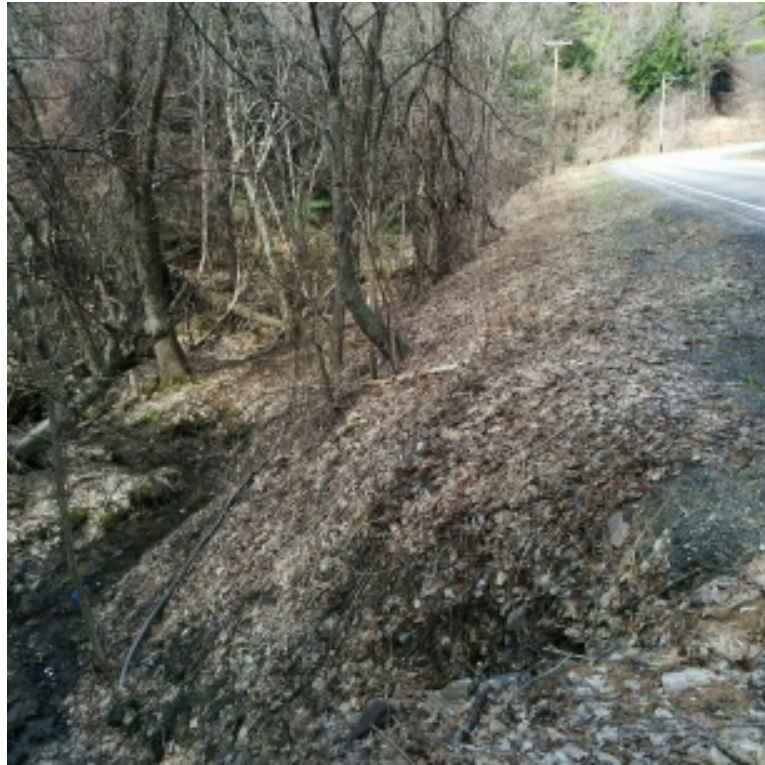
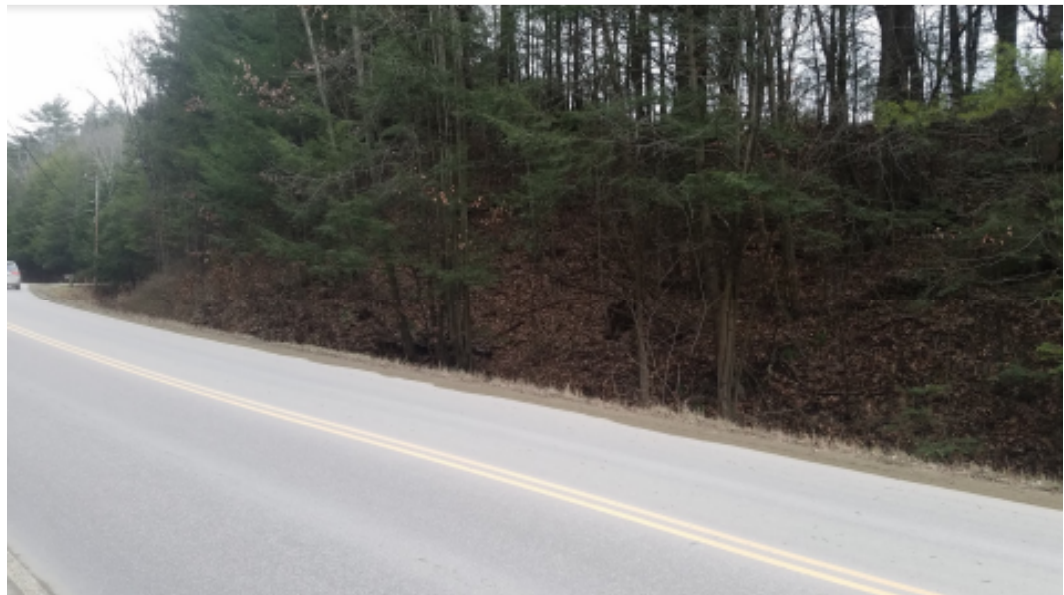
Figure 4-17. Steep Roadside Slopes in the Hollow

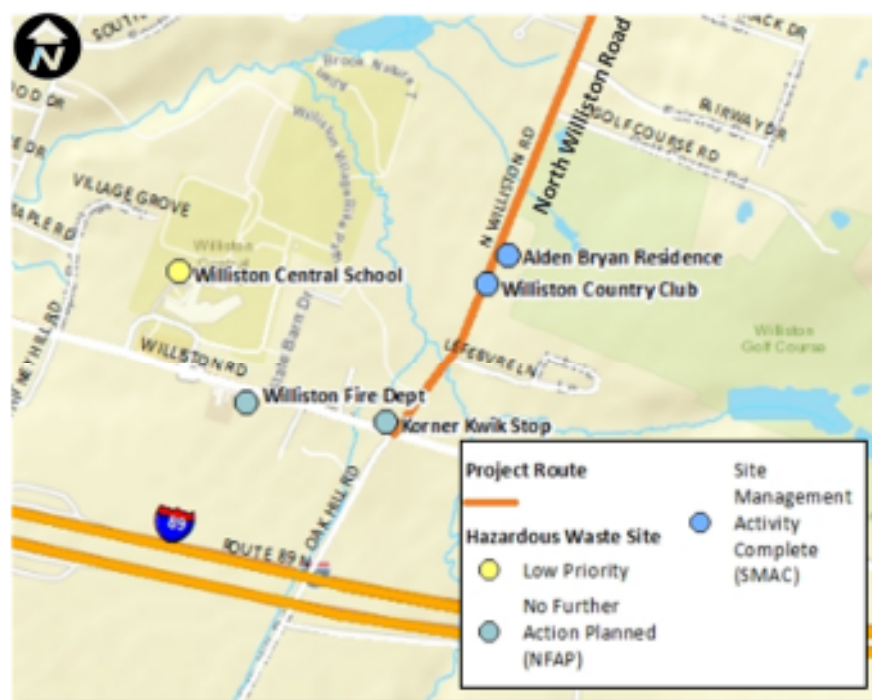
Figure 4-22. Hazardous Waste Sites

- **Hazardous Waste Sites** (Figure 4-22): There are three hazardous waste sites along North Williston Road. None of them are priority sites. All three are located at the southern end of North Williston Road.

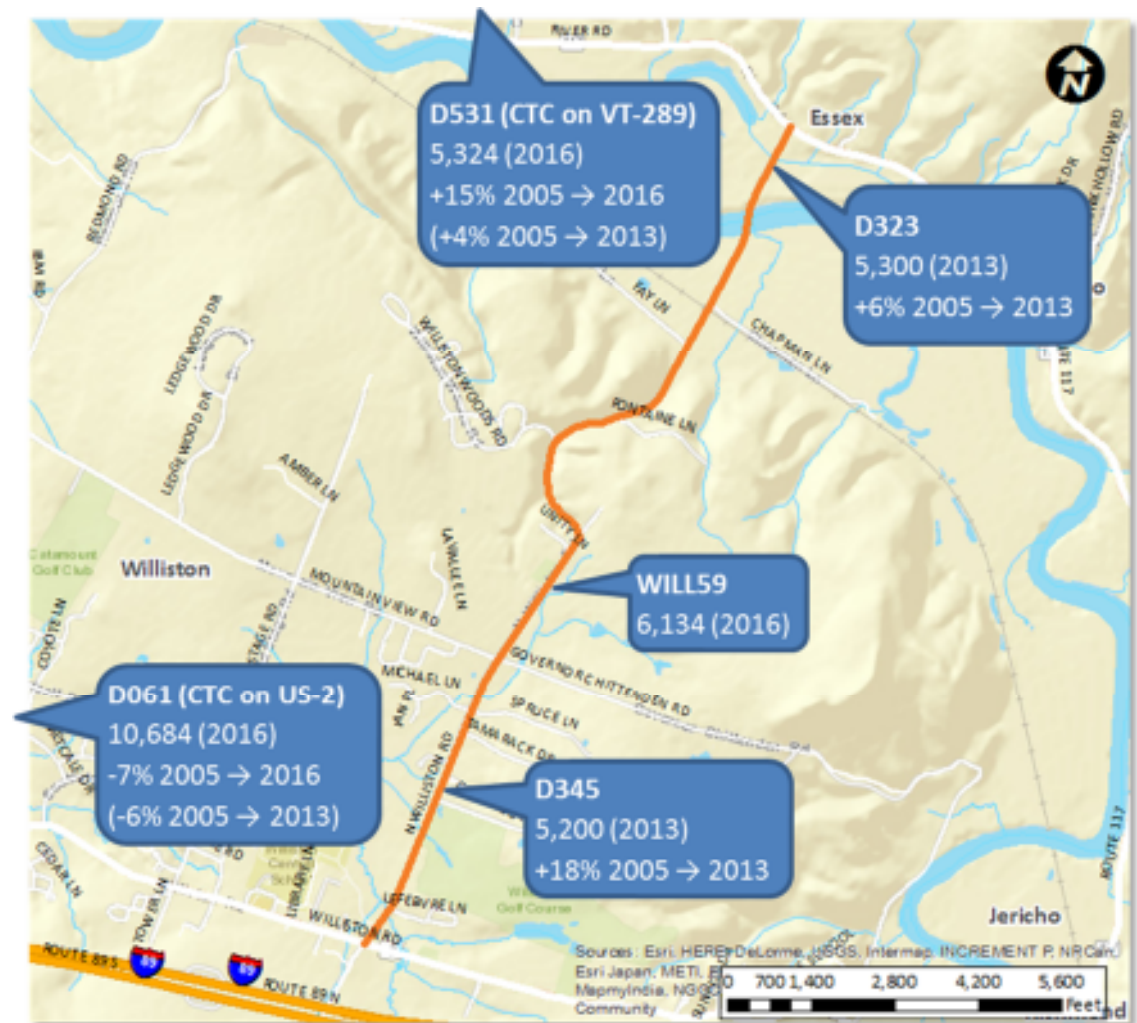
Figure 5-1. Automatic Traffic Recorder Locations and Data

There are three automatic traffic recorder (ATR) locations along North Williston Road with recent data. Two of them have historic data that shows an increase in traffic of 6 to 18 percent between 2005 and 2013. The nearby continuous traffic counter (CTC) on VT Route 289 also shows an increase in traffic over this time period. Contrary to these increases, a nearby CTC along US-2 just east of Industrial Ave experienced a 6% decline in traffic between 2005 and 2013, and other nearby ATRs have also experienced a decline in traffic.

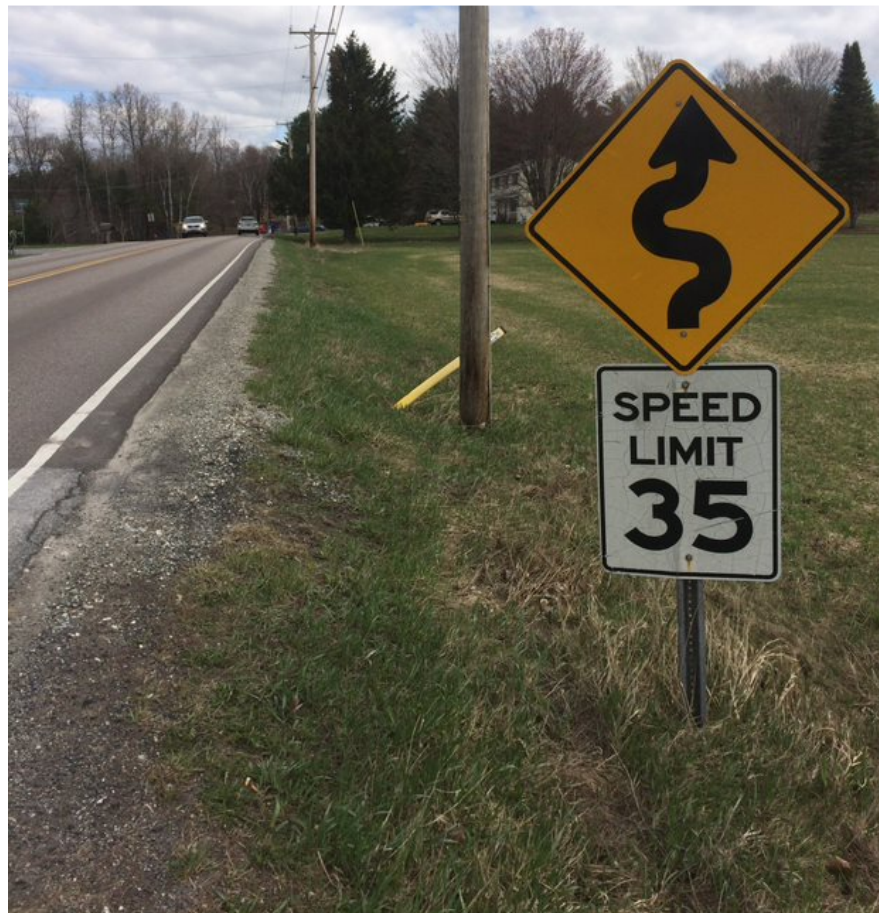
The posted speed limit on North Williston Road is 35 mph. The speed limit remains the same throughout the entire corridor - including along the flat, straight sections of the road and through the narrow and curved hollow. An adequate number of speed limit signs are posted throughout the corridor in both directions. The northbound speed limit sign prior to the hollow is co-located with a curve warning sign (Figure 5-2). The MUTCD recommends separate installation for separate, unrelated signs. Additionally, both signs appear to be placed below recommended installation height.

Figure 5-2 Low-Sitting Signage

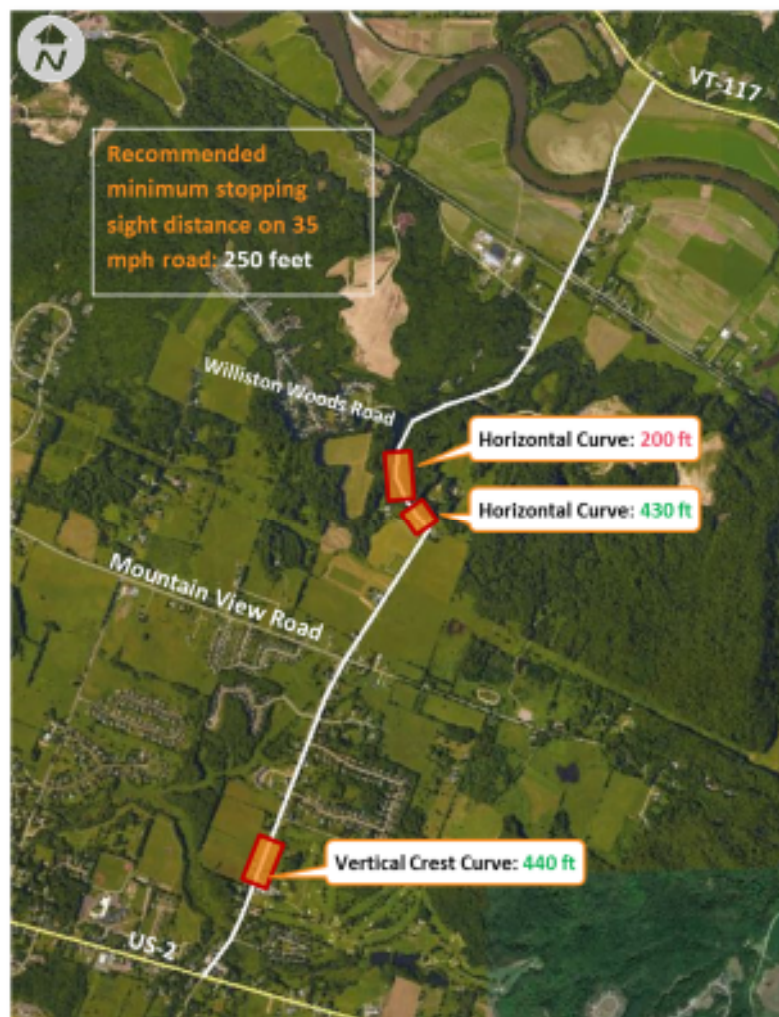
Figure 5-7. Stopping Sight Distances (Measured on Site)

Stopping sight distances were measured along North Williston Road in areas where it was unclear if vehicles would have adequate sight distance. The three areas measured are shown in Figure 5-7. They include one crest curve in the residential section of the road and two horizontal curves in the hollow. Only one of the measurements was less than the recommended minimum sight distance of 250 feet - in a horizontal curve of the hollow, caused by the sharp turn coupled with the presence of a bank on the sides of the road with dense vegetation (see Figure 5-8).

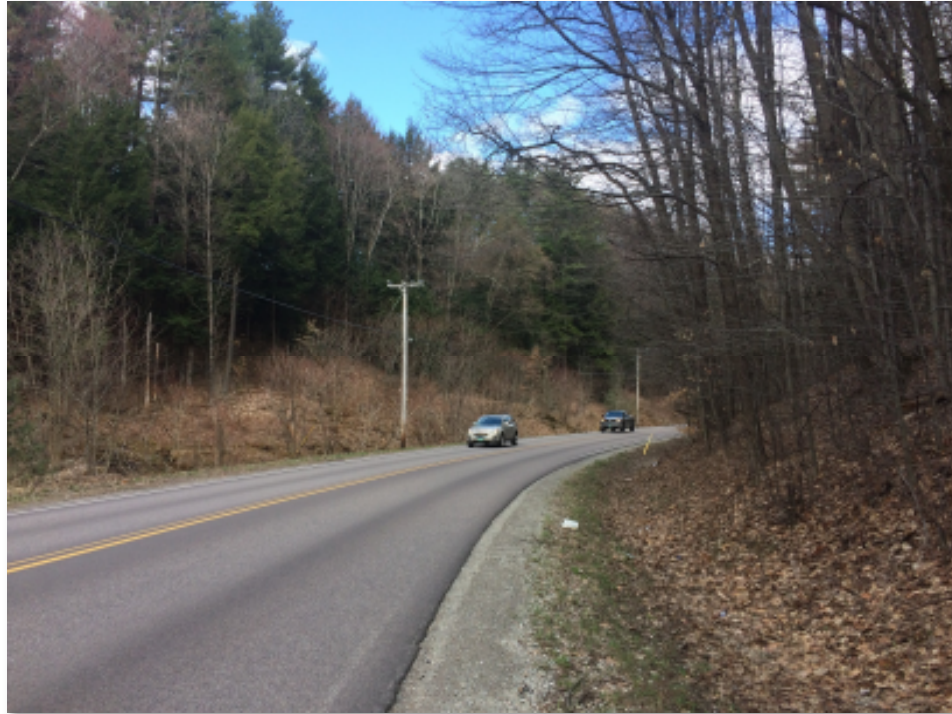
Figure 5-8. Restricted Stopping Sight Distance in the Hollow

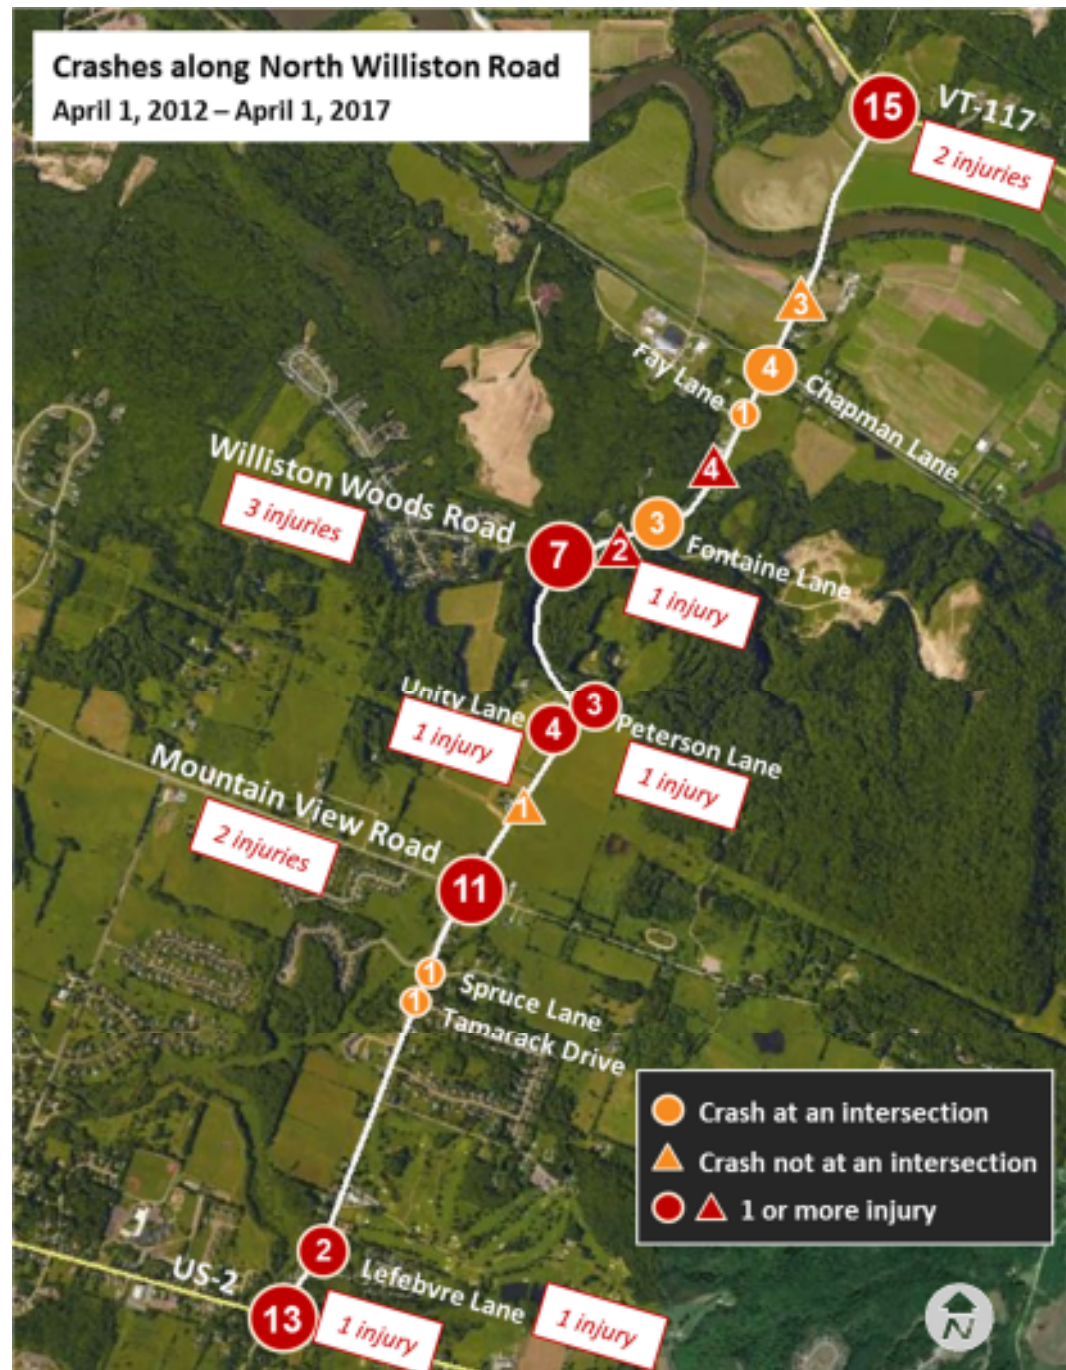
Figure 5-9. Crash Locations

Notably, following the 2013 partial implementation of safety recommendations at the Mountain View Road and North Williston Road intersection, crashes have reduced from 18 collisions in a five-year period (January 1, 2006 – December 31, 2010) to 11 collisions in the most recent five-year period (April 1, 2012 – March 31, 2017).
