**Chittenden County Brownfields Program  
Site Nomination / Assistance Request Form**

Proposed Riverside Housing Project  
676 Riverside Avenue / 56 Bright Street, Burlington, Vermont

KAS, Inc. (KAS) is pleased to present the attached report for the above-referenced property. The Phase I Environmental Site Assessment (ESA) was conducted in compliance with ASTM E 1527-13 and the Tier 1 VES was completed in accordance with ASTM E2600-10. Recognized environmental conditions (RECs) were identified in connection with the property as follows:

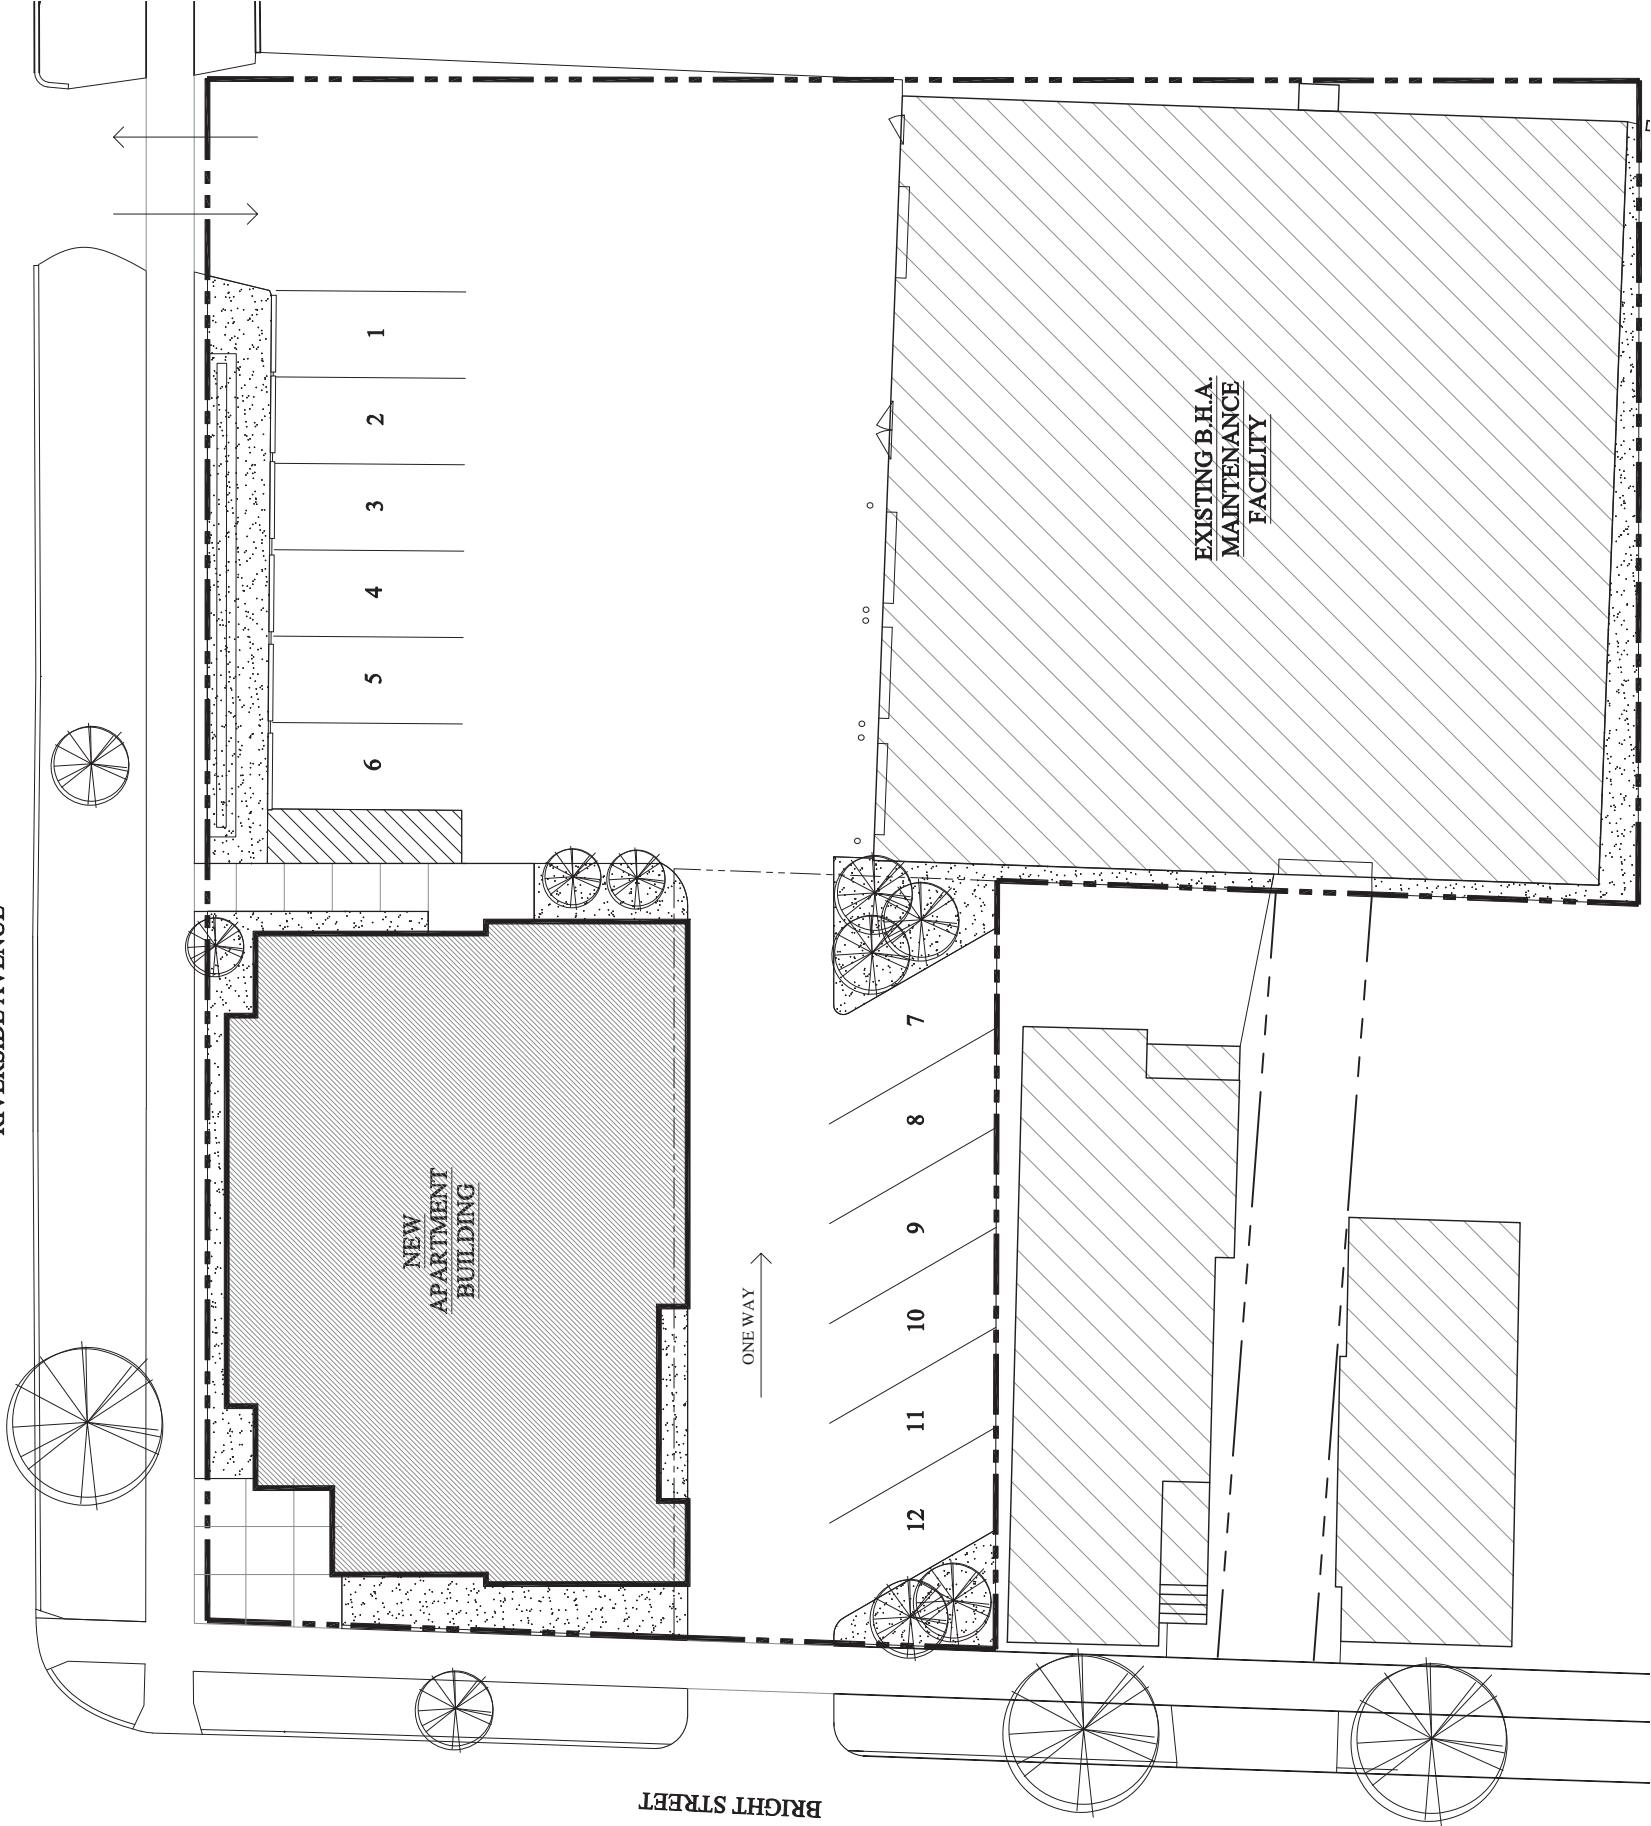
PROPOSED SITE INFORMATION

- PROPOSED APARTMENT BUILDING 14 UNIT = 7 SPACES REQUIRED (ASSUMES 1 SPACE / DWELLING UNIT WITH WAIVER FOR 50%)
- EXISTING MAINTENANCE FACILITY = 5 SPACES REQUIRED (ASSUMES BUILDING IS CONSIDERED "AUTOMOTIVE REPAIR / SERVICE" BUILDING - 2 SPACES PLUS 1 SPACE PER BAY (3 BAYS)
- TOTAL PARKING SPACES = 12 (1 H/C SPACE)

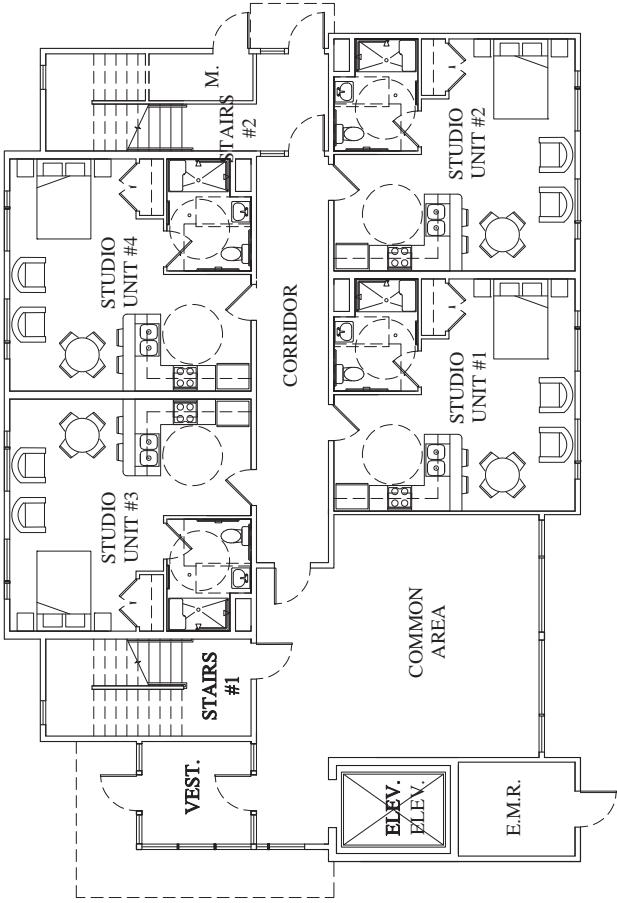
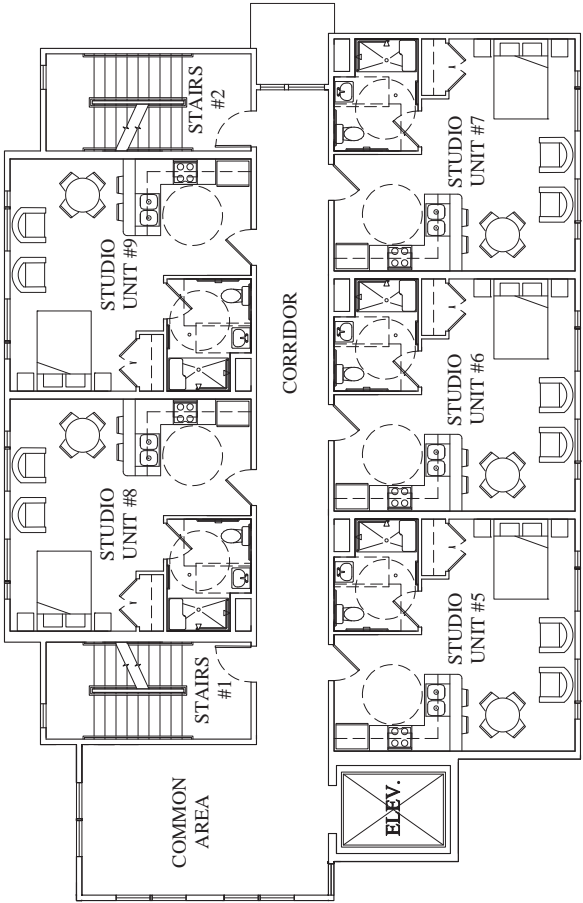
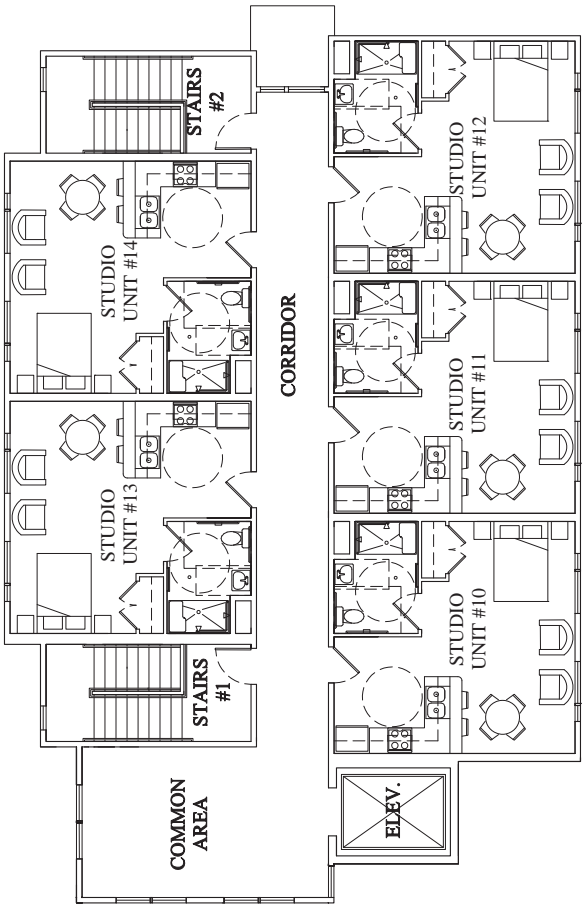
FIRST FLOOR PLAN - OPTION 'A'

- 3 STORY BUILDING - 9,306 TOTAL SF
- 14 STUDIO UNITS - 4 UNITS 1ST FLOOR, 5 UNITS 2ND FLOOR, 5 UNITS 3RD FLOOR
- ELEVATOR AND ELEVATOR MACHINE ROOM
- COMMON AREA ADJACENT TO ENTRY AREA AND ELEVATOR LOBBY
- SMALL MECHANICAL ROOM
- MAIN ENTRY AT CORNER OF BRIGHT STREET AND RIVERSIDE AVE.
- BASEMENT OPTIONAL - STORAGE OF COMMON SPACE

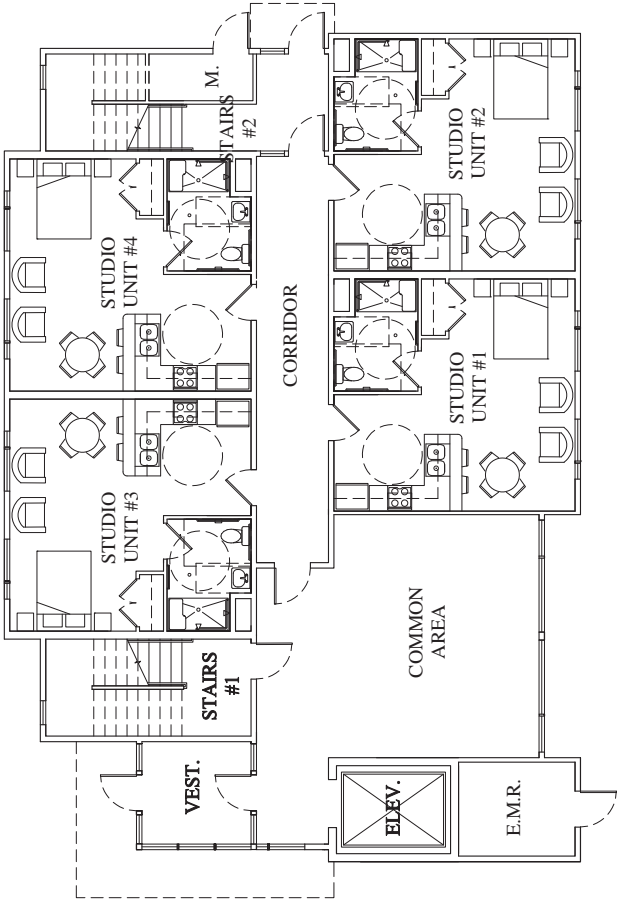
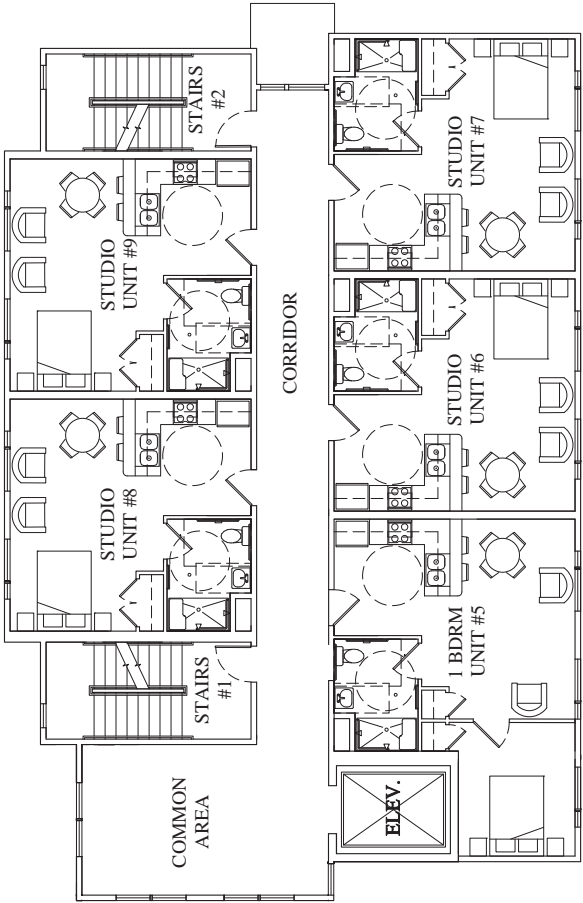
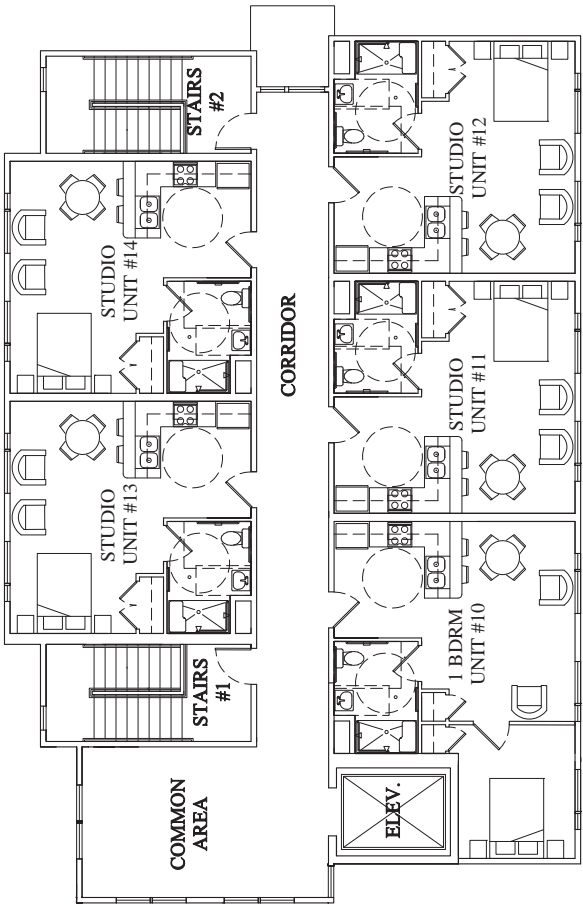
FIRST FLOOR PLAN - OPTION 'B'

- 3 STORY BUILDING - 9,480 TOTAL SF
- 12 STUDIO UNITS & 2 ONE BEDROOM UNITS = 4 STUDIOS 1ST FLOOR, 1 ONE BEDROOM AND 4 STUDIOS 2ND FLOOR, 1 ONE BEDROOM AND 4 STUDIOS 3RD FLOOR.
- ELEVATOR AND ELEVATOR MACHINE ROOM
- COMMON AREA ADJACENT TO ENTRY AREA AND ELEVATOR LOBBY
- SMALL MECHANICAL ROOM
- MAIN ENTRY AT CORNER OF BRIGHT STREET AND RIVERSIDE AVE.
- BASEMENT OPTIONAL - STORAGE OF COMMON SPACE

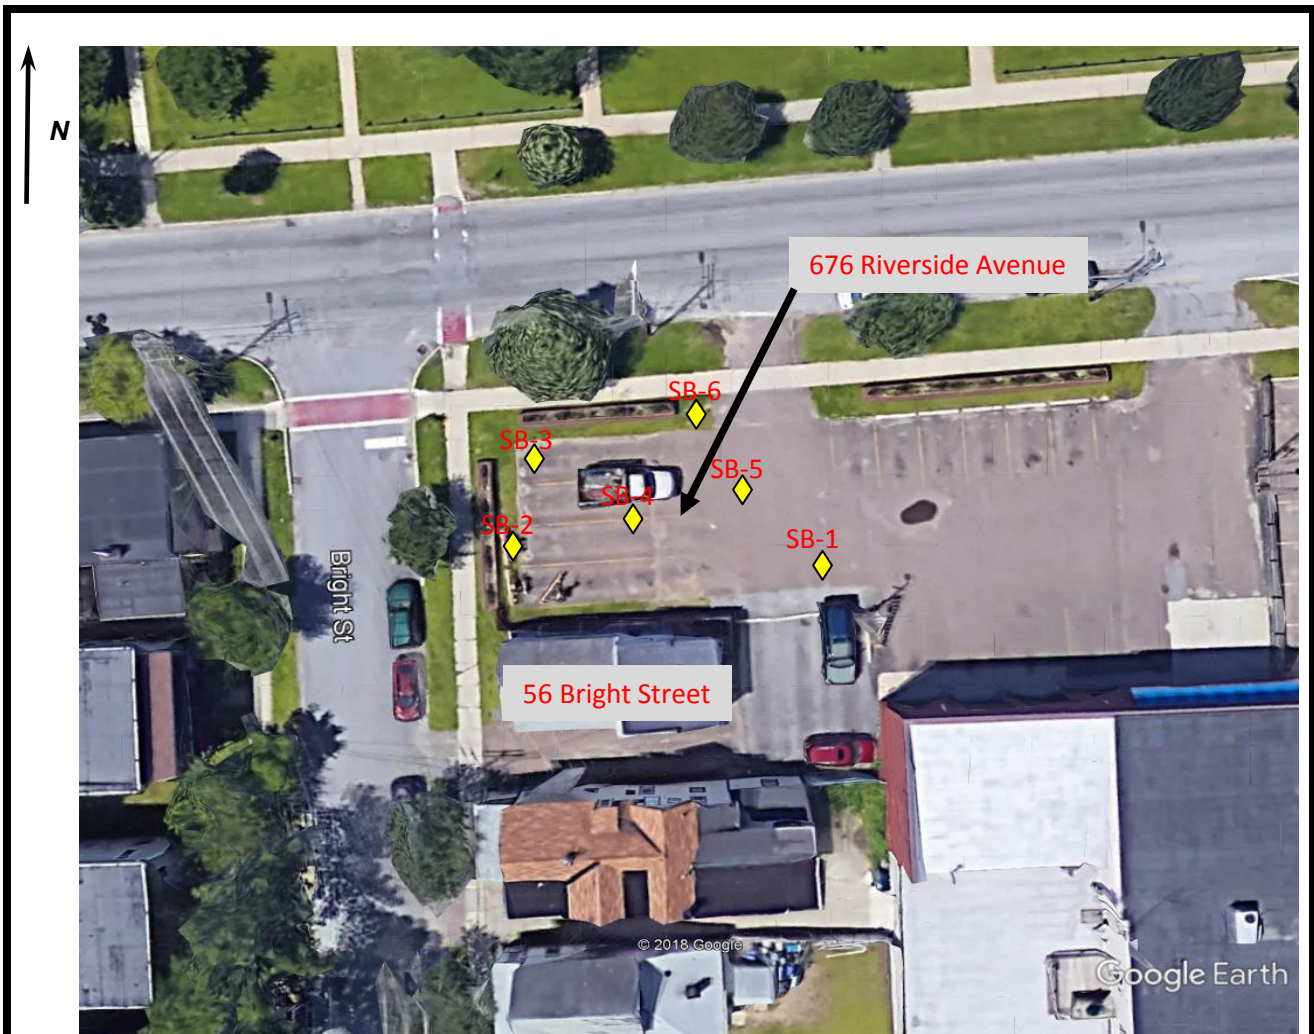
KAS Job Number 505180495  
Source: Google Earth

Approximate Soil Boring Location
