MEMO: Homework for Water Quality Sampling Discussion
TO: CCRPC MS4 Subcommittee
FROM: Kristen Balschunat, Stream Team Coordinator

Proposal for 2019 LaRosa Partnership Program

2018 Water Quality Monitoring Report

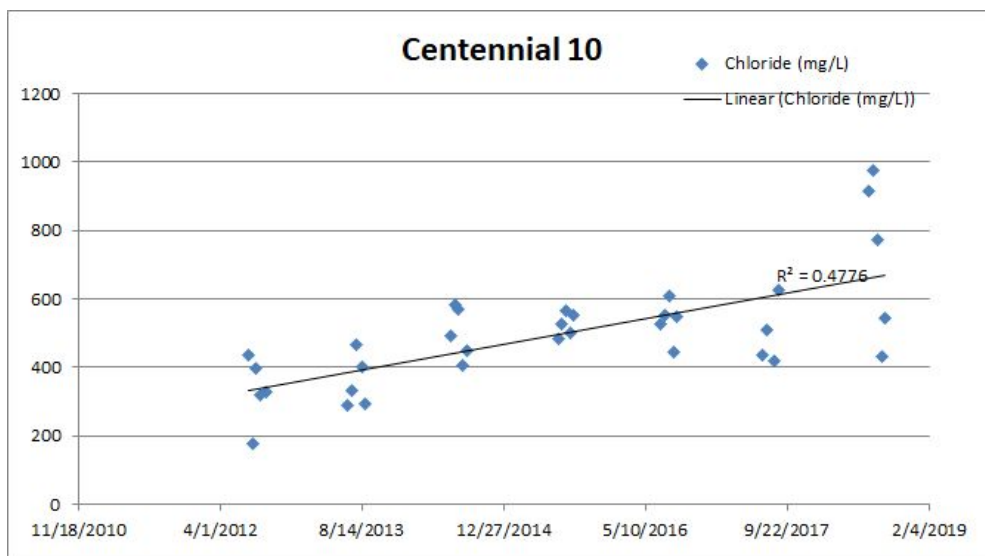
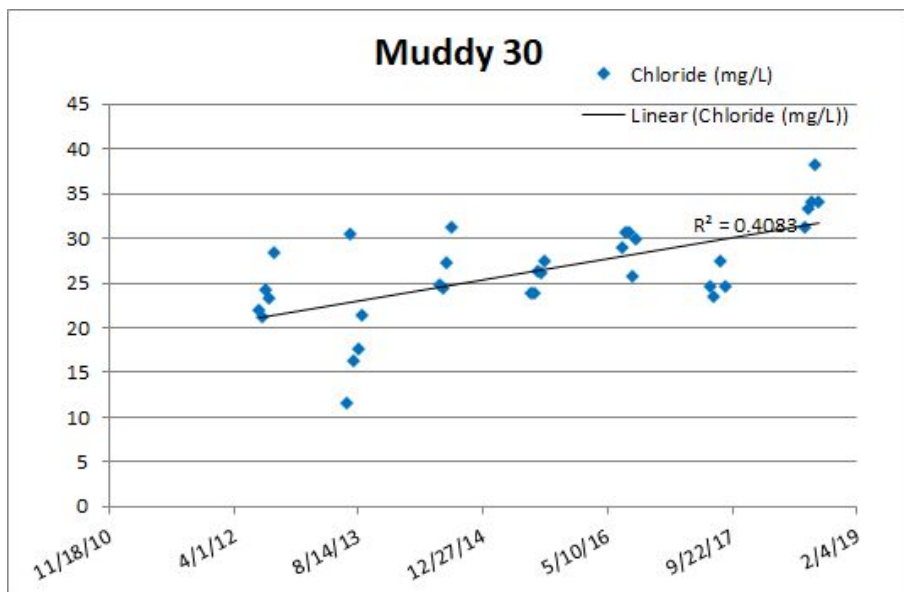
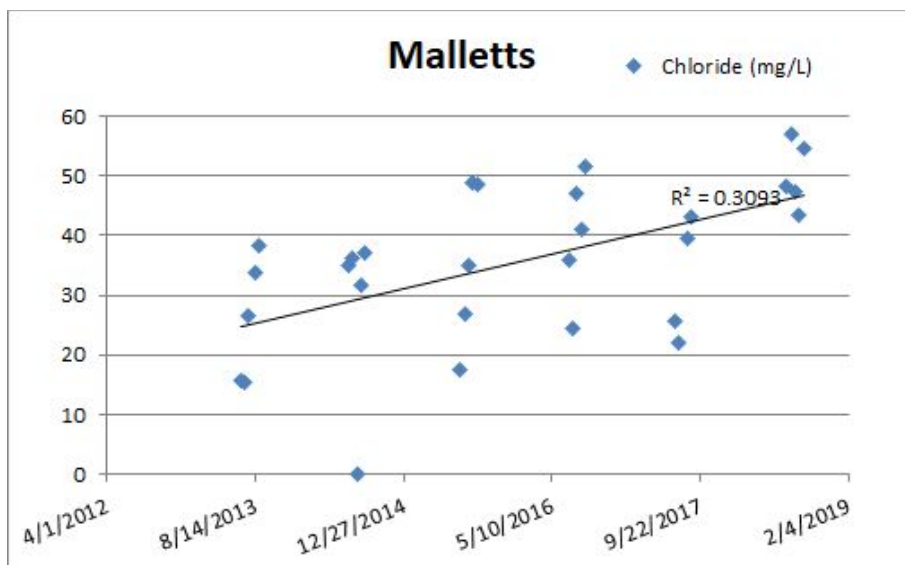
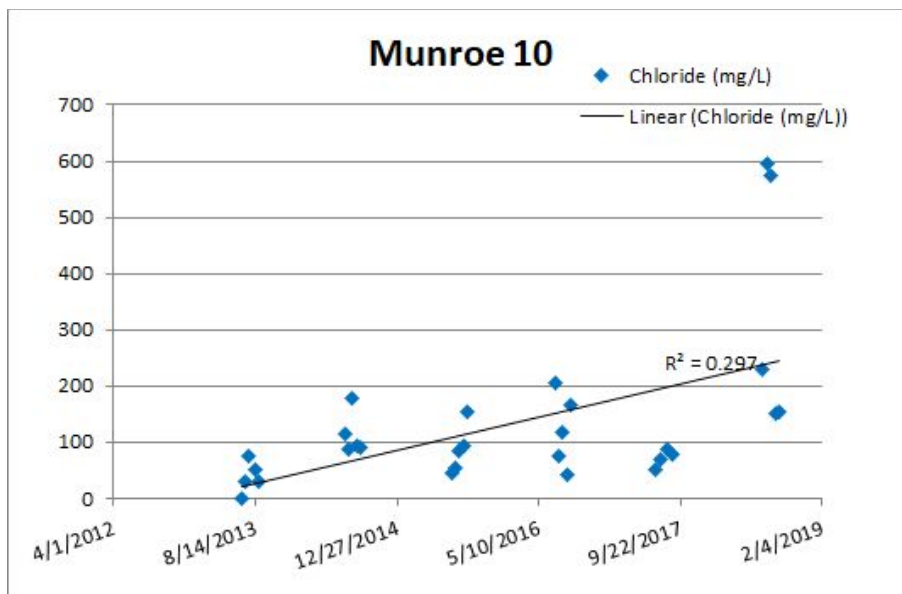
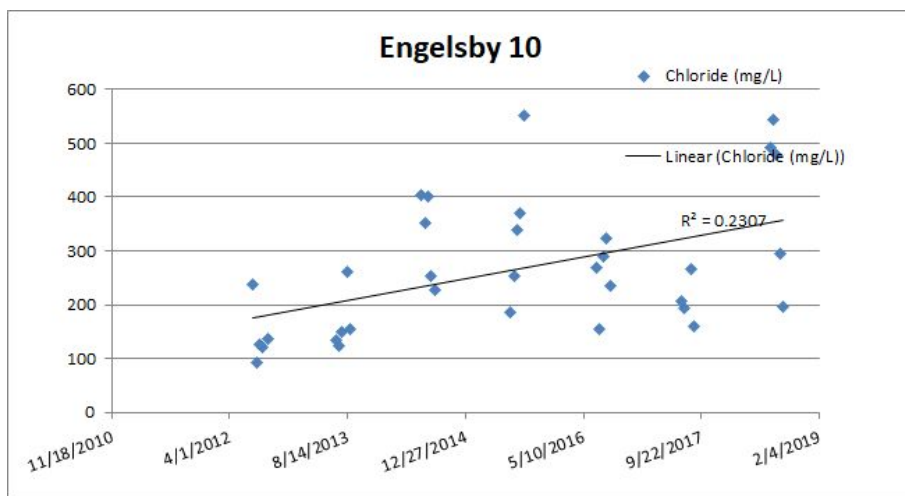
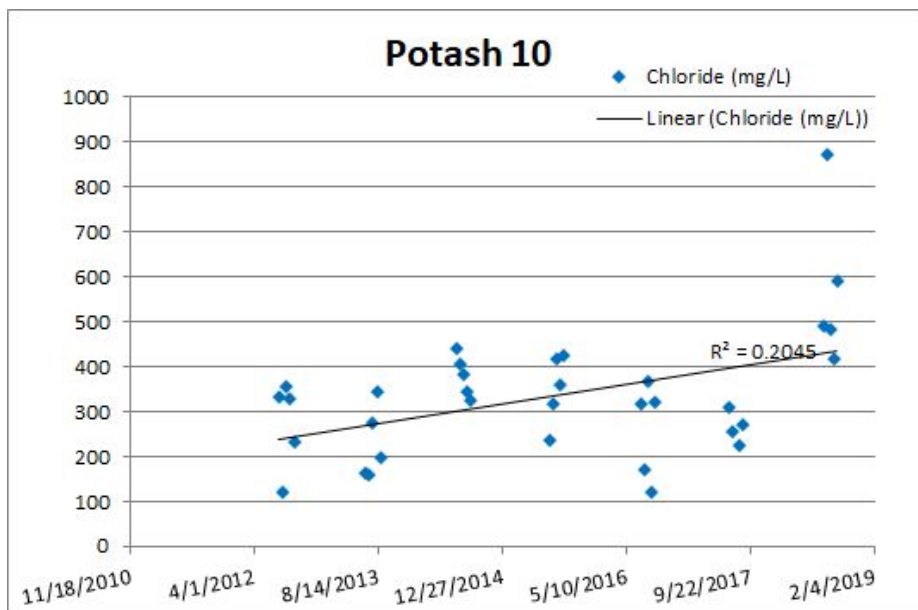
Appendix F. Notable Trends in Chloride Increases Over Time By Site. Sorted in descending order by R2 values.

Chloride data from this sampling program suggests that of the 14 sites that have been sampled for 6 or more years, chloride levels are trending upwards in 10 of them (Centennial 10, Engelsby 10, Indian 10 and 20, Malletts 10, Muddy 30, Munroe 10 and 20, and Potash 10 and 20). These trends are not statistically significant but highlight an important stressor to monitor closely. Appendix F documents graphs of these trends.
