Chittenden County Brownfields Program

Site Nomination / Assistance Request Form

Site Name: 195-201 Flynn Avenue

Vanasse Hangen Brustlin, Inc. ("VHB") is pleased to present the City of Burlington ("the City") with the following proposal to prepare a Work Plan and perform a Phase II Environmental Site Assessment ("ESA") at the properties located at 195-201 Flynn Avenue, Burlington, Vermont (the "Site"). The Site consists of two north-south adjacent parcels: 195 Flynn Ave ("Lot 1", southern lot) and 201 Flynn Ave ("Lot 2", northern lot). The Site currently contains one building that was formerly used as a general auto repair and services shop. This Phase II ESA will be designed to support the future redevelopment of the Site by investigating the potential for impacts to soil, groundwater, and soil vapor associated with multiple Recognized Environmental Conditions ("RECs") identified during VHB's July 2023 Phase I ESA conducted for the Site.

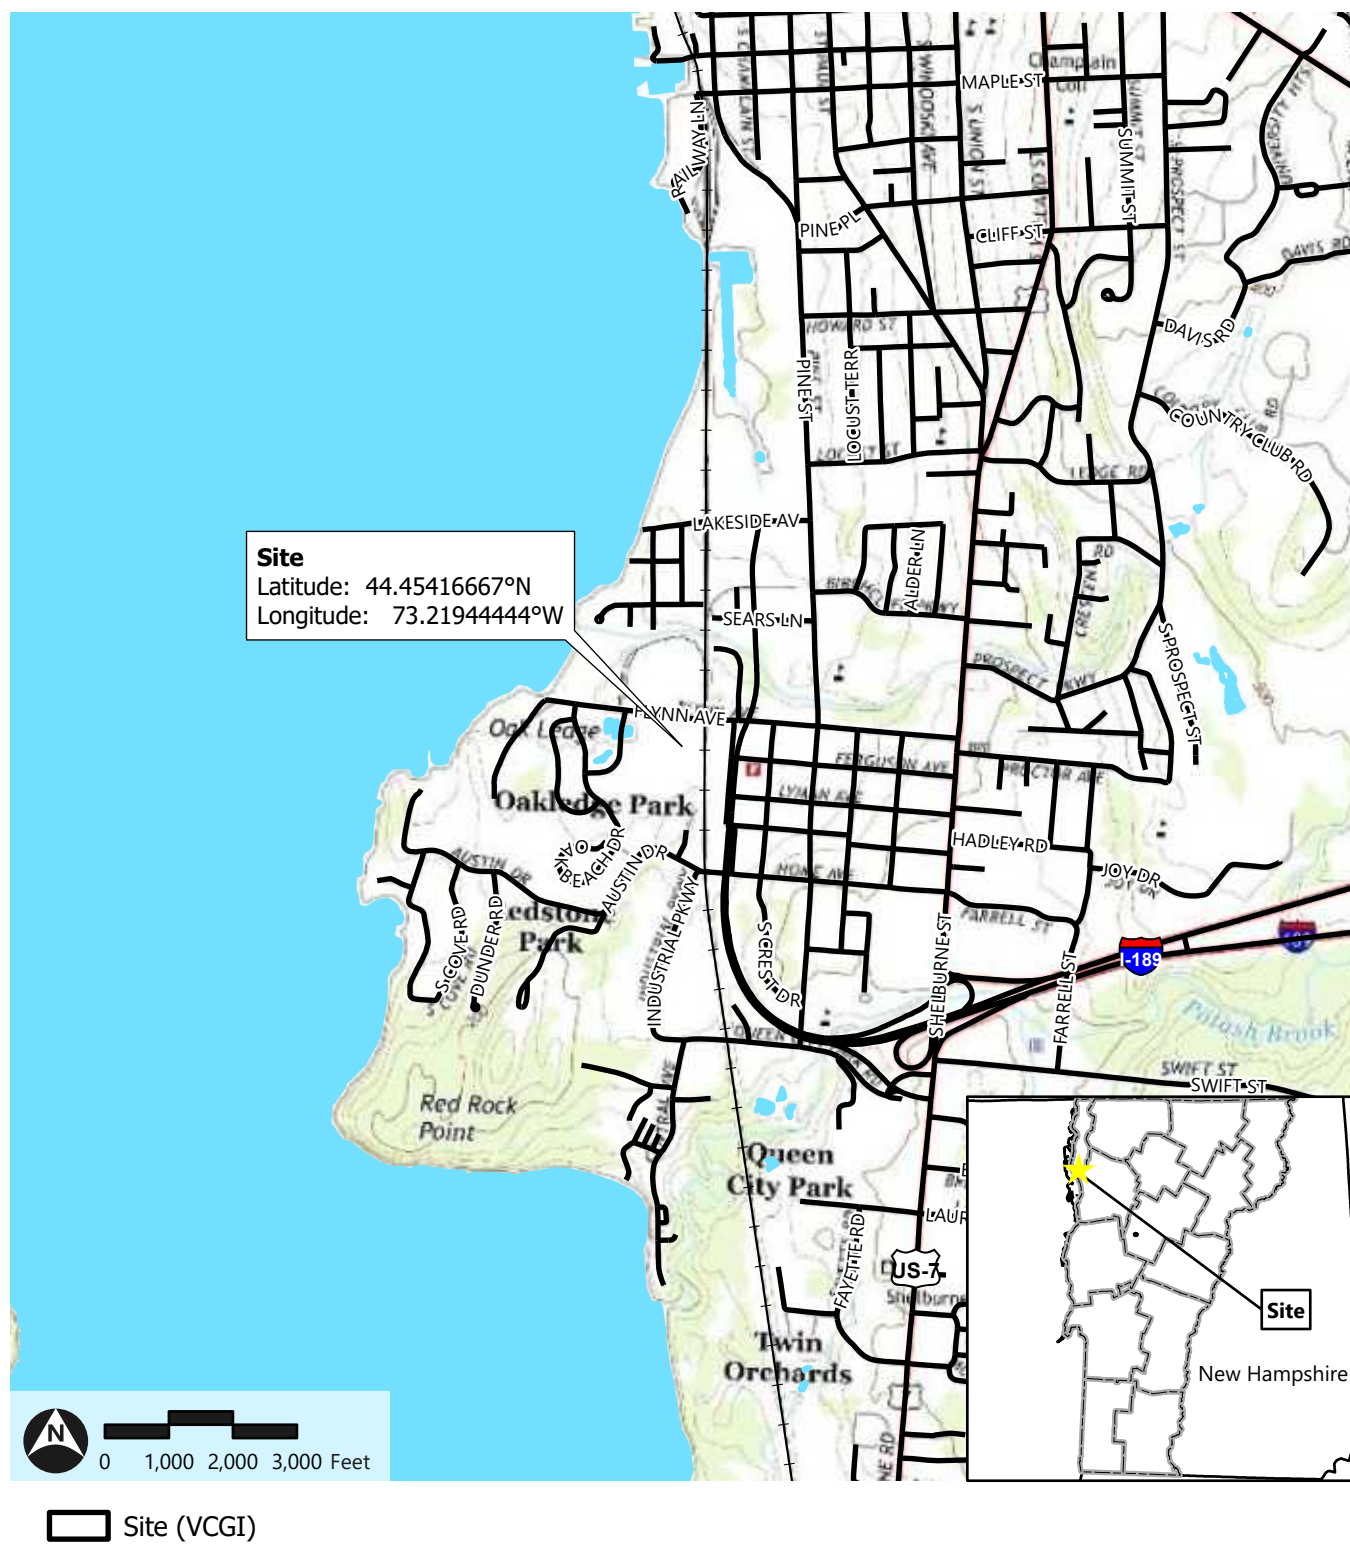
Figure 1: Site Location Map

195-201 Flynn Avenue - Burlington, Vermont

A Site Location and Local Area Map showing the location of the Site is provided as **Figure 1**, a Site Plan depicting the Site and relevant Site features is included as **Figure 2**, and a Site Vicinity Map showing the vicinity of the Site and nearby sensitive receptors is provided as **Figure 3**.

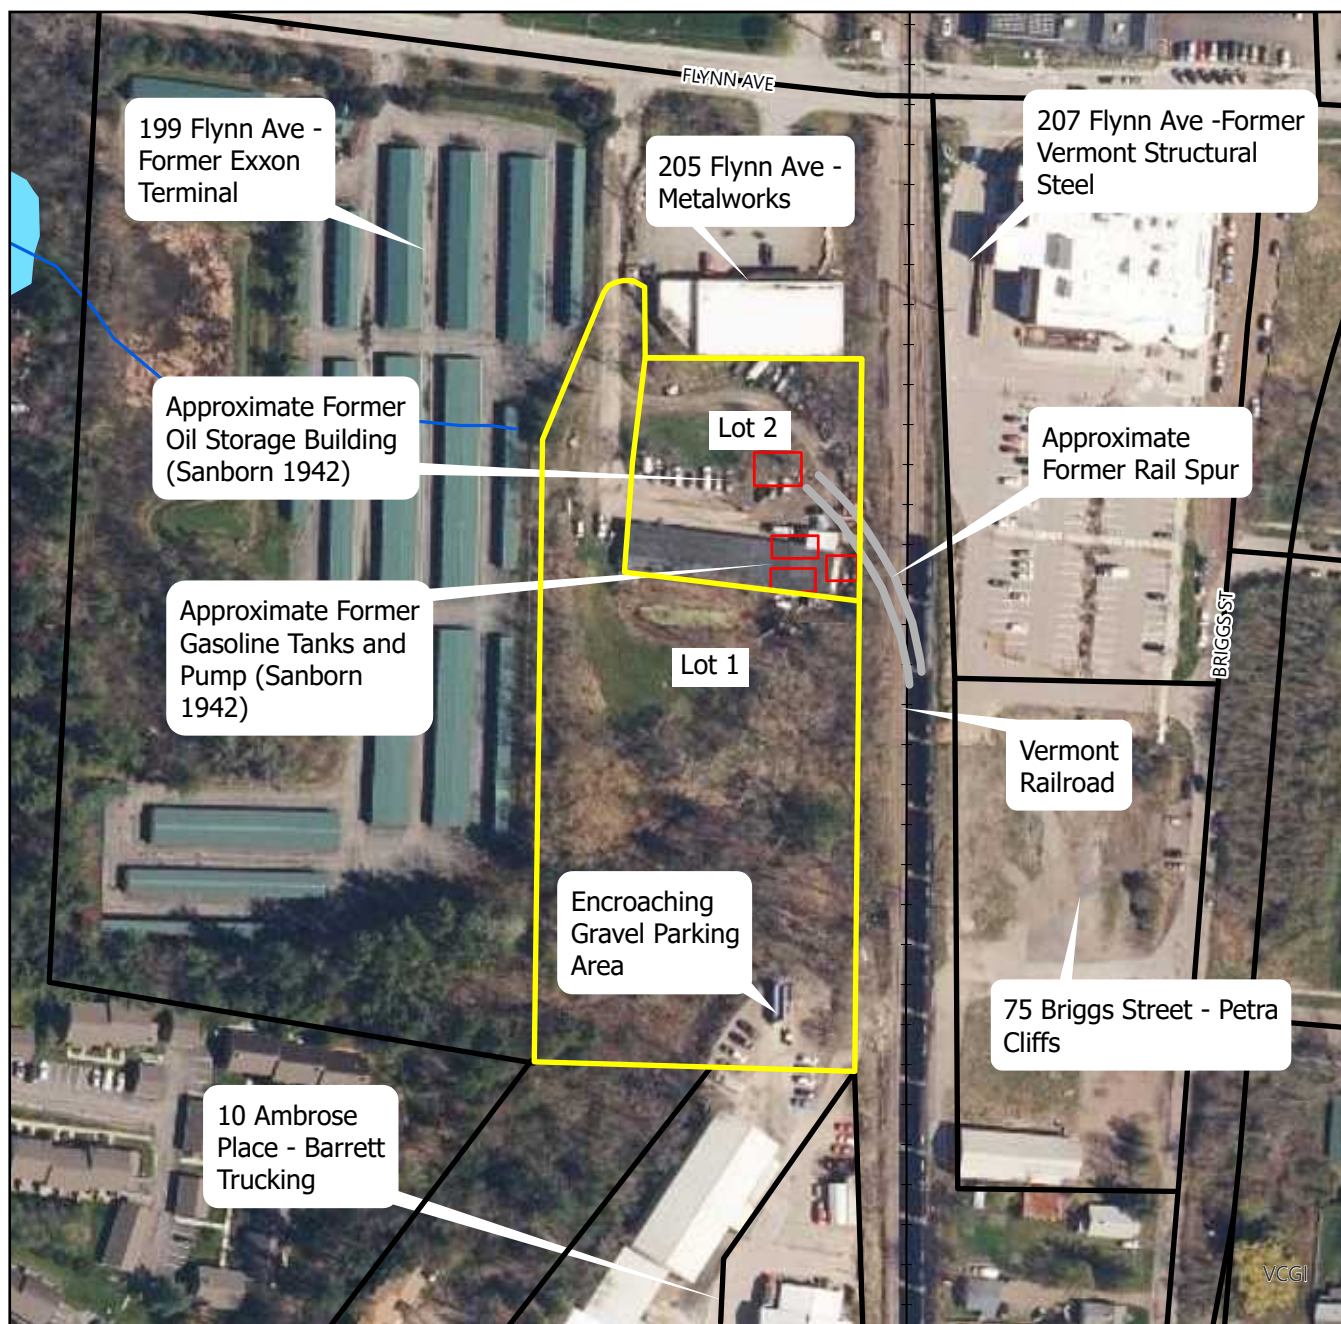
Figure 2: Site Map

195-201 Flynn Avenue | Burlington, Vermont

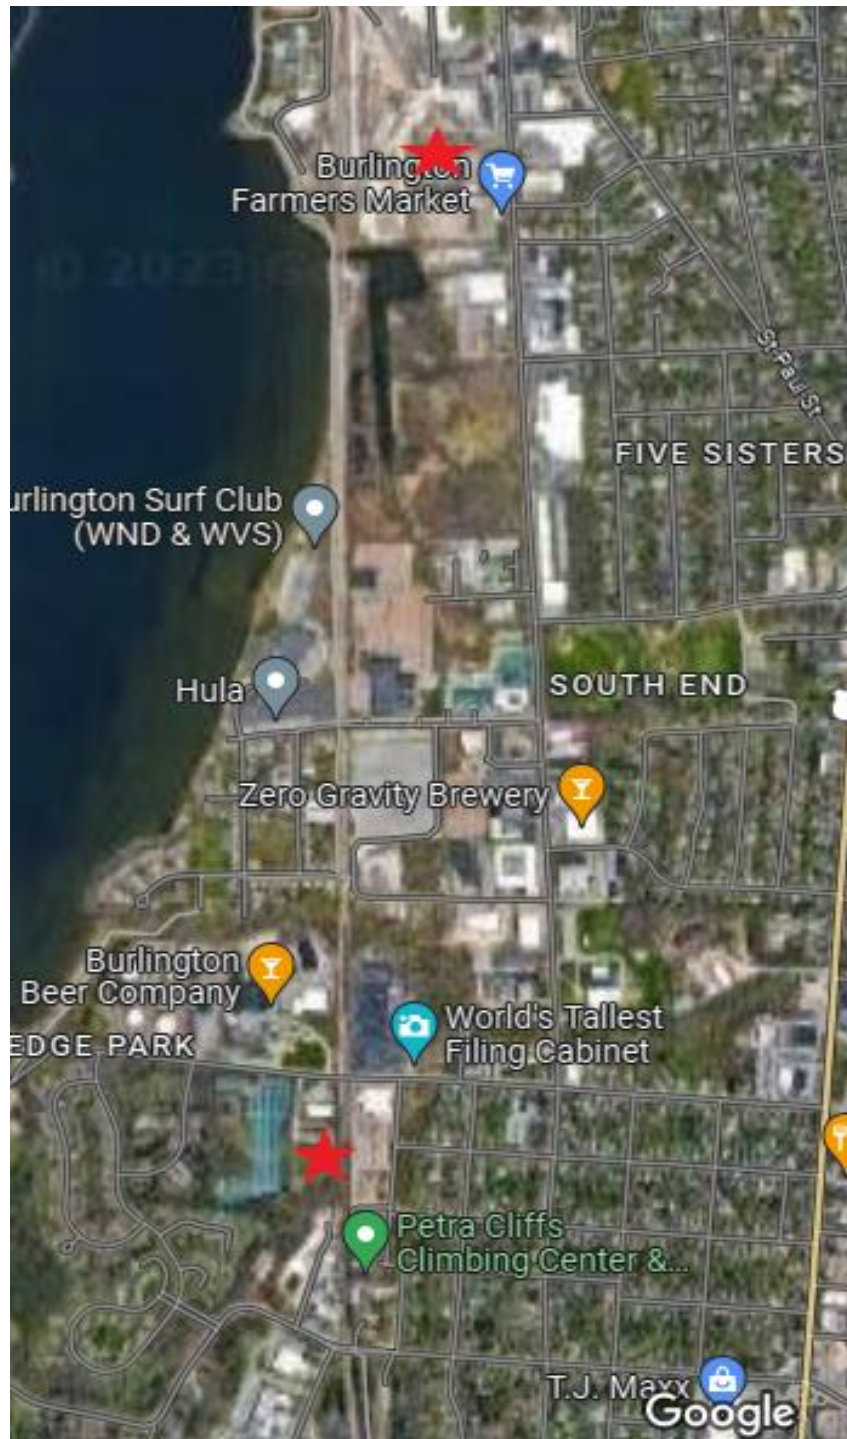
South End Map – 339 Pine Street Red Star To The North

195-201 Flynn Avenue Red Star To The South

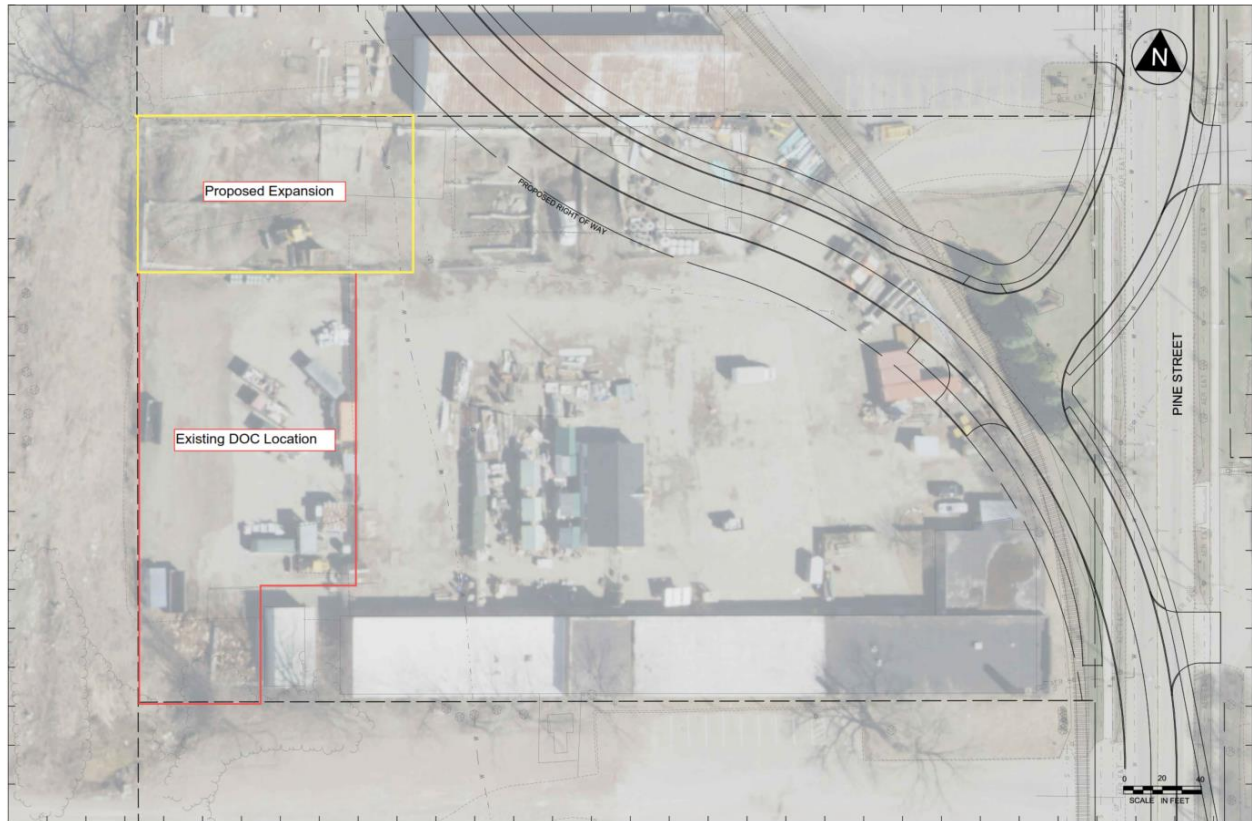
339 Pine Street Proposed DOC Expansion & REP Proposed Path

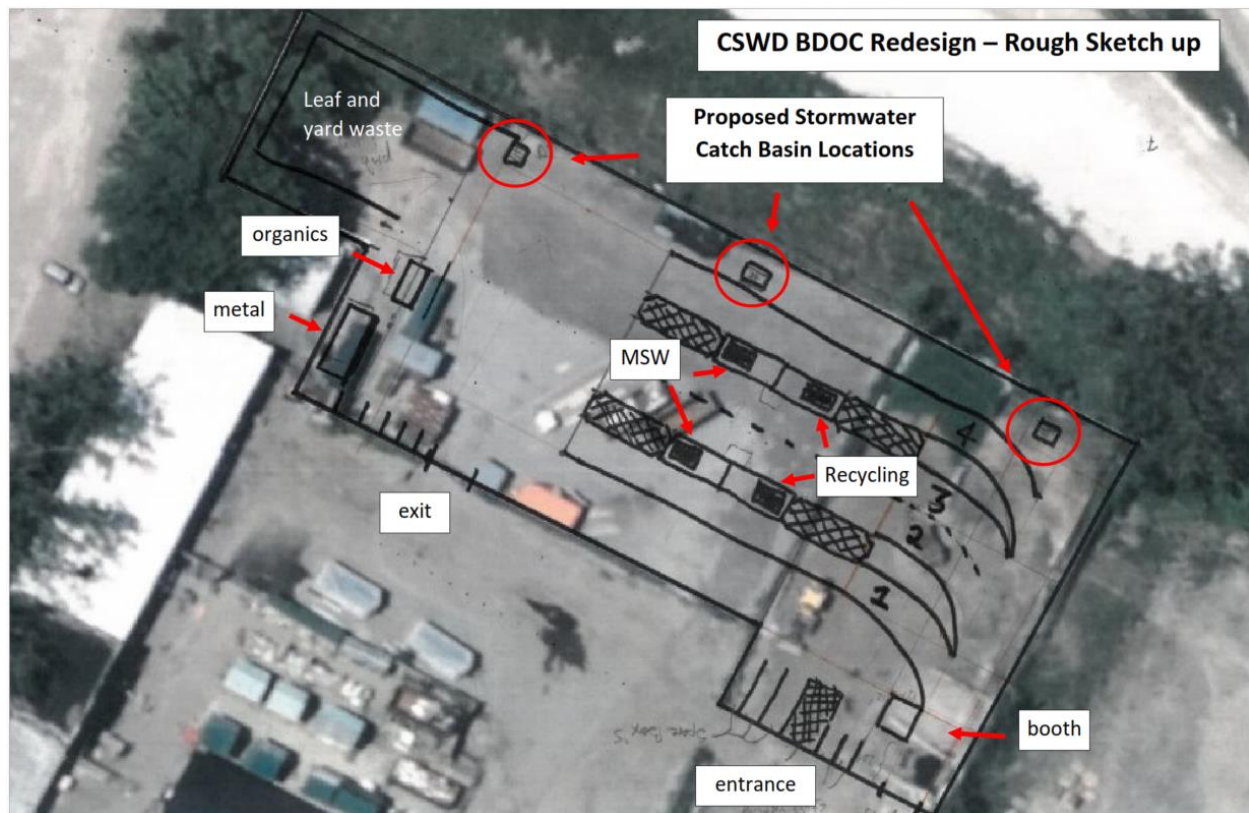
339 Pine Street DOC Conceptual Design – Will start services with single lane, and possibly expand depending on throughput. Open Tuesday through Saturday.
