Colchester-Essex Network Transportation Study

Alternatives Assessment Meeting Severance Road Corridor + Main Street Colchester Village September 24, 2013

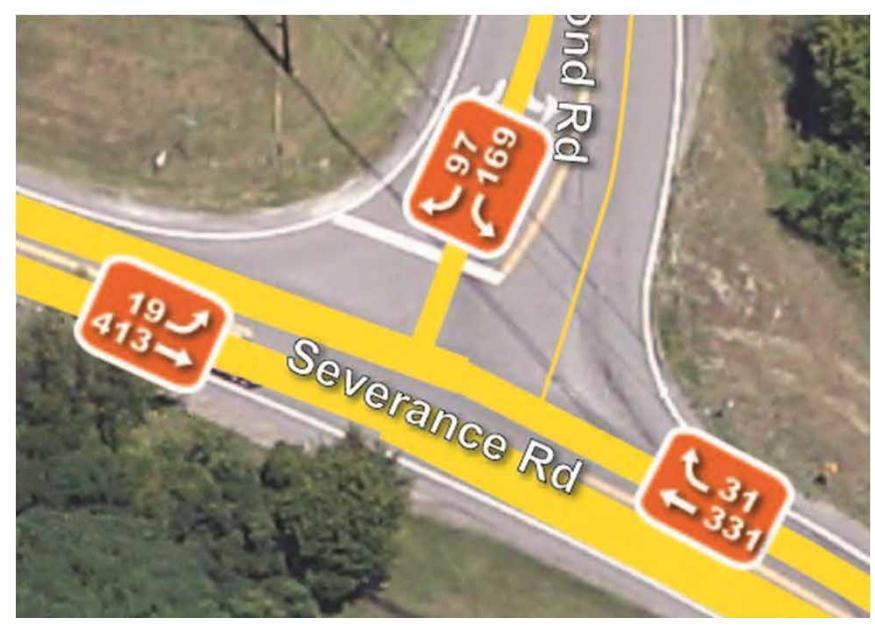
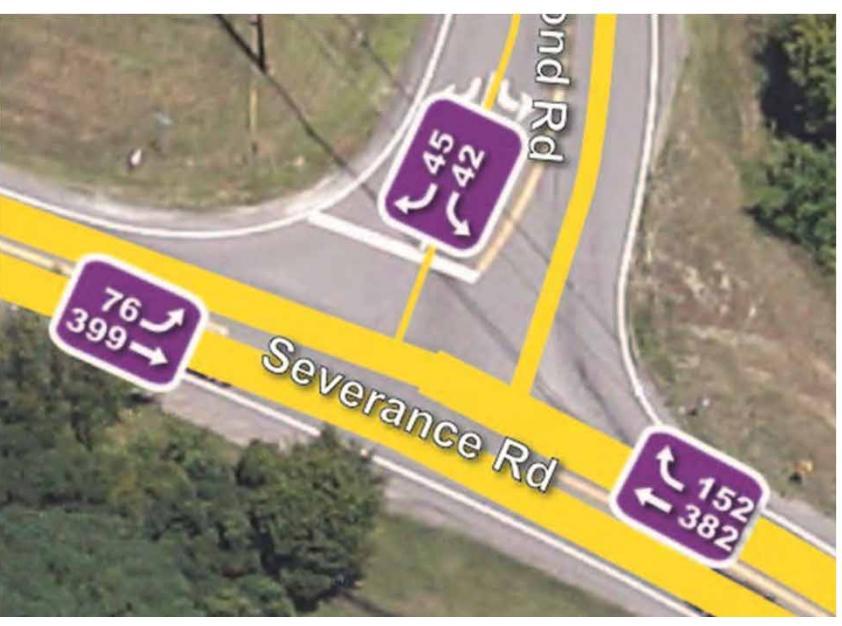
Severance Road: Mill Pond Rd Intersection

- Very little delay now and in the future
- Turn lanes are warranted to improve safety and reduce queuing
 - Eastbound left-turn lane
 - Westbound right-turn lane

AM Peak Hour

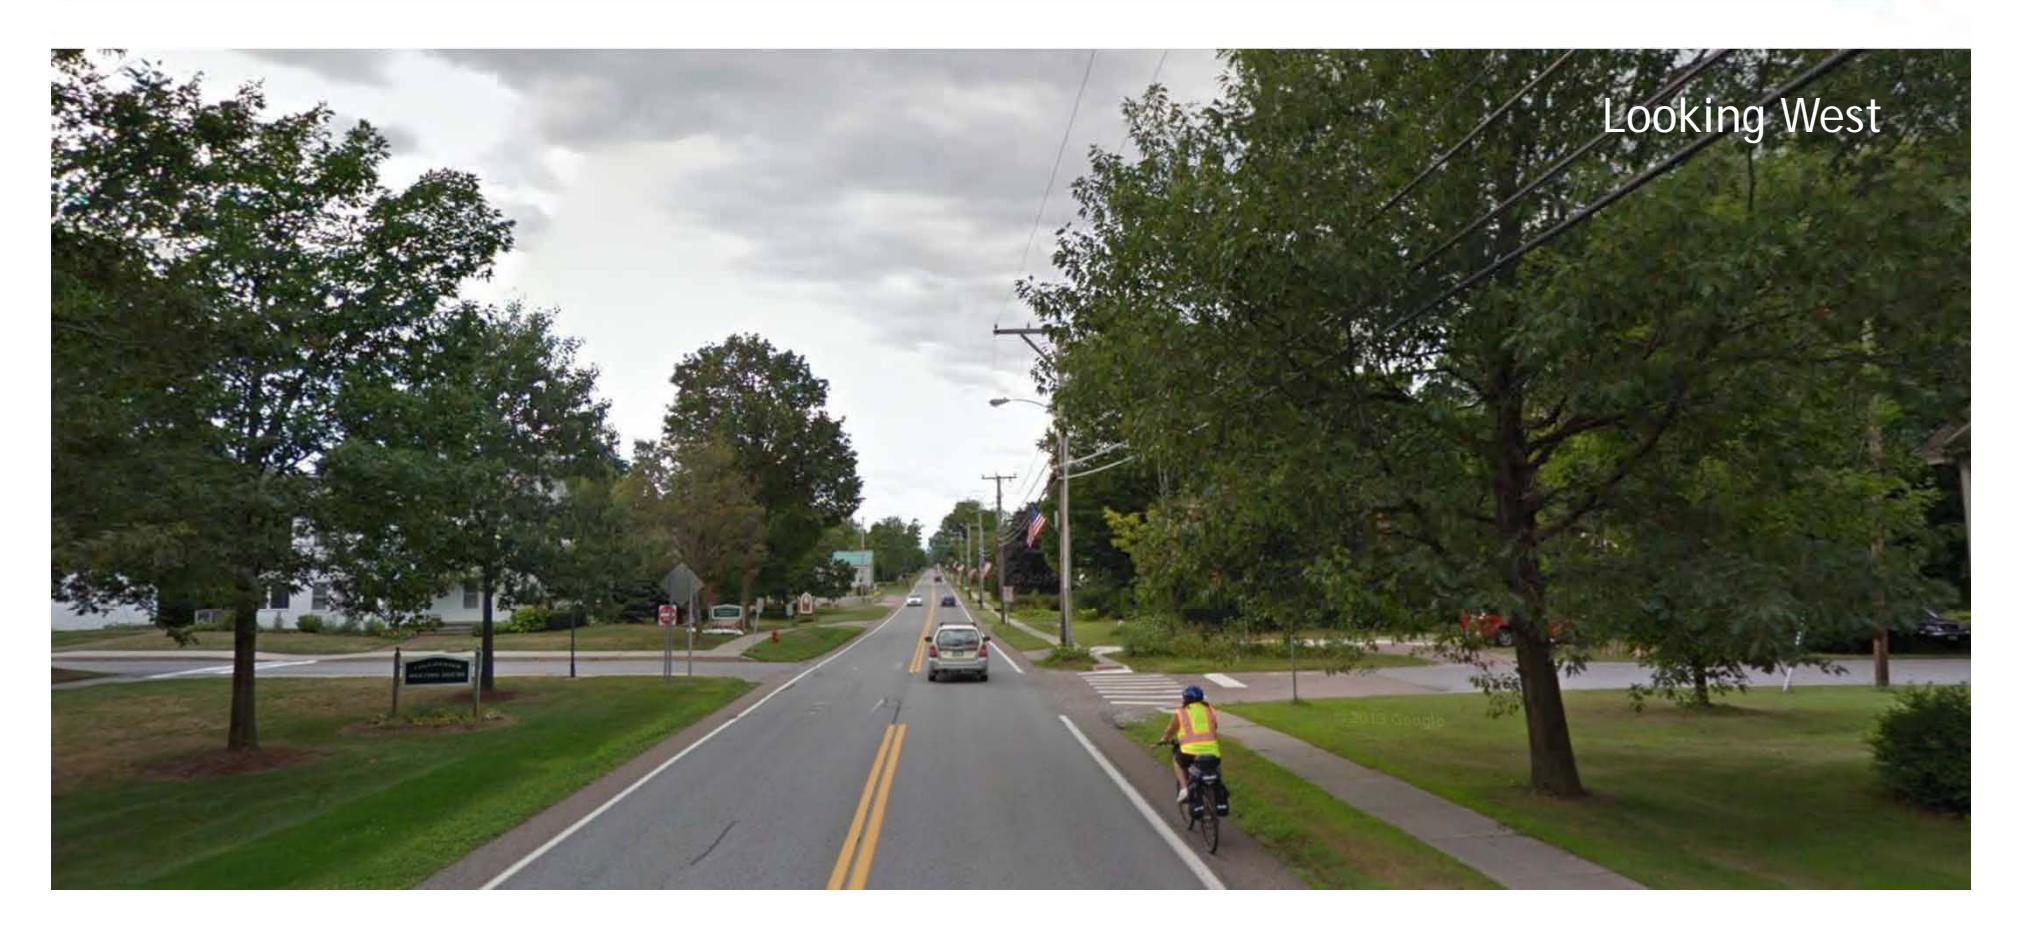
Main Street Today in the Village

- Urban minor arterial road
- State route VTrans Maintained
- 35 mph speed limit, 25 mph school zone
- 49.5' Right-of-Way

- 11' Travel lane width
- 1' to 2' shoulder width
- Overland drainage flow and absorption in grass area

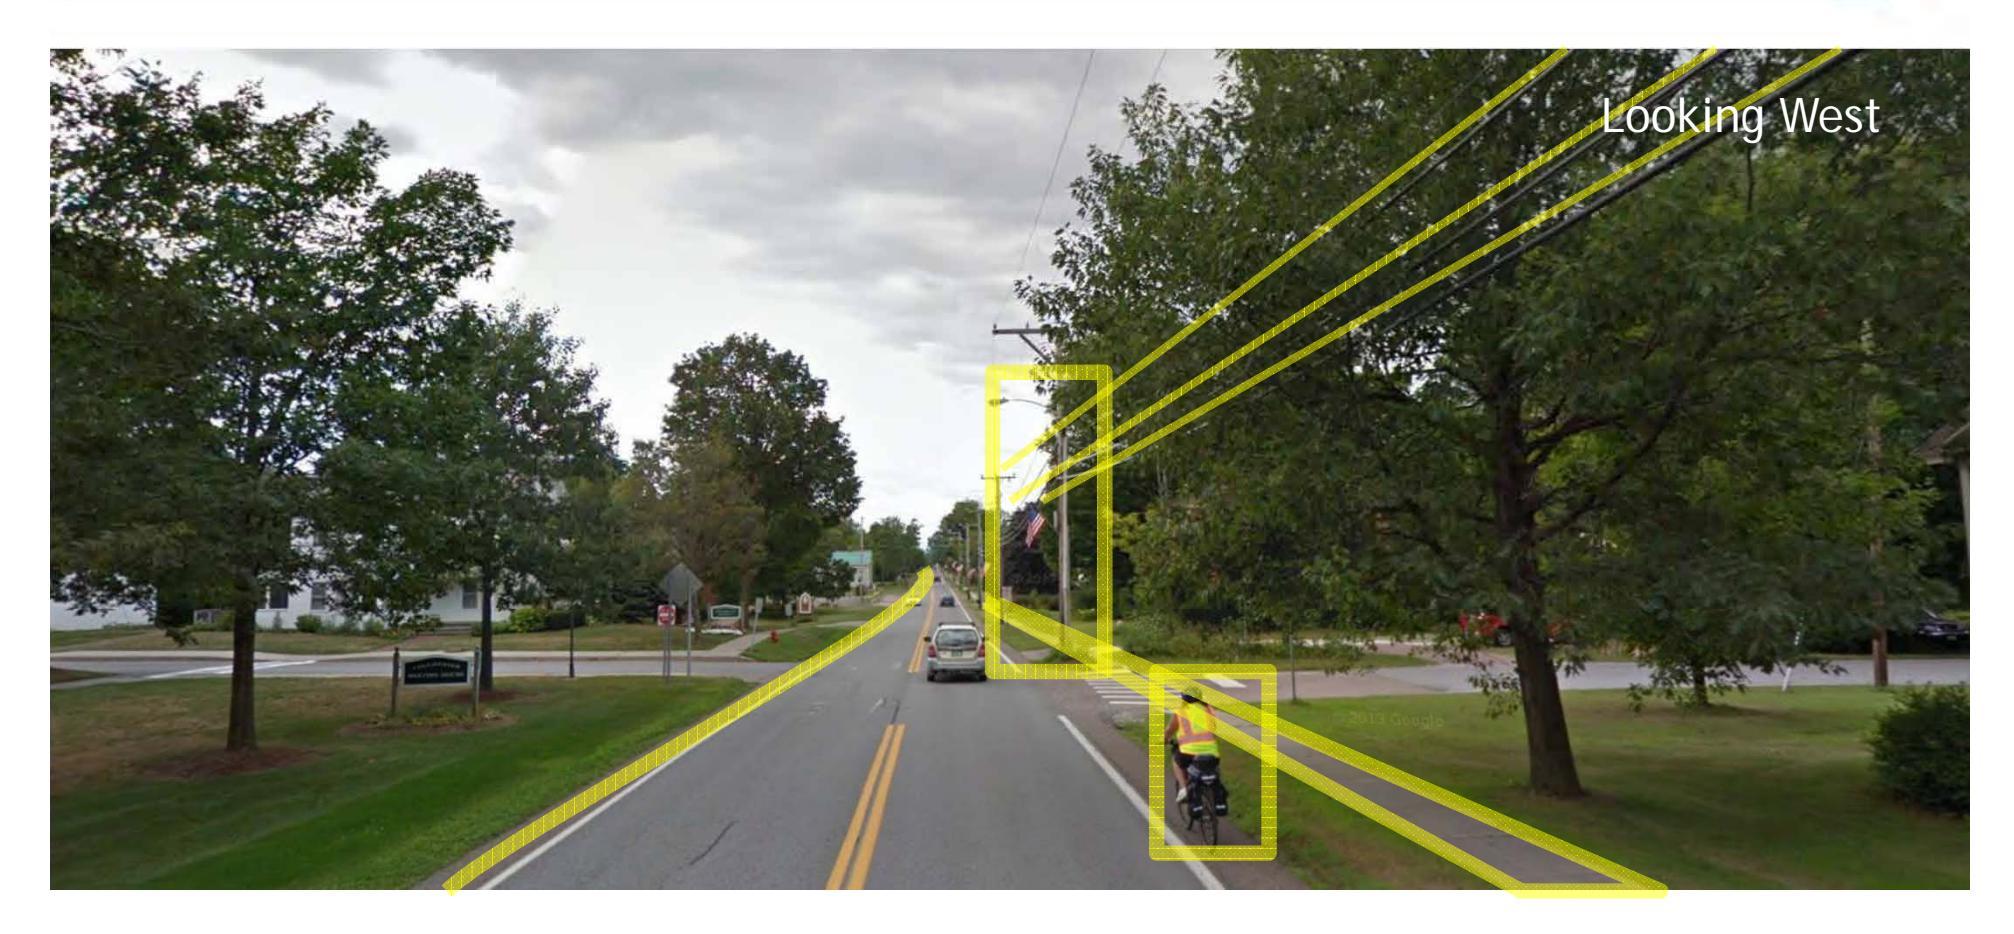
Main Street Today in the Village

- Utility & light poles on the north side, east of Village Rd (3' off edge of pavement)
- 4' sidewalk on the north side
- \approx

Drivers veer towards the center of the road to avoid bicyclists in the narrow shoulder

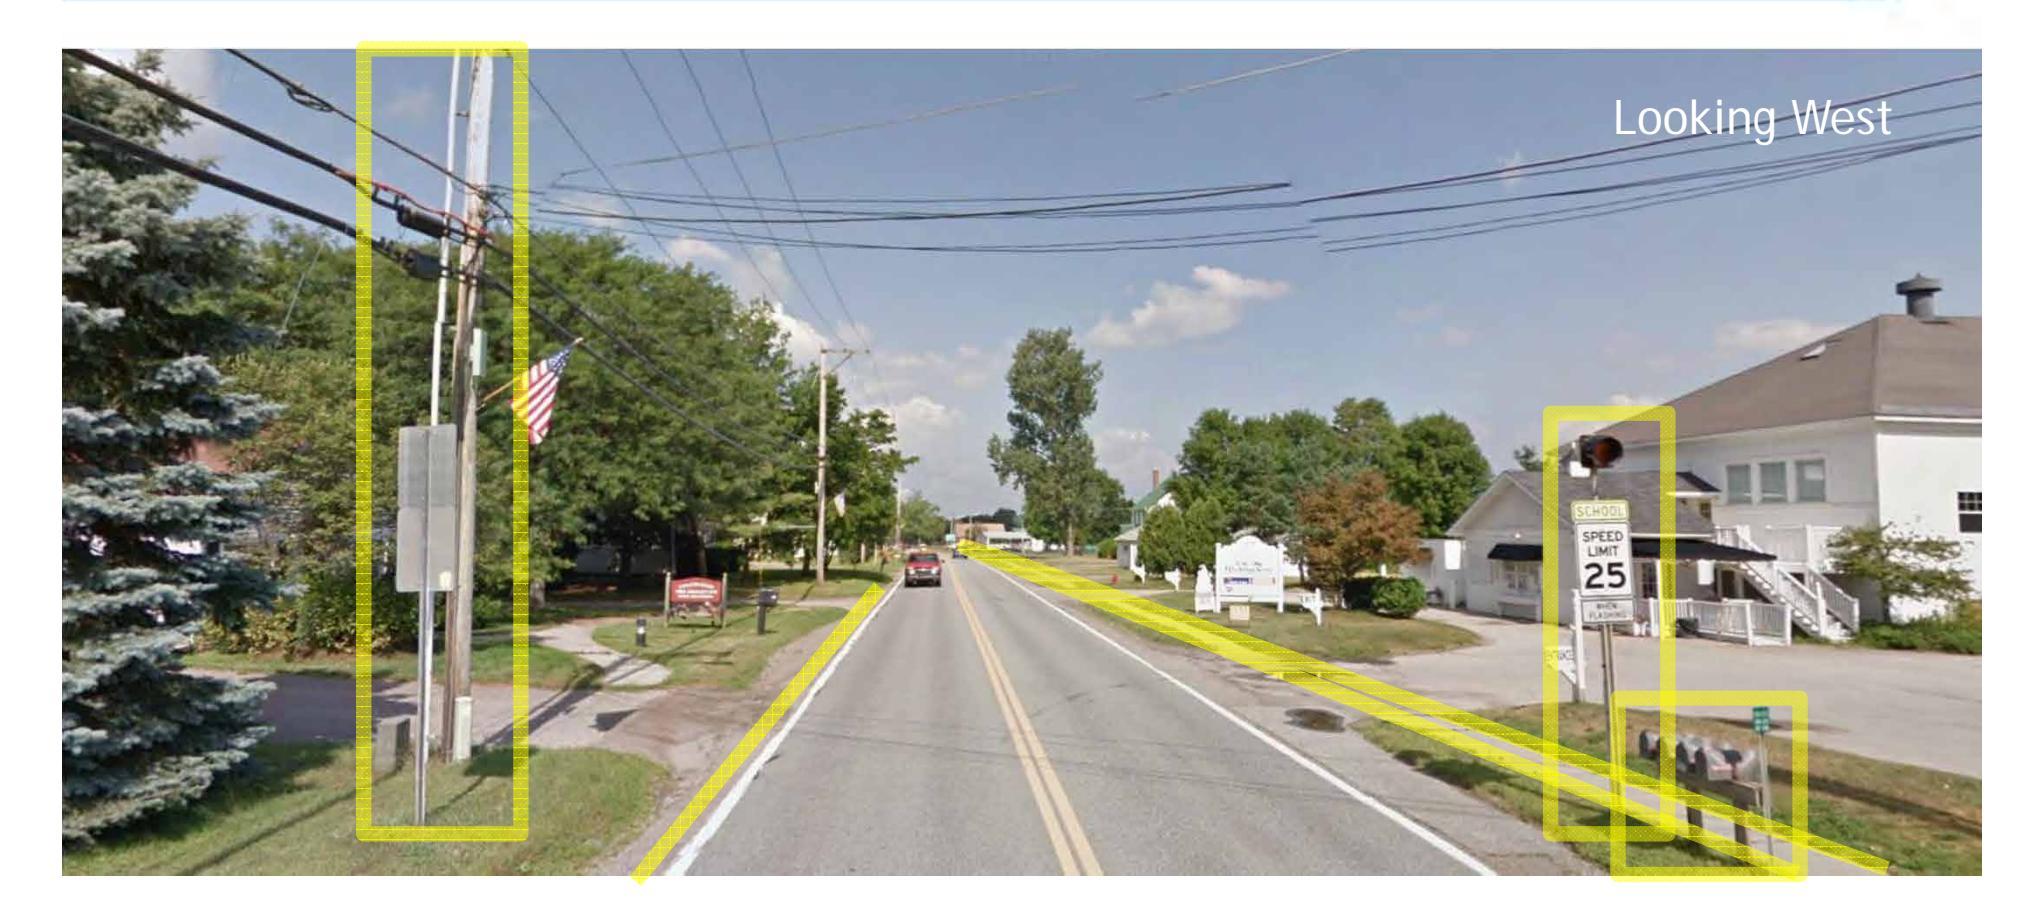
Main Street Today

- Utility & light poles on the south side, west of Village Dr. (~8' off edge of pavement)
 - 4' sidewalk on the north side
- \approx

Considerations for signage, mailboxes in landscaped buffer

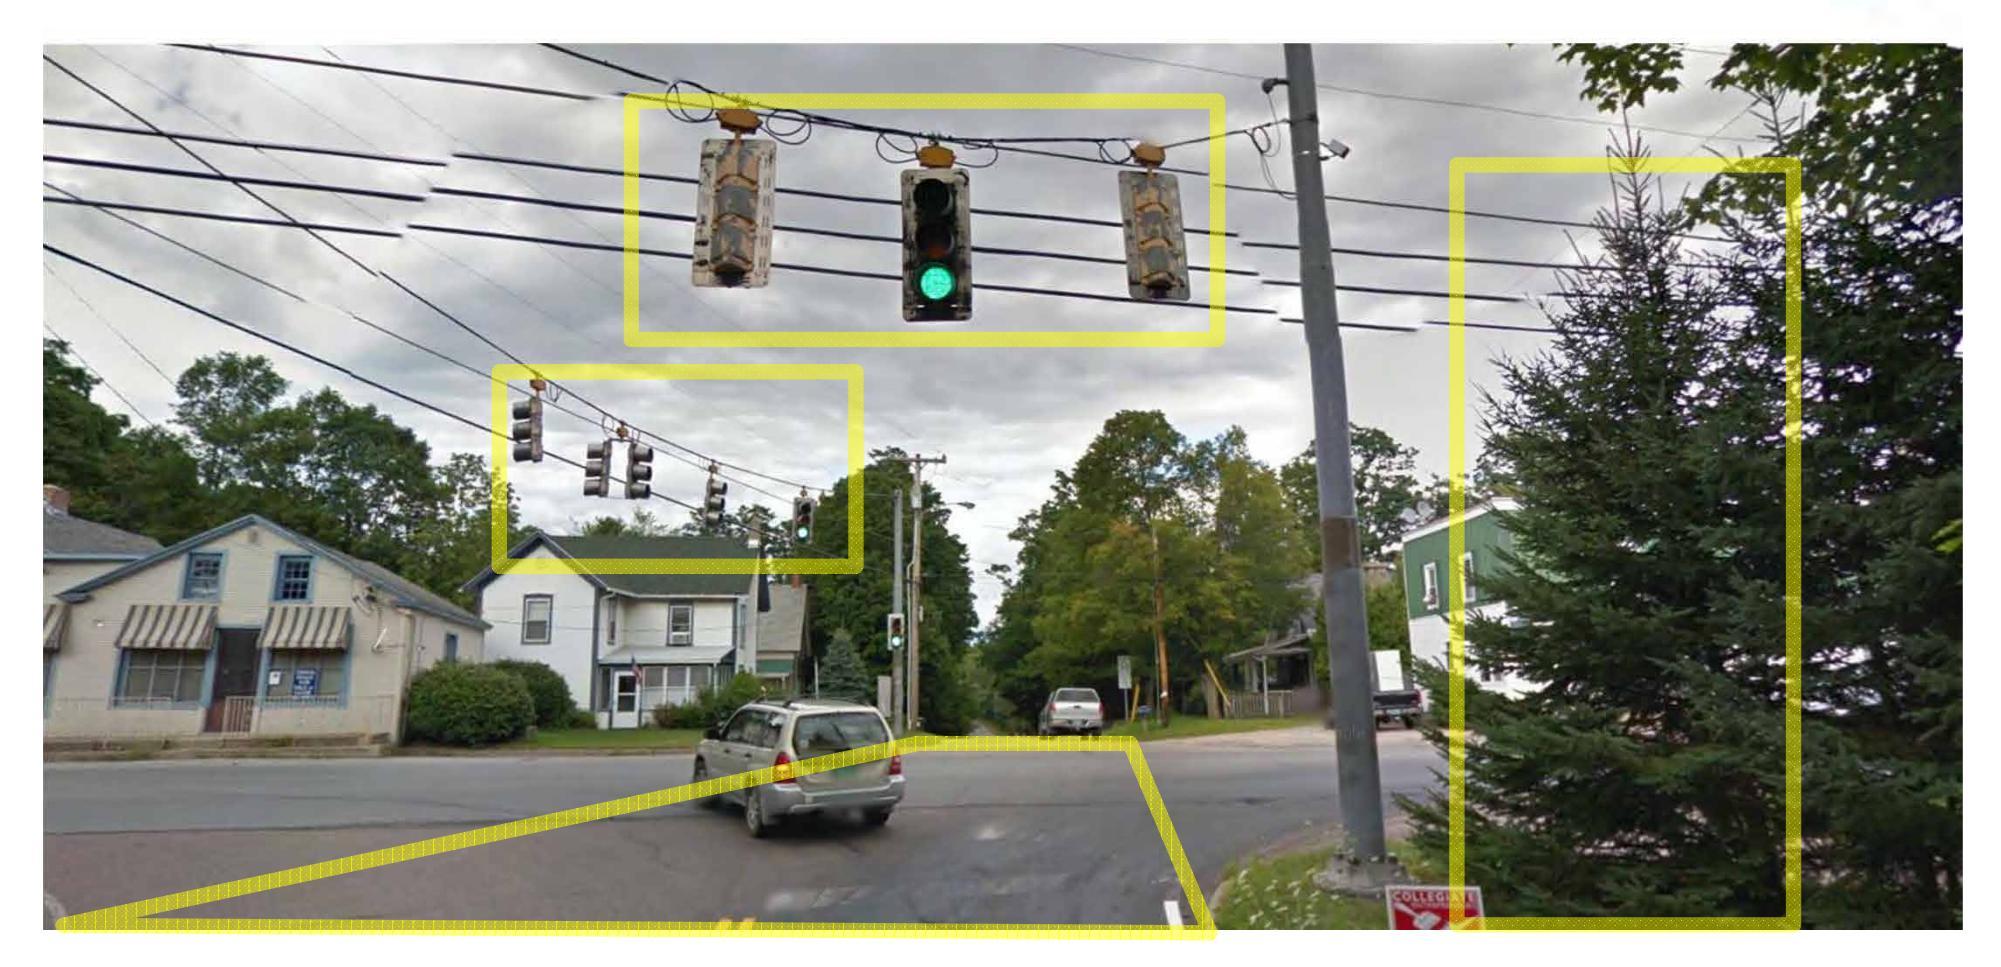
Main Street, Mill Pond Road, and East Road Today

- Topography and alignment
- Poor sight distances
- Potential for signal optimization

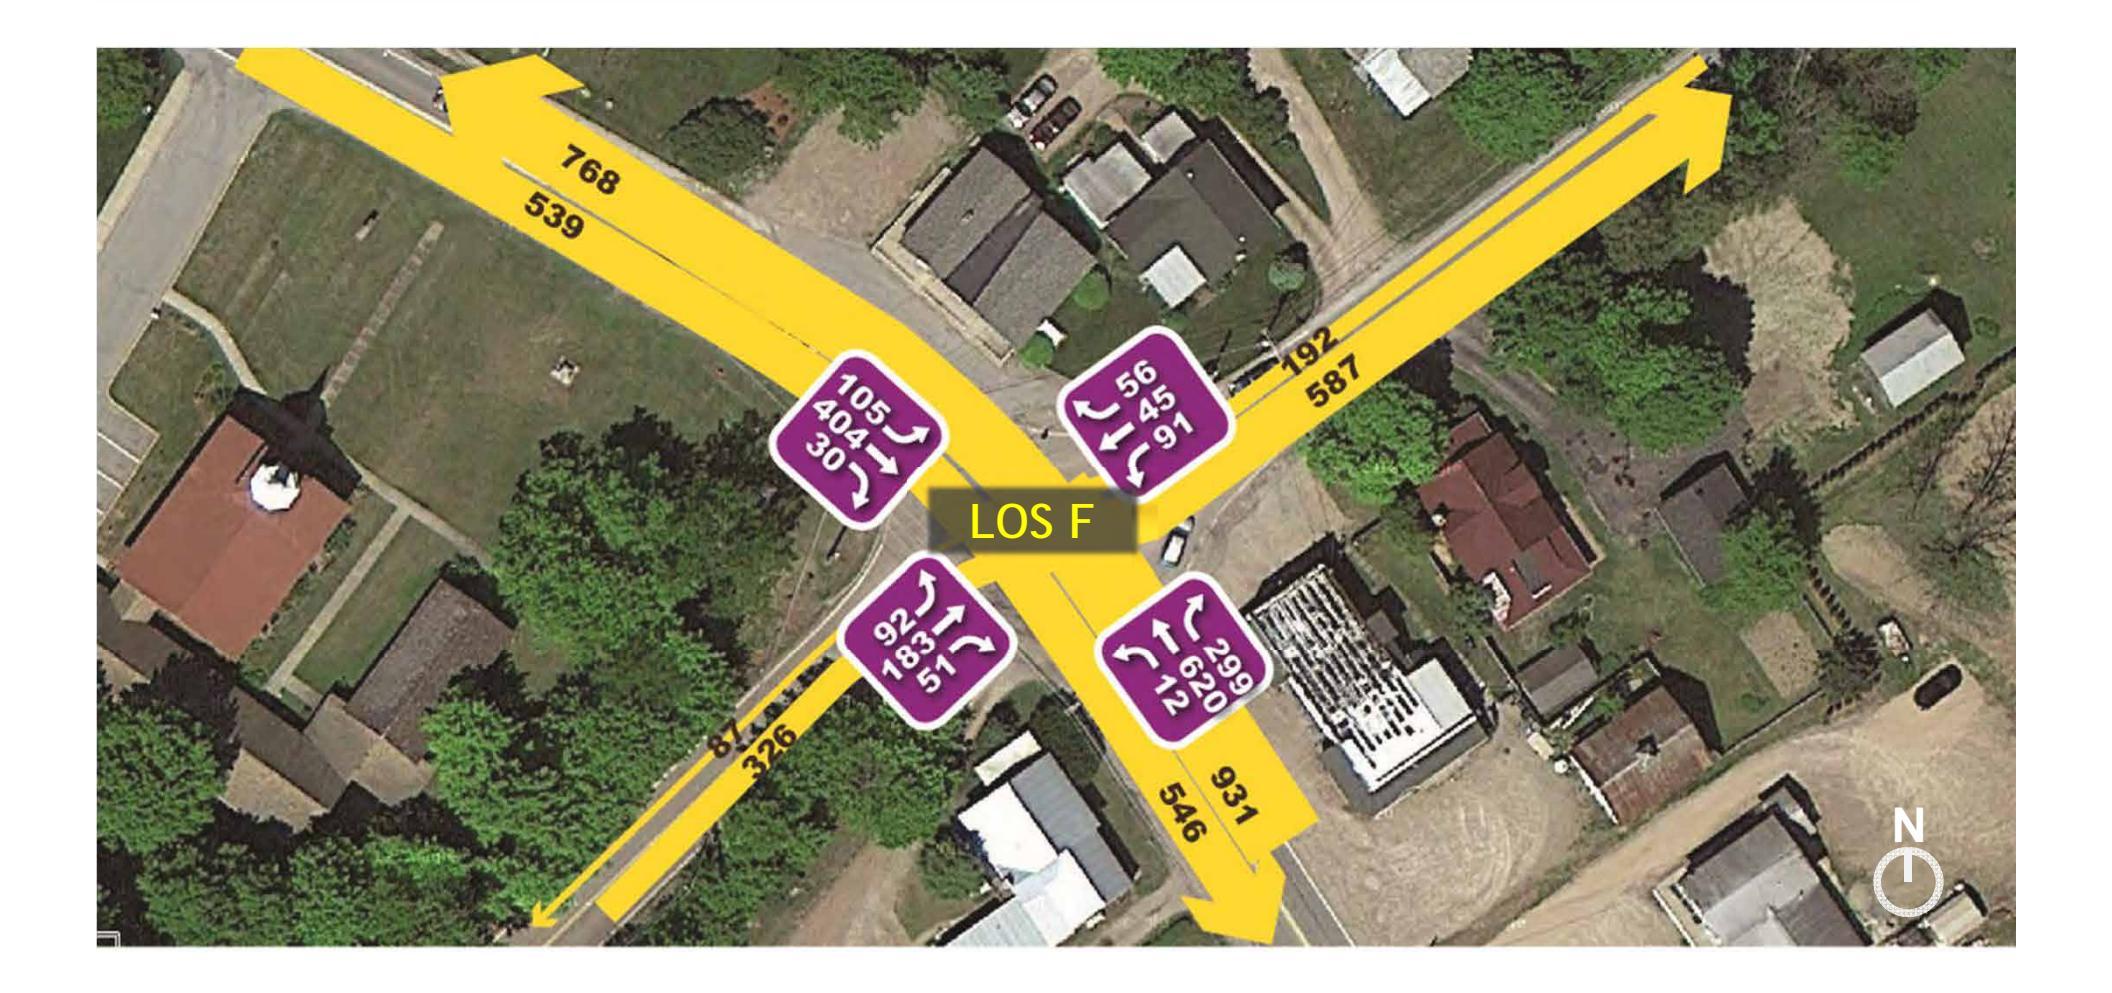
Main St, Mill Pond Rd, and East Rd in 2030 (PM Peak)

2030		
	LOS	Delay (seconds)	Queue (feet)
1. No Build, no detection	F	100+	6 ft – 140 ft
2. Optimize signals + Detection, with dedicated left-turn pockets in both directions on VT 2A	Е	64	7 ft – 37 ft

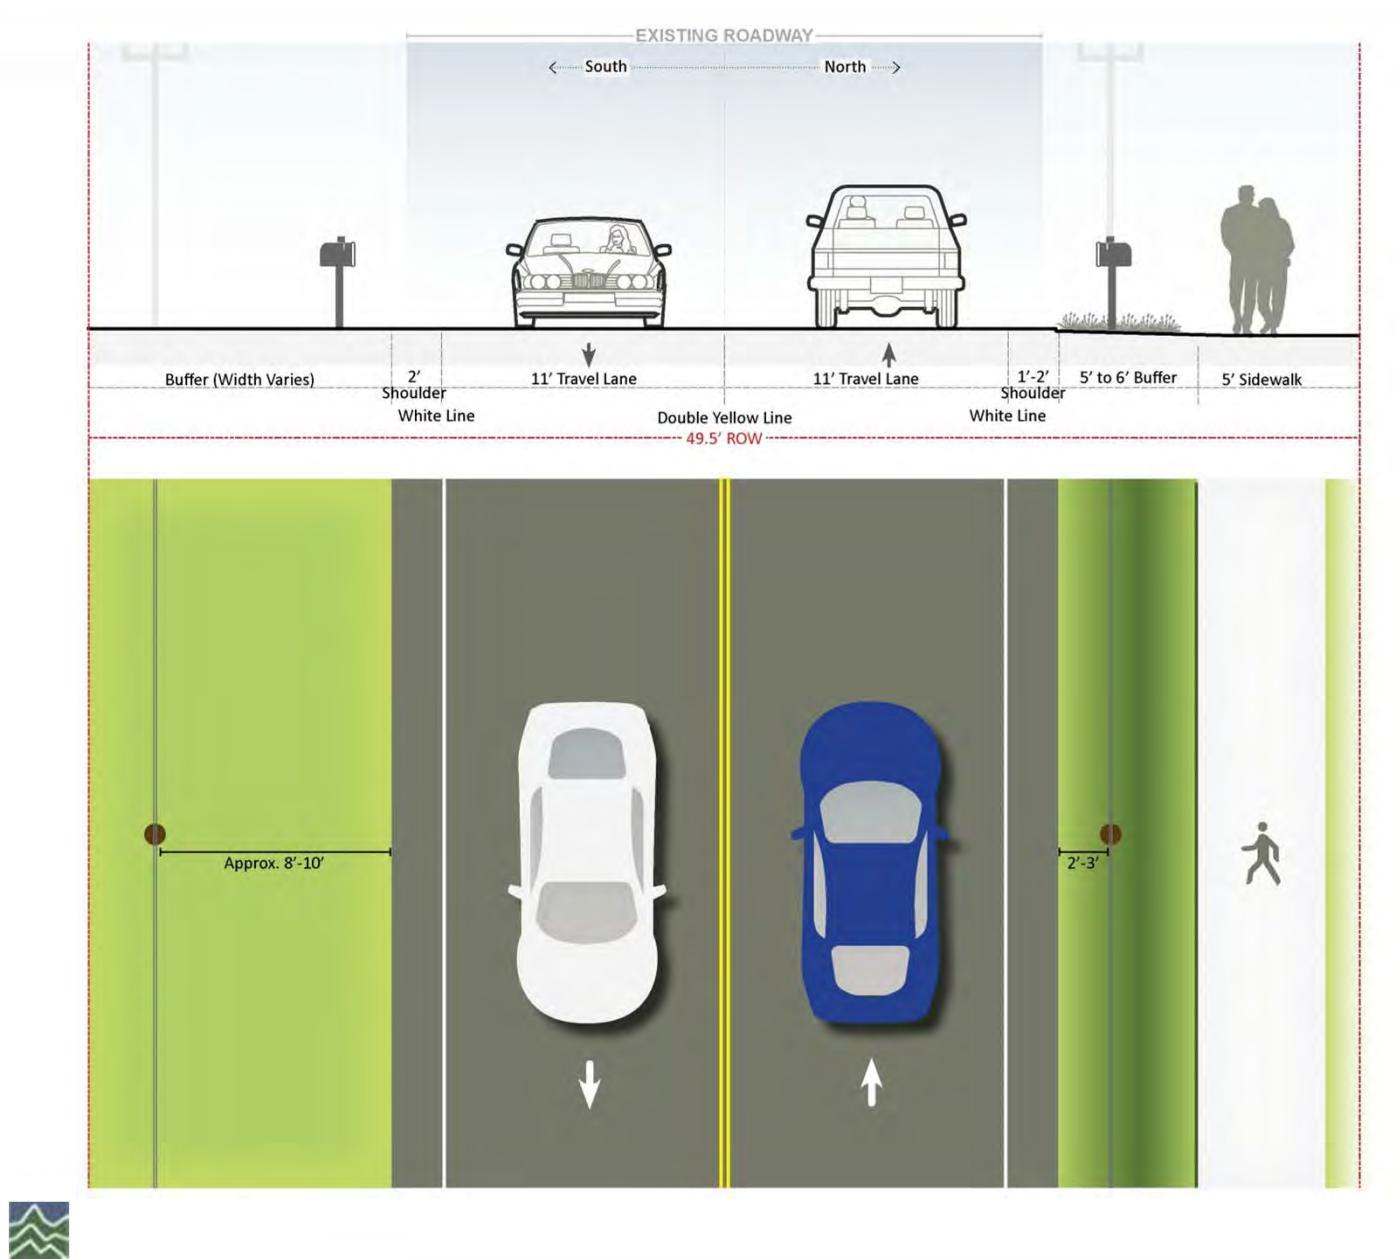
Alt 1: Walkable Neighborhood – Street Section

Utility poles are located on either the south or north side of Main Street, not both. This figure shows how they may be accommodated in both situations.

All utility poles remain in existing locations.

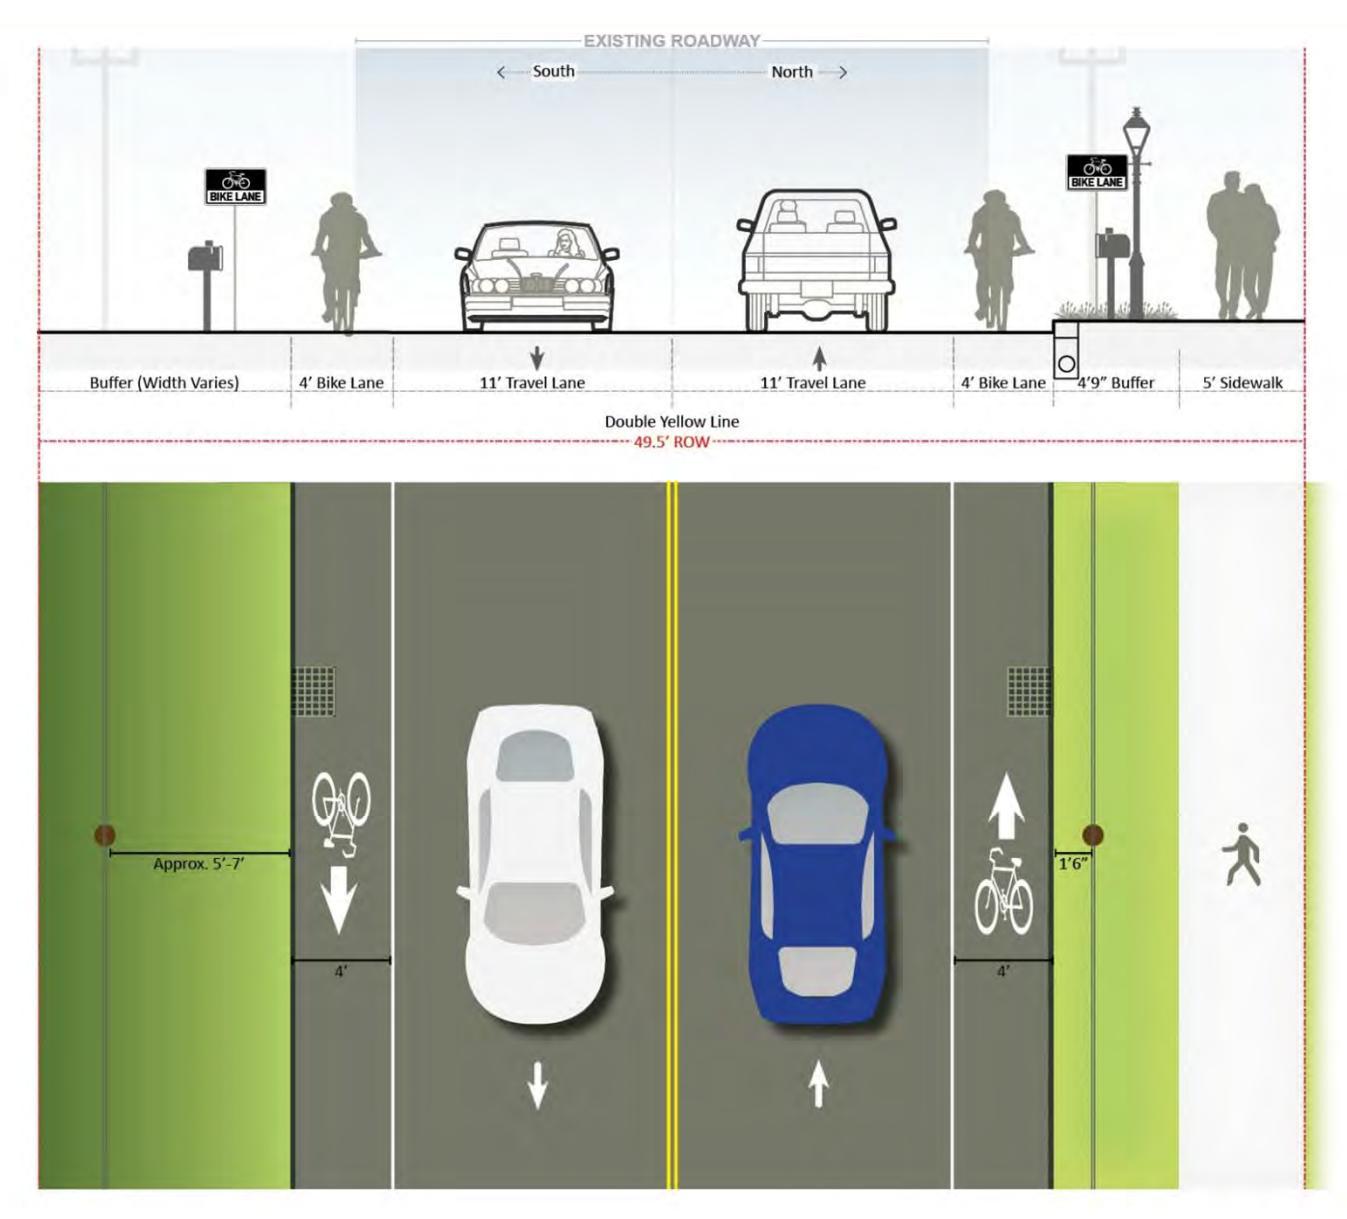
Alt 2: Main Street Character – Street Section

- Utility poles are located on either the south or north side of Main Street, not both. This figure shows how they may be accommodated in both situations.
- Utility poles on the north side shifted by approximately 1'6" to accommodate bike lane and plow.
- Utility poles on south side remain in existing location.

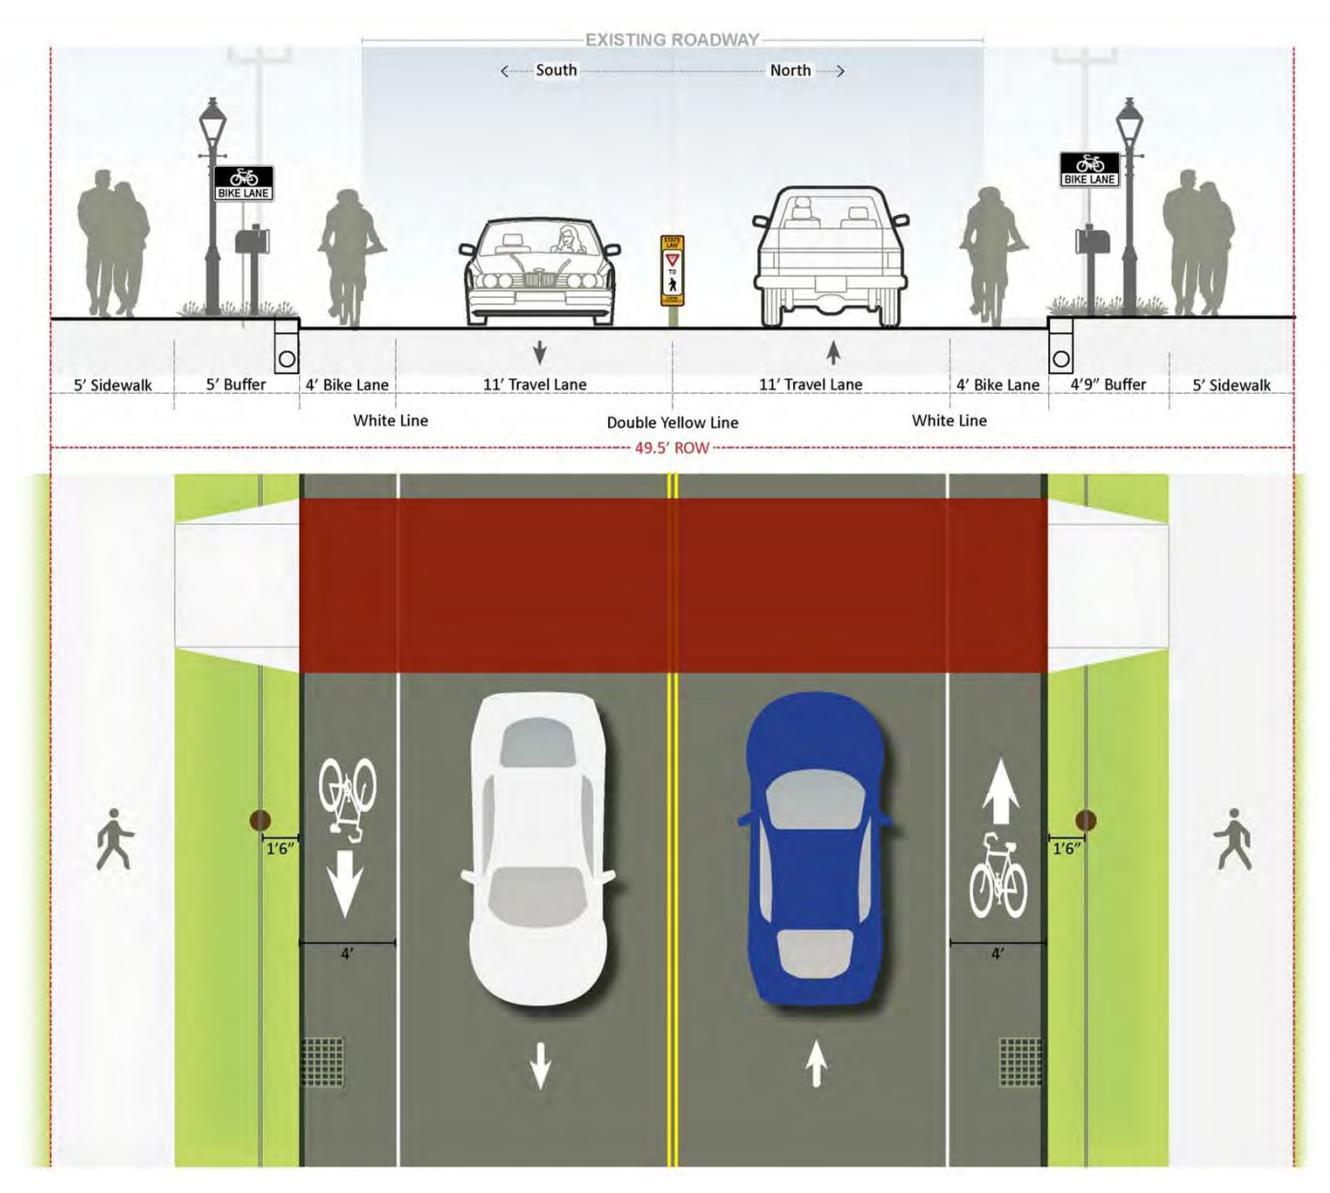
Alt 3: Village Destination – Street Section

- Utility poles are located on either the south or north side of Main Street, not both. This figure shows how they may be accommodated in both situations.
- Utility poles on the south side shifted by approximately 5'10" towards the road to accommodate sidewalk and landscaped buffer.
- Utility poles on north side shifted by 1'6" away from the road to accommodate bike lane and plow.
