# Protocol for Identification of Areas Sensitive to Landslide Hazards in Vermont

Prepared for the Vermont Geological Survey by

December 31, 2012

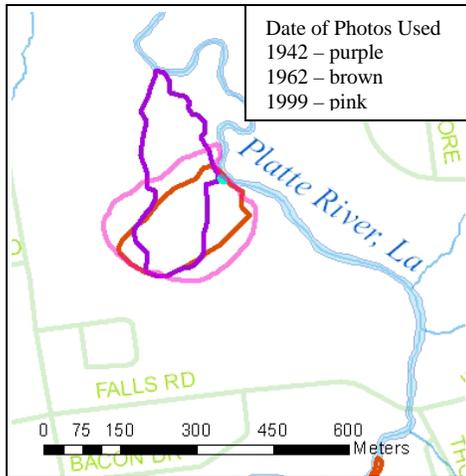
This drawing shows the outlines of a low-angle rotational slide in the La Platte River site area. Each different color outline was made during photo interpretation of different date aerial photographs. All of these landslides are the same and therefore have the same LS\_ID number SLP-02.

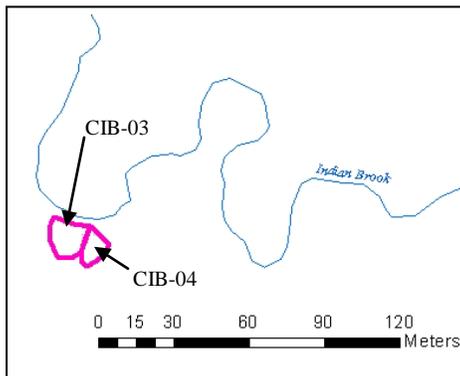
This drawing shows the outlines of two translational slides in the Indian Brook site area. The slides share a boundary, but are distinct slides and therefore have different LS\_ID numbers, CIB-03 and CIB-04.

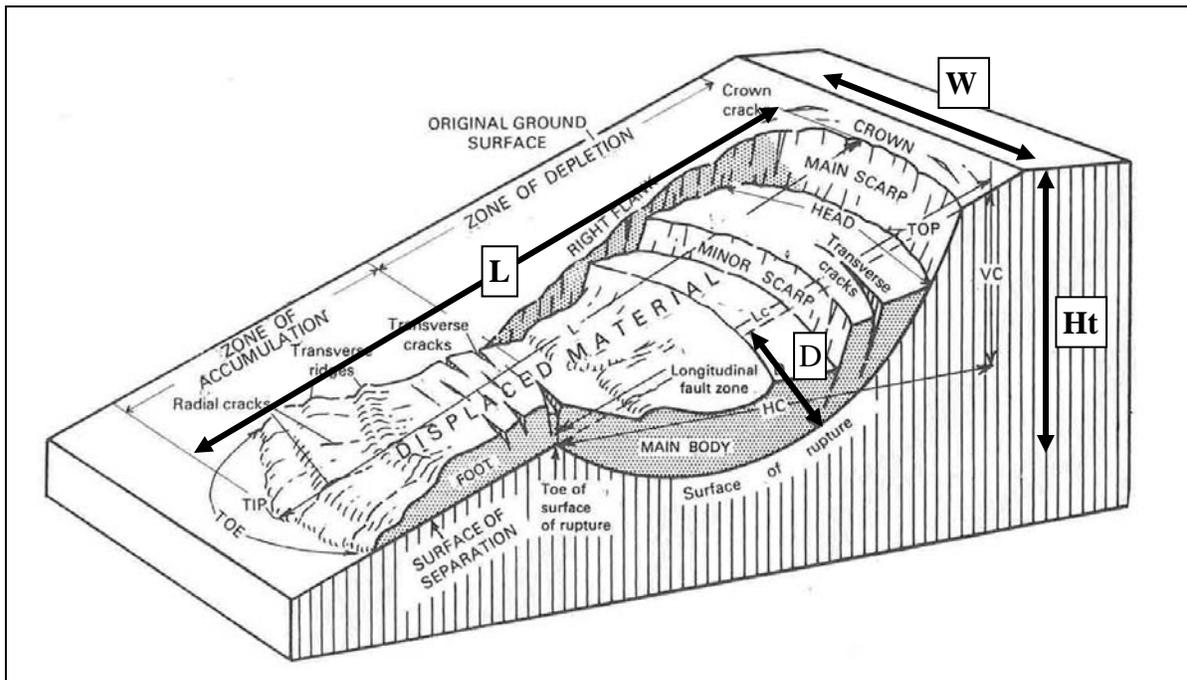
Figure 1. Generalized complex rotational slump/flow showing principal features. Landslides with this overall form are common on clayey to sandy lacustrine deposits throughout Vermont. In many cases the displaced material has been at least partially eroded away by stream flow. Length (L) refers to the total slope length from crown to the tip of the toe. Width (W) refers to the width of the feature measured across the slope at the location of greatest width. Depth (D) is measured in a vertical plane and perpendicular to the original slope. Height (Ht) refers to the vertical height from the toe up to the top of the slide. Modified from Cruden and Varnes (1996, Figure 3-3).

*Height:* The vertical height should be obtained, when possible, by actual measurement. This may be done by tape and clinometer, rangefinder and clinometer, or by hand-leveling up the feature. Shown as Ht on Figures 1 and 3.

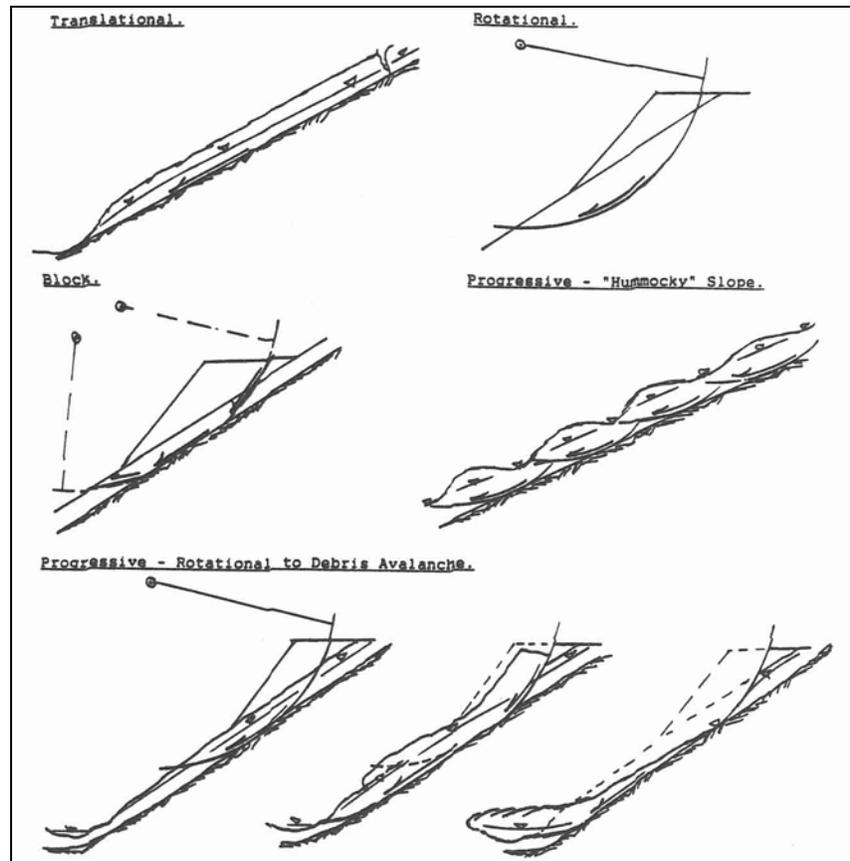
Figure 2. The translational and rotational forms of slope failures and composite forms. The pure translational slide would have a tension crack at the top and be completely translational from there down. Actual translational slides will often have some shearing motion in the upper part and may well break out in the lower parts as one or more rotational shears. The lower set of three sketches shows a rotational slide progressively changing to a debris avalanche or flow as a result of the disaggregation of the sliding mass. From Prellwitz and Remboldt (1994, Figure 5A.2).

The most common types of landslides in Vermont are the slides, which take two general forms as shown in Figure 2; rotational slides (here called rotational slumps) and translational slides. The translational slides generally occur on unstable slopes underlain by weathered, dense till, as well as slopes underlain by sandy to clayey lacustrine deposits, while the rotational slides (here called rotational slumps) are more common on unstable slopes underlain by sandy to clayey lacustrine deposits. Both rotational and translational failures imply that the material has internal cohesion, otherwise the material would disintegrate into some sort of flow. They are described in more detail in the following sections.

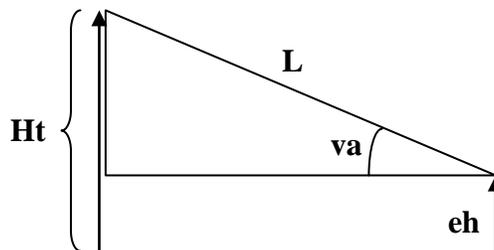
Figure 3. Calculation of height of a landslide. L = slope distance, va = vertical angle, eh = eye height, Ht = total height of landslide.

One way to calculate the height is use the formula  $Ht = L\sin(va)$ , where Ht = height, L = slope distance, and va = the vertical angle from the top of the slide to the toe. The slope length L can be measured with either a tape or a laser rangefinder. The vertical angle needs to be measured with a clinometer. If the measurements are made by a person standing at the bottom of the slope, then the eye-height (eh) of the person needs to be added to the calculated height as follows:  $Ht = (L\sin(va)) + eh$ .

Example:  $L = 18.6$  m,  $\nu_a = 36^\circ$ , and  $e_h = 1.8$  m.

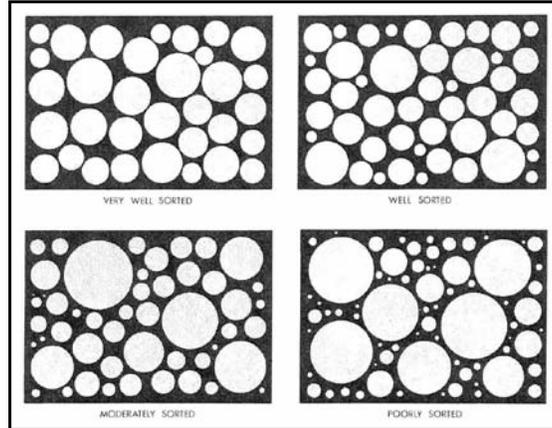
Figure 3. Sorting of particles. Very well sorted materials have uniform grain size (upper left) while poorly sorted materials have a wide variation in grain size (lower right). From Boggs (1994).

*Sorting:* Sorting is the degree to which grains are of a uniform size (Figure 3). A very well sorted material has a uniform grain size while a very poorly sorted material has a wide range in grain sizes. The soil engineer’s term “grading” is the inverse of sorting, with well graded soils having a wide variety of grain size and uniformly/poorly graded soils being of uniform size.
